SERVICE BULLETIN

SB-033018 REV B

DATE ISSUED: 5/13/2018
DATE EFFECTIVE: 4/1/2018
SUPERSEDES NOTICE: N/A
SUBJECT: Engine oil return fitting clearance and torque checks

AIRCRAFT AFFECTED: **MODEL:** ICON A5
S/N: 00001-00036

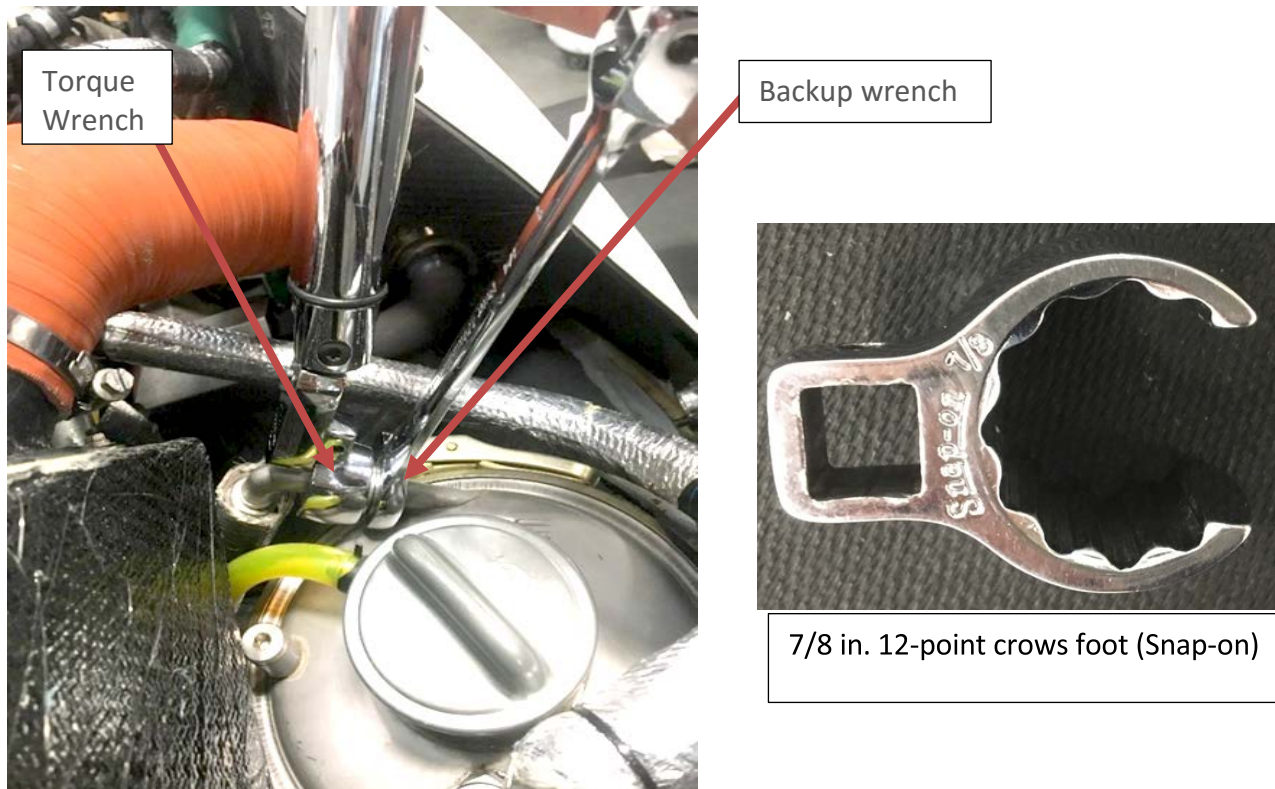
CAUTION: Ensure a back-up wrench is used on the oil tank fitting during torquing process. Damage to the oil tank may occur if a back up wrench is not used.

Figure 1: Engine Oil Tank return hose fitting torquing and 7/8 in. 12-point crows foot special tool

1. ____ Torque the oil tank oil return hose fitting to 300-350 in-lb. Use a back up wrench to oppose the torque as shown in Figure 1. This torquing method will require a torque offset calculation detailed in FAA Advisory Circular 43.13-1B chapter 7 Figure 7-2.

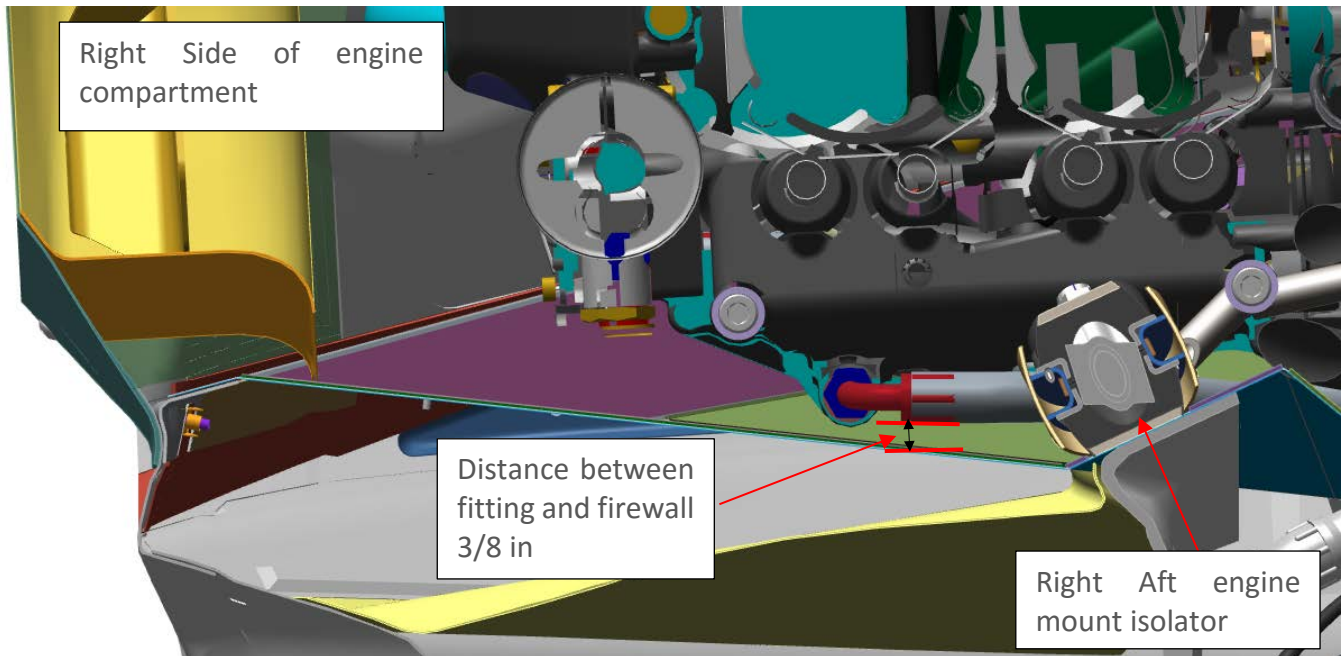
Figure 2: Clearance between oil return hose fitting and firewall

2. ____ Check the clearance between the firewall and the engine oil return fitting. The clearance should be set to approximately 3/8" from the firewall. If not set the initial torque in step 3,

annotate the results then lightly loosen the oil fitting to adjust. Torqueing of the fitting is in step 3 and 4 below.

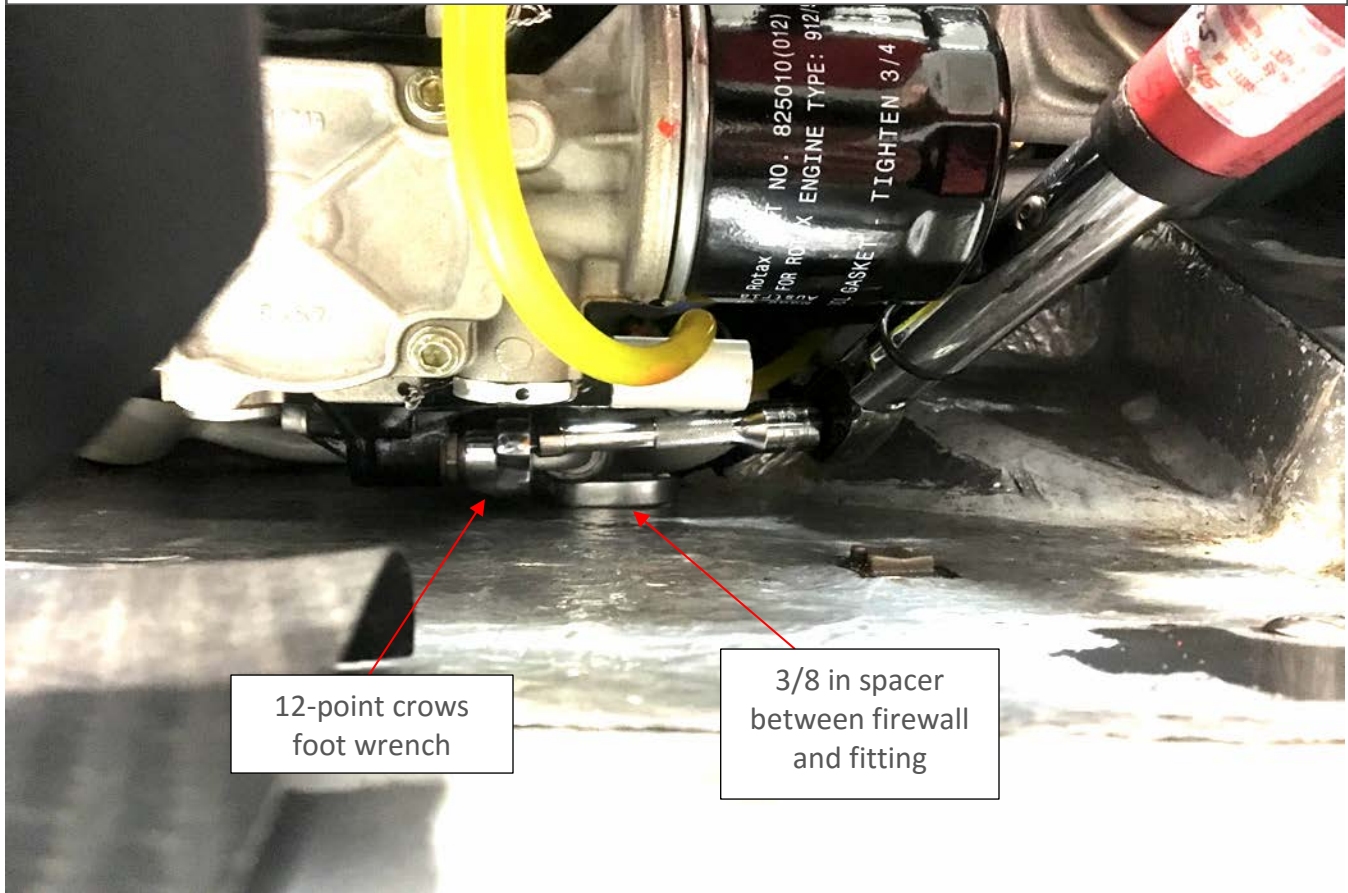
Figure 3: Engine oil return line fitting torquing

3. ____ Set the initial torque of the engine oil return line 90° fitting to **150 in-lb**. This can be done **without** removing the engine if using a 7/8 in. 12-point crows foot wrench. Place an approximate 3/8" shim block between fitting and the firewall while torqueing to ensure the fitting doesn't move closer to the firewall during the torqueing process. This torque will also require a torque offset calculation detailed in FAA A.C. 43.13-1B chapter 7, Figure 7-2. This operation is shown in Figure 3 below: **Note below if the fitting moves while torqueing to 150 in-lb. This information will be required to receive reimbursement for the warranty claim.**

4. ____ Using the same procedure in step 3 set the final torque of the engine oil return line 90° fitting at **300-350 in-lb.**
