SERVICE BULLETIN

SB-041018 REV B

DATE ISSUED: 6/14/2018
DATE EFFECTIVE: 6/14/2018
SUPERSEDES NOTICE: SB-041018-A
SUBJECT: Rudder pedal brake master cylinder lower attachment bolt replacement and rod end inspection

AIRCRAFT AFFECTED: **MODEL:** ICON A5
S/N: 00001-00020, 00022-00036

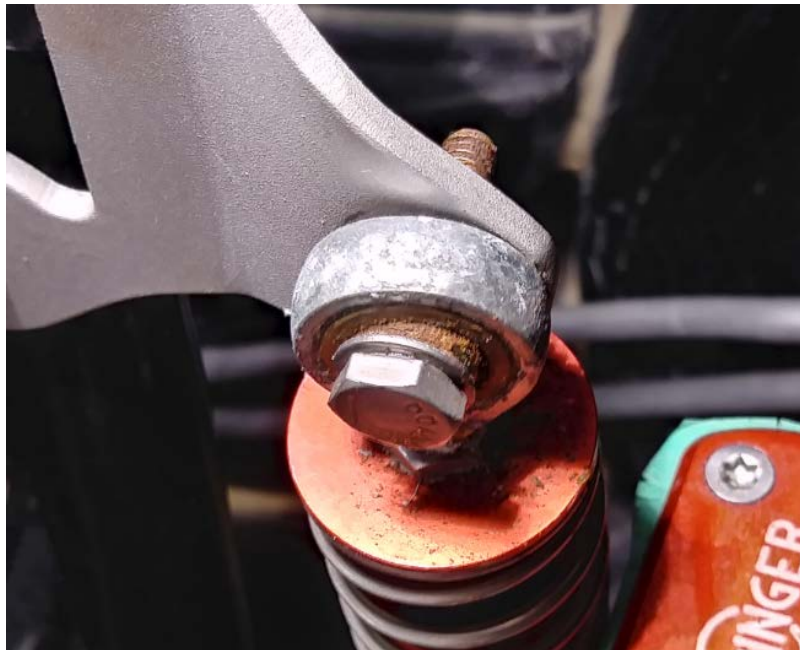
1. Inspect all brake master cylinder rod ends for corrosion. If corrosion is present replace the rod end with new by following the below procedure. An example of unacceptable corrosion is shown in Figure 2.
2. If **NO** corrosion is present lubricate all brake master cylinder rod ends using a needle nose grease fitting adapter and Molykote G4700. Post lubrication, conduct lower attachment bolt replacement procedure below.

Figure 2: Unacceptable Corrosion on rod end.

1. Remove both upper and lower brake master cylinder attachment bolts and retain hardware for re-installation
2. Remove corroded rod ends and discard
3. Replace corroded rod ends with new ZM-001 Rod ends. Lubricate the rod ends with Molykote

4. Apply Loctite 243 to the new rod end threads prior to installation.
5. Set the distance between both rod ends (center of rod end to center of rod end) to 6.94 +/- 0.05 inches for S/N: 00022-00036 or 7.82 +/- 0.05 inches for S/N: 00001-00020.
6. Lock jam nuts and torque to 40-50 in-lb.
7. Reinstall brake pedal to brake master cylinder attachment bolt, washers, and bushings torque to 20 in-lb.
8. After complete, proceed to the brake master cylinder attachment bolt replacement procedure below:

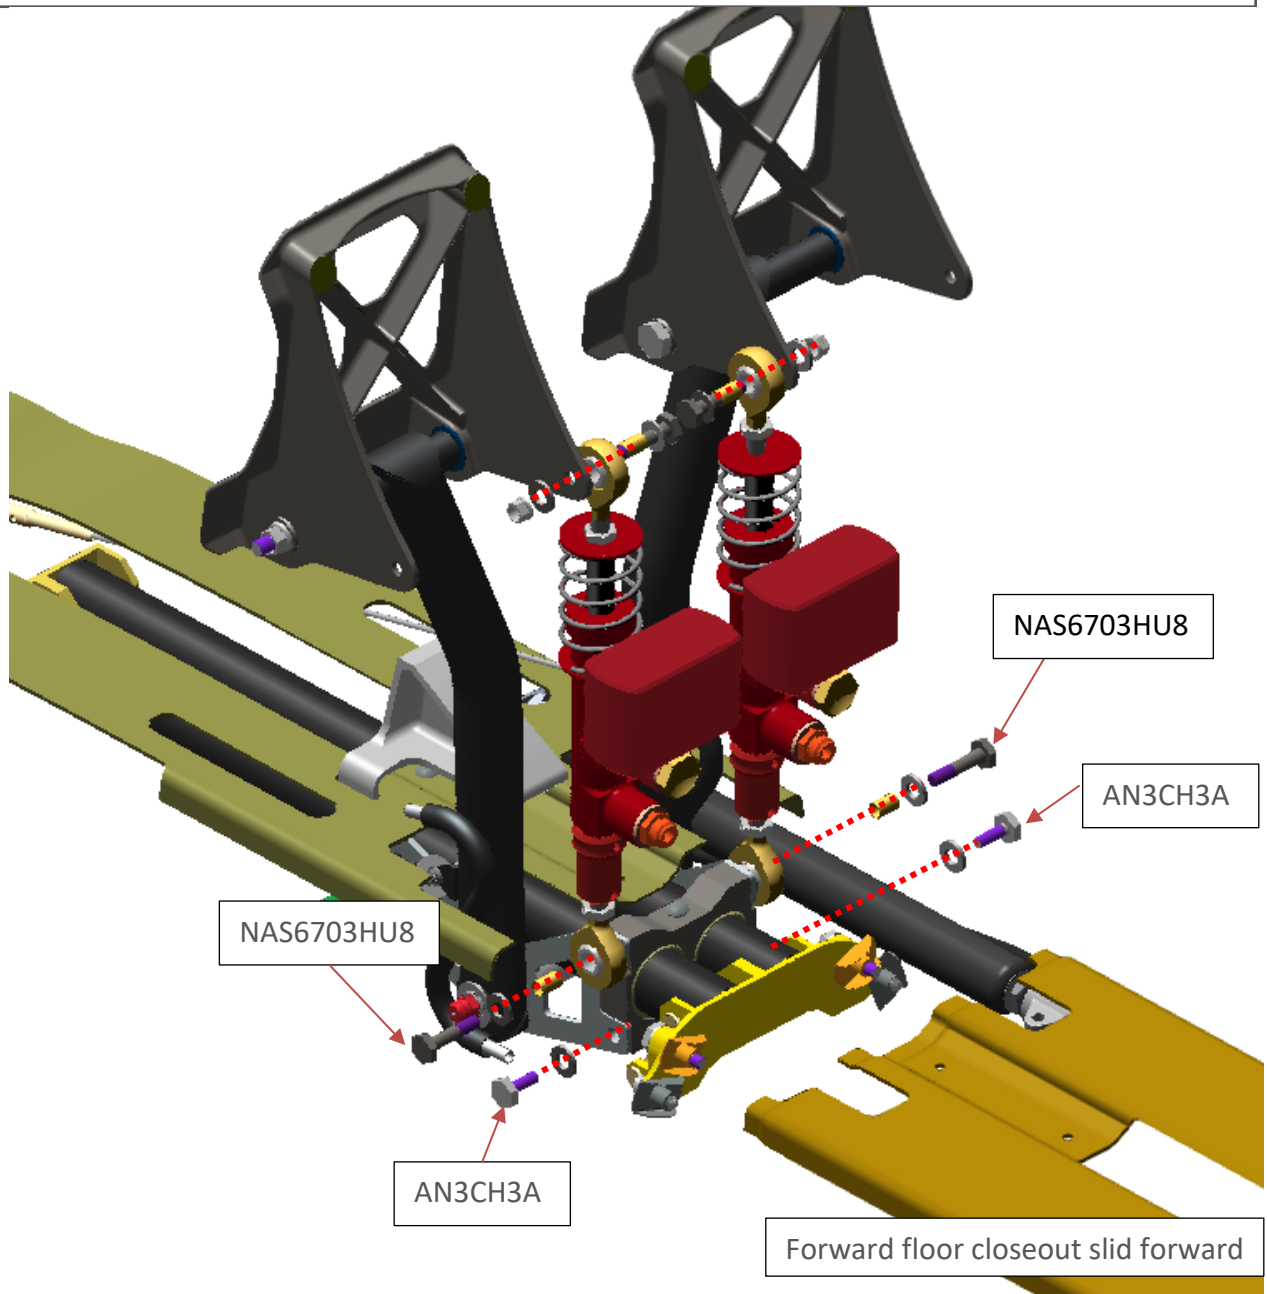
Figure 3: Brake master cylinder and rudder pedal carriage bolts to be replaced. Founder's Edition copilot rudder pedal design shown.

1. Remove the brake master cylinder lower bolts and discard, retain the washer and bushing.
2. Install new brake master cylinder lower attachment bolt with NAS6703HU8 bolt, torque to 26 in-lb as shown in figure 3 below.
3. Remove lower forward rudder pedal mechanism carriage bolt as shown in figure 3.
4. Install new lower forward rudder pedal mechanism carriage bolts with AN3CH3A, torque to 26 in-lb.
5. Safety wire the two bolts on each side together using 0.032" in safety wire as shown in Figure 4.
6. Repeat steps 1-5 of this procedure for both sets of rudder pedals.
7. Reassemble the aircraft.

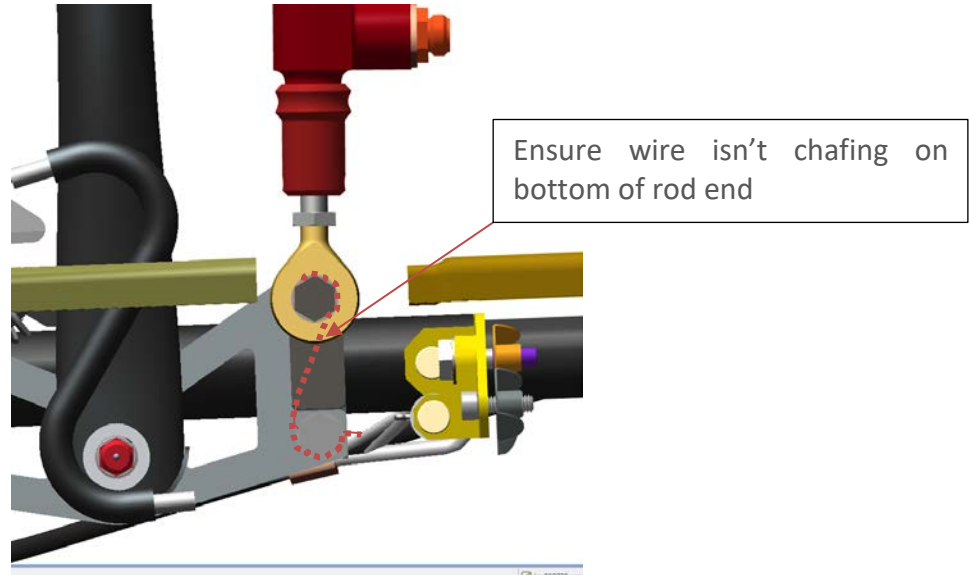
Figure 4: Safety wire detail.
