## SERVICE BULLETIN

SB-050718 REV A

**DATE ISSUED:** 5/18/2018  
**DATE EFFECTIVE:** 5/18/2018  
**SUPERSEDES NOTICE:** N/A  
**SUBJECT:** Torque verification on vertical tail forward attachment bracket and aft pitch pulley pivot bolt

**AIRCRAFT AFFECTED:** **MODEL:** ICON A5  
**S/N:** 00022-00027

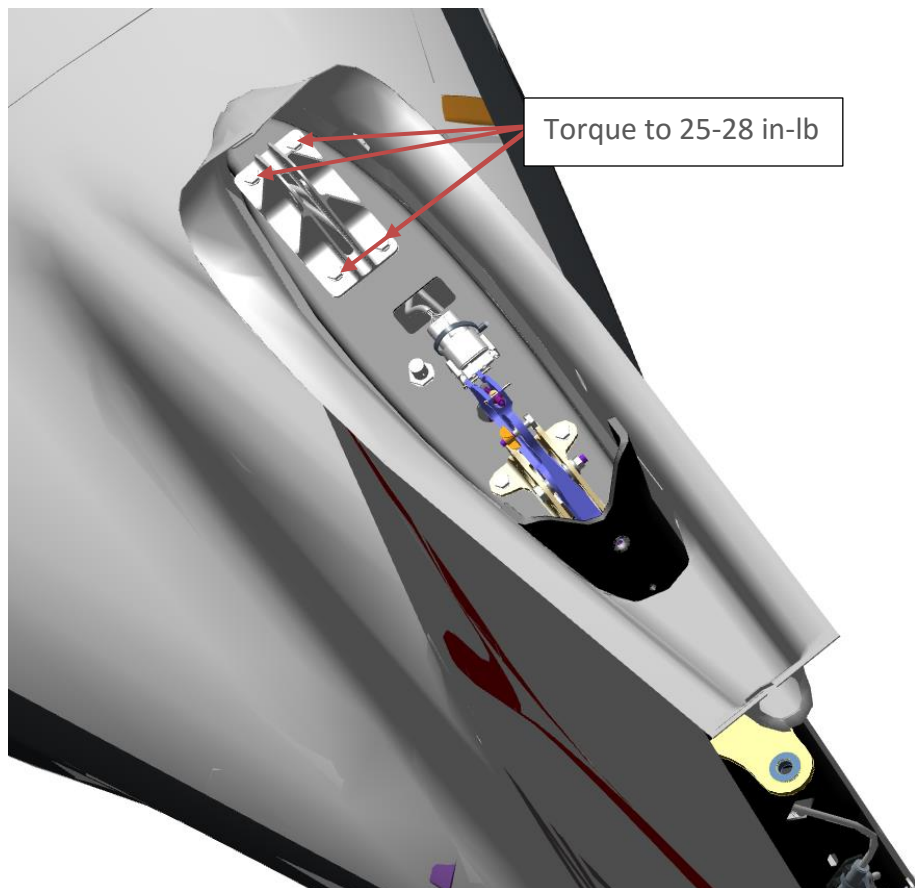
Figure 1: View of the vertical tail with the horizontal tail removed

ICON is committed to designing, manufacturing, delivering, and supporting a high quality Light Sport Aircraft, providing a level of safety well beyond expectations. Recently received production quality issue reports indicated that the horizontal tail attachment bracket and aft pitch pulley pivot hardware may be under torqued. Inspection of several aircraft has shown that the horizontal tail attachment hardware were slightly under torqued but clamped to the vertical tail rib. Additionally, the aft pitch pulley pivot bolt was also found slightly under torqued but clamped to the attachment bracket. Verify correct torque on the forward horizontal tail attachment bracket attachment hardware and aft pitch pulley pivot bolt.

1. Torque all four forward horizontal tail bracket to vertical tail attachment hardware to 25-28 in-lb as shown below in Figure 1. Prior to torquing mark all bolts then back them off by one-quarter turn, then proceed to torque them to the set value.
