SERVICE BULLETIN

SB-051818 REV C

DATE ISSUED: 6/27/2018
DATE EFFECTIVE: 6/27/2018
SUPERSEDES NOTICE: SB-051818 Rev B
SUBJECT: Rudder Centering Spring Replacement

AIRCRAFT AFFECTED: **MODEL:** ICON A5
S/N: 00022-00028,00030-00036, 00039
REQUIRED ACTION: Remove and Replace the Rudder Centering Spring

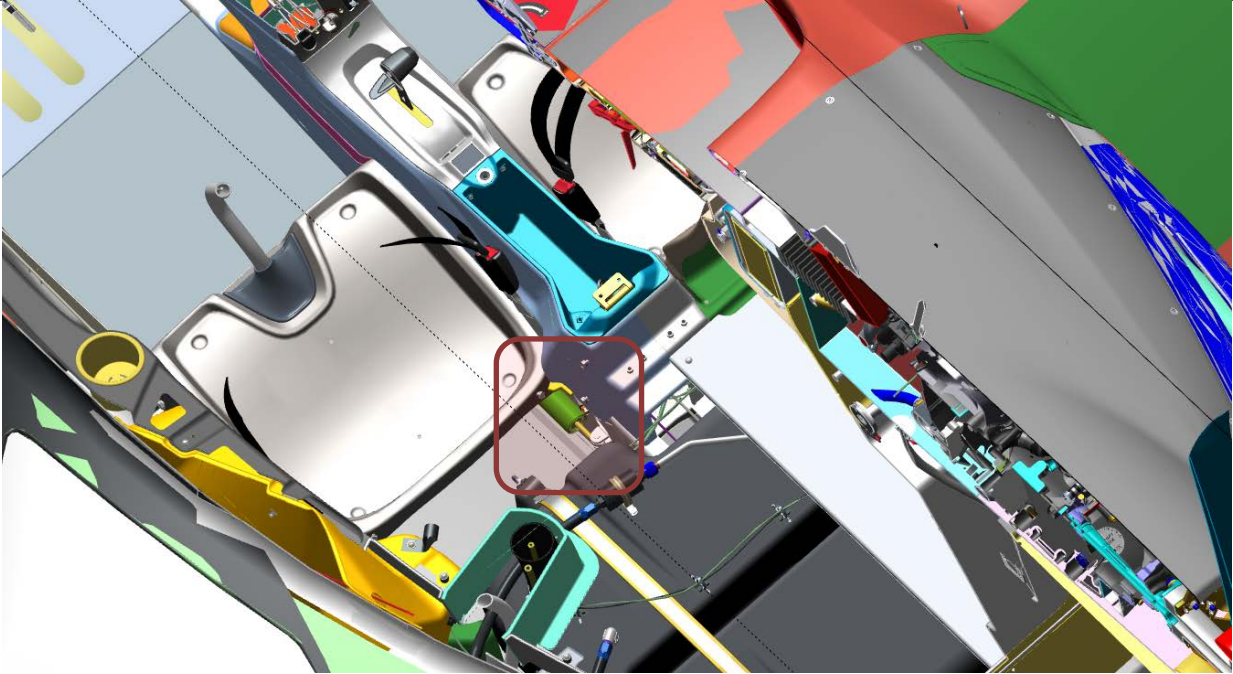
Figure 1: Location of Rudder centering spring (identified in red box)

1. It is permissible to disassemble the aircraft as required to permit accessibility, inspection, adjustment, maintenance, and repair in accordance with the latest release of the Aircraft Maintenance Manual, ICA000833.
2. Remove, the right and left side baggage floors, left main cockpit side panel, left seat aft closeout, and left seat back.
3. Remove the rudder centering spring by disconnecting the forward and aft retention hardware. Retain all hardware for installation of new rudder centering spring.
4. Mark the removed rudder centering spring with Serial number, Tail number, and Time in service at removal. Return the removed rudder centering spring back to ICON Customer Service to receive reimbursement for warranty parts and labor.

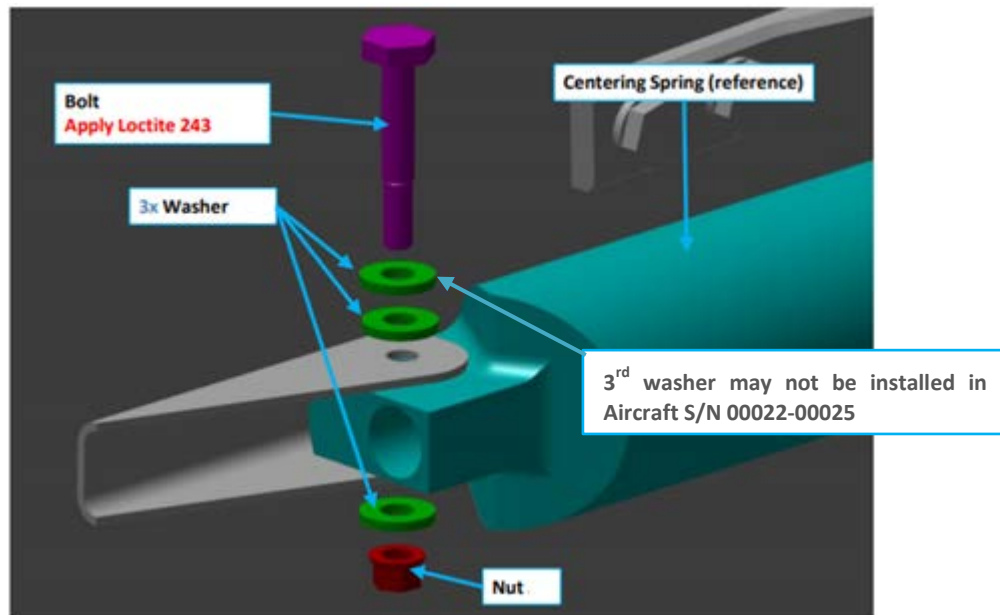
Figure 2: Rudder Centering Spring Hardware Configuration (Forward)

1. Install forward centering spring hardware as shown in Figure 2 above. Apply Loctite 243 to the threads of the bolt and torque hardware to 10-13 in-lb
2. Install aft centering spring hardware as shown in figure 3 above. Ensure that the groove in the control cable rod end is facing outboard. Add Tef-gel to threads prior to installation of nut and torque hardware to 18 in-lb.

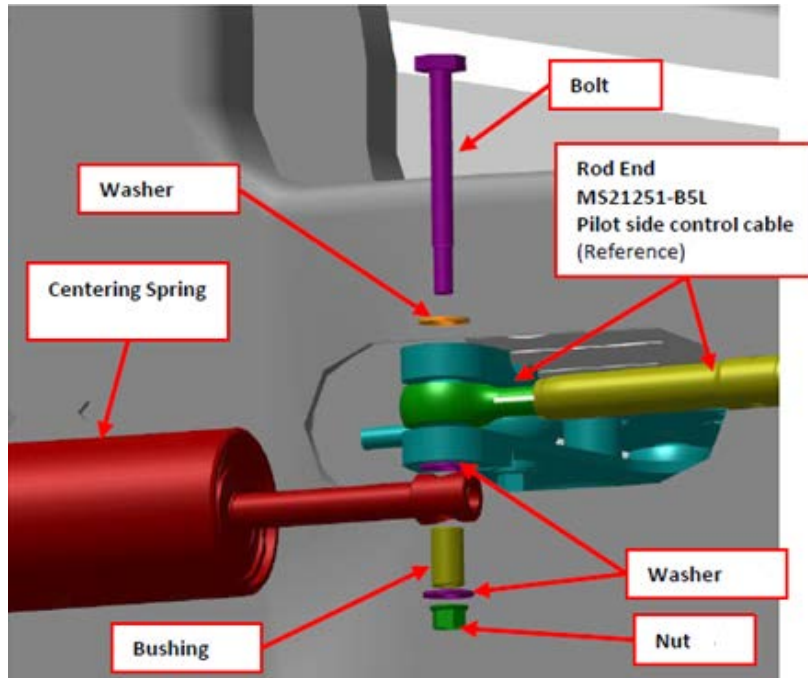
Figure 3: Rudder Centering Spring Hardware Configuration (Aft)
