SERVICE BULLETIN

SB-082718 REV A

DATE ISSUED: 9/14/2018
DATE EFFECTIVE: 9/14/2018
SUPERSEDES NOTICE: None.
SUBJECT: Fuel Tank Sump Line Modification

AIRCRAFT AFFECTED: **MODEL:** ICON A5
S/N: 00022 through 00036

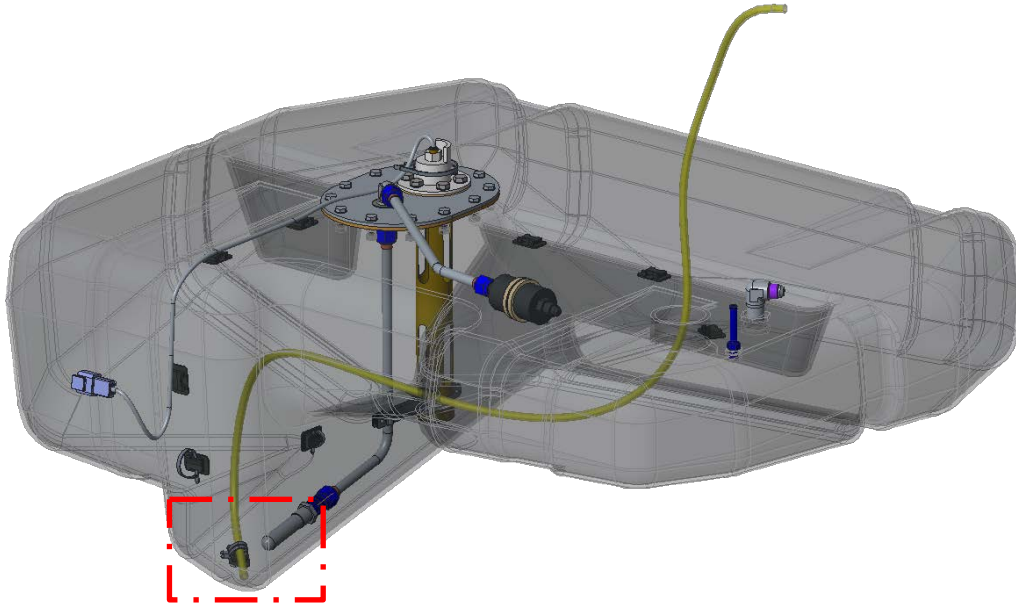
Figure 1: Fuel sump tie block location.

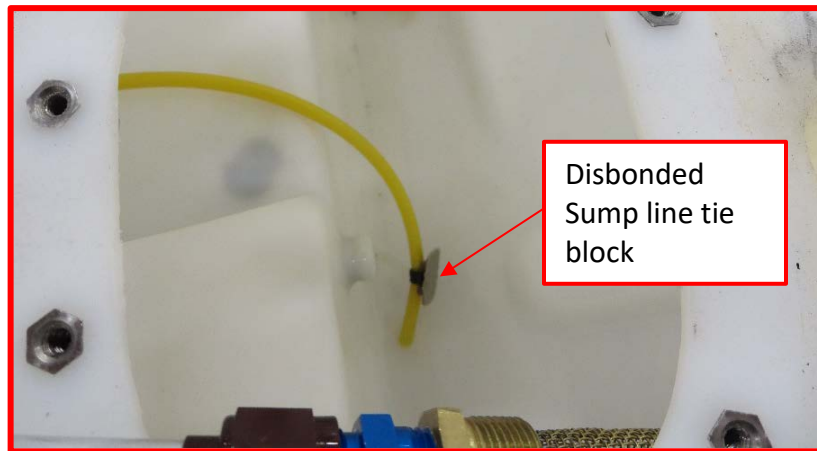
ICON is committed to designing, manufacturing, delivering, and supporting a high-quality Light Sport Aircraft, providing a level of safety well beyond expectations. During routine maintenance of the aircraft, it was discovered that the fuel sump line tie block disbonded due to poor bond prep of the fuel tank surface. The failure location is shown in the Figure 1 and 2. On two aircraft, this condition has resulted in limitation of the fuel sump effectiveness beyond acceptable limits. This Service Bulletin provides instructions to modify the fuel system to correct this condition.

Figure 2: Fuel sump line disbonded from fuel tank.

REQUIRED ACTION: Replace existing fuel sump system with latest version of system.

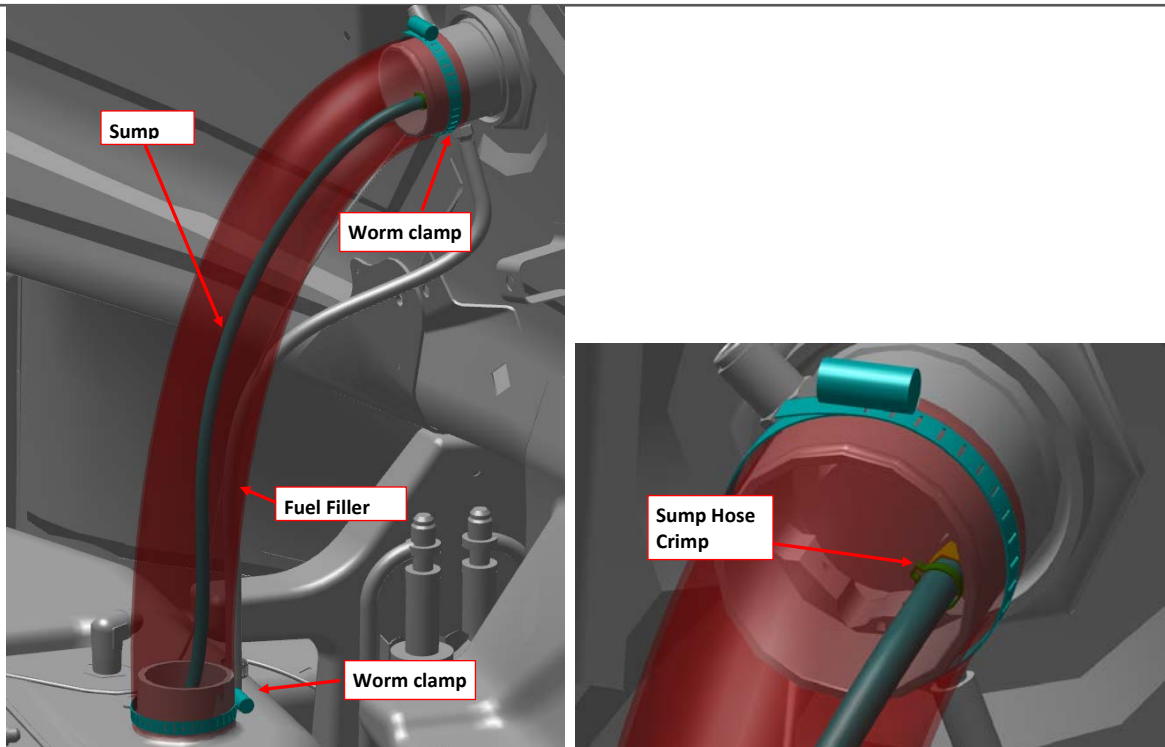
Figure 3: Fuel filler neck disconnection

1. Disassemble the aircraft as required to permit accessibility, inspection, adjustment, maintenance, and repair in accordance with the latest release of the Aircraft Maintenance Manual, ICA000833.
 - a. This will require:
 - i. Pumping of usable fuel from fuel tank.
 - ii. Removal of baggage floors.
 - iii. Removal of seat backs, removal of seat bases is permissible if required.
 - iv. Removal of baggage side panels (LH side only).
2. Disconnect the fuel filler neck by loosening the worm clamps at the top and bottom of the fuel filler neck. Refer to Figure 3.
3. Disconnect the fuel sump line by removing the indicated sump hose crimp in Figure 3.

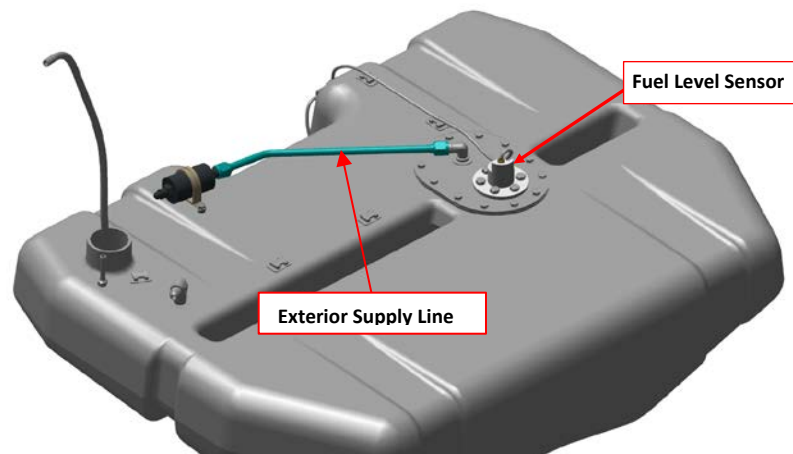
Figure 4: Fuel tank supply line

4. Disconnect exterior supply line. Refer to Figure 4.

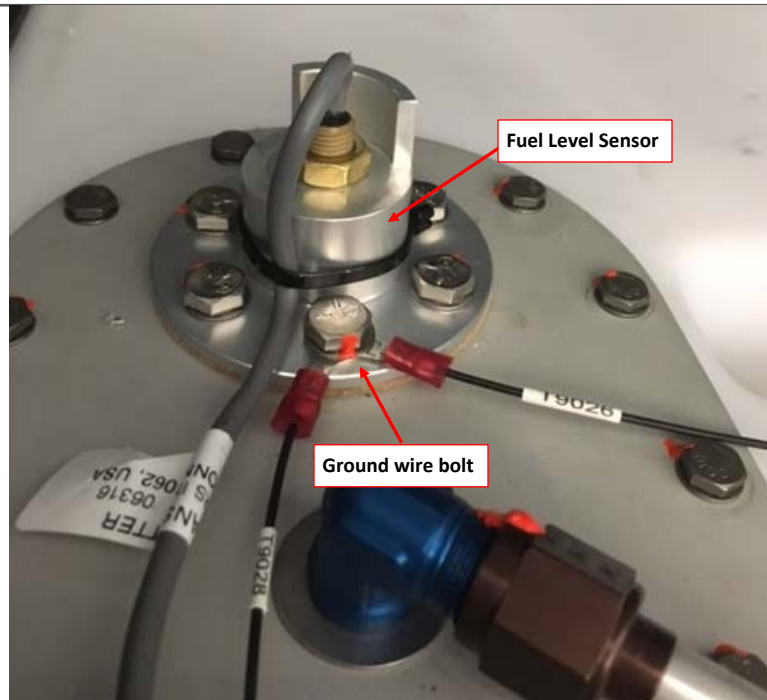
Figure 5: Ground wire bolt.

5. Remove zip ties securing the electrical harnesses on top of the tank, remove bolt securing ground wires (refer to Figure 5), and disconnect fuel level sensor.

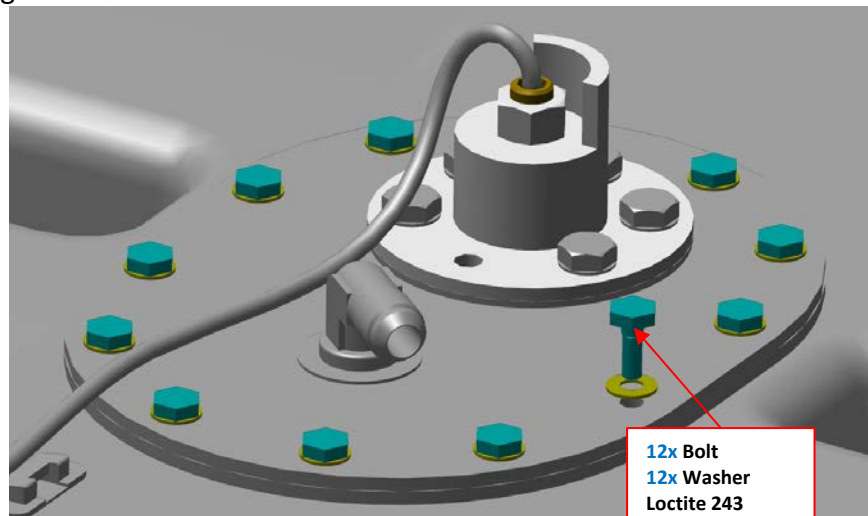
Figure 6: Fuel Tank Access Plate.

6. Remove bolts that secure access plate and remove the access plate assembly from the fuel tank. Refer to Figure 6.

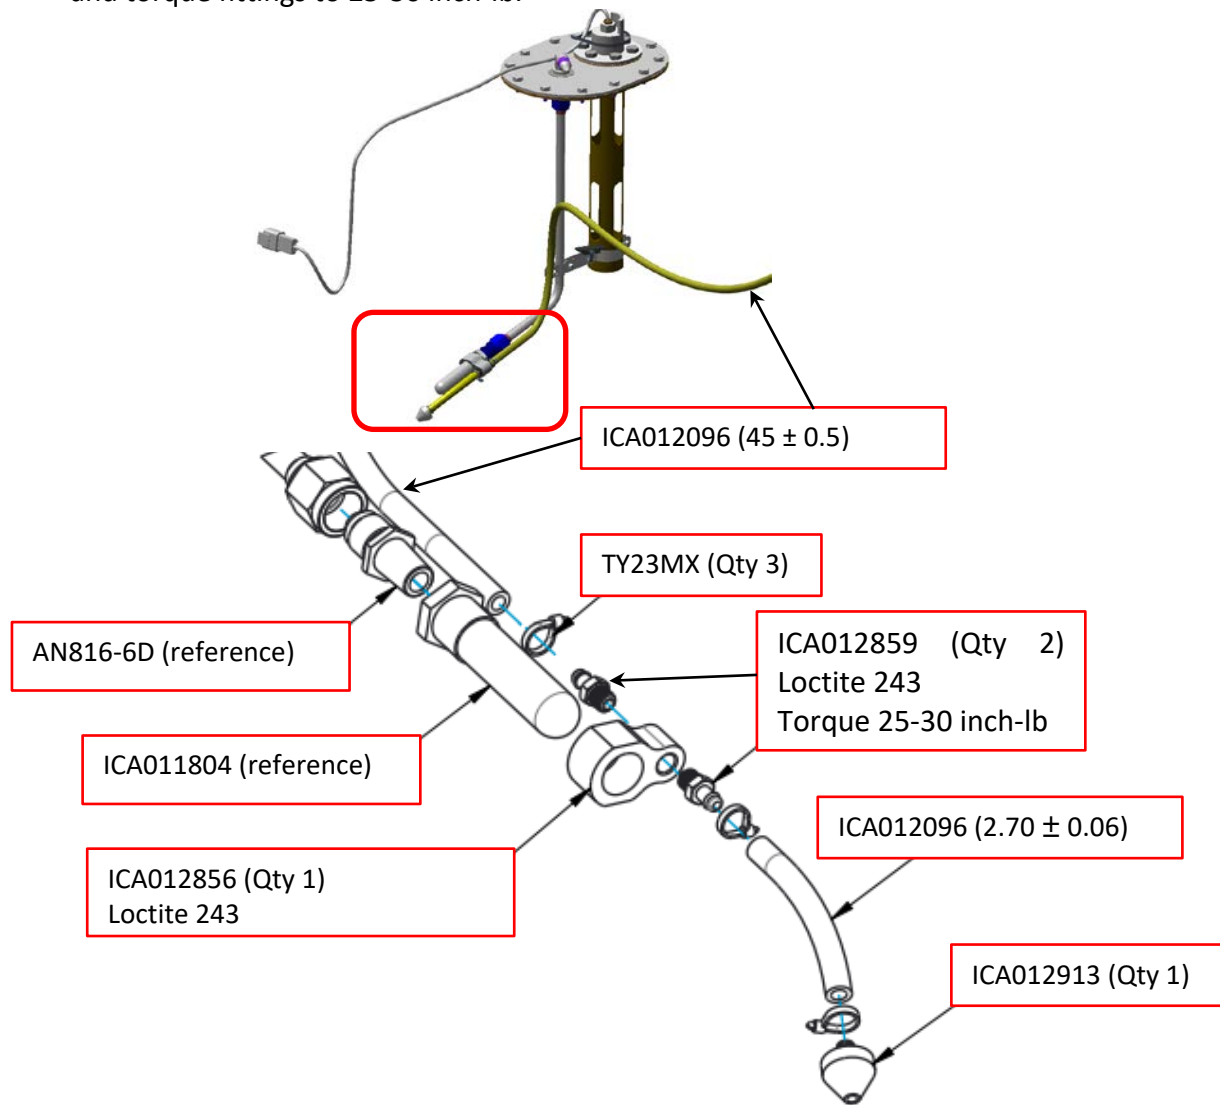
Figure 7: Fuel tank sump modification

1. Identify the male end of the fuel sump to fuel pickup clamp (ICA012856). The male end is the wider side of the tapered threads. Apply Loctite 243 in 360° bead to the lead threads of the male fitting. Thread the clamp onto finger strainer (ICA011804) to finger tight torque, then using the wrenching flats on the clamp and a second wrench opposing the torque on the finger screen orient the clamp as shown in Figure 7 below. Turn the clamp at least ½ turn tighter from finger tight, then continue tightening to orient fitting as shown, adding no more than a full turn. **Do not** loosen to achieve alignment.
2. Install straight tube fittings (ICA012859) into the clamp. Apply Loctite 243 prior to installation and torque fittings to 25-30 inch-lb.

3. Cut a length of Tygon tubing (ICA012096) to length of 2.70 ± 0.06 -inches and attach it to the straight fitting with a TY23MX ty-rap. Refer to Figure 7.
4. Install the clunk (ICA012913) on the opposite end of the 2.70 ± 0.06 -inch length tubing and ty-rap the fitting side of the clunk with a TY23MX ty-rap. Refer to Figure 7.
5. Cut a length of Tygon tubing (ICA012096) to a length of 45 ± 0.5 -inch length and route it through the tank and secure it in the filler neck. Refer to Figure 8. Temporarily Allow the opposite end to be loose in the tank near the low spot of the tank.
6. Position the assembled fuel tank access plate assembly near the port and connect the fuel sump tube to the straight fitting on the clamp and secure with a TY23MX ty-rap. Refer to Figure 8.

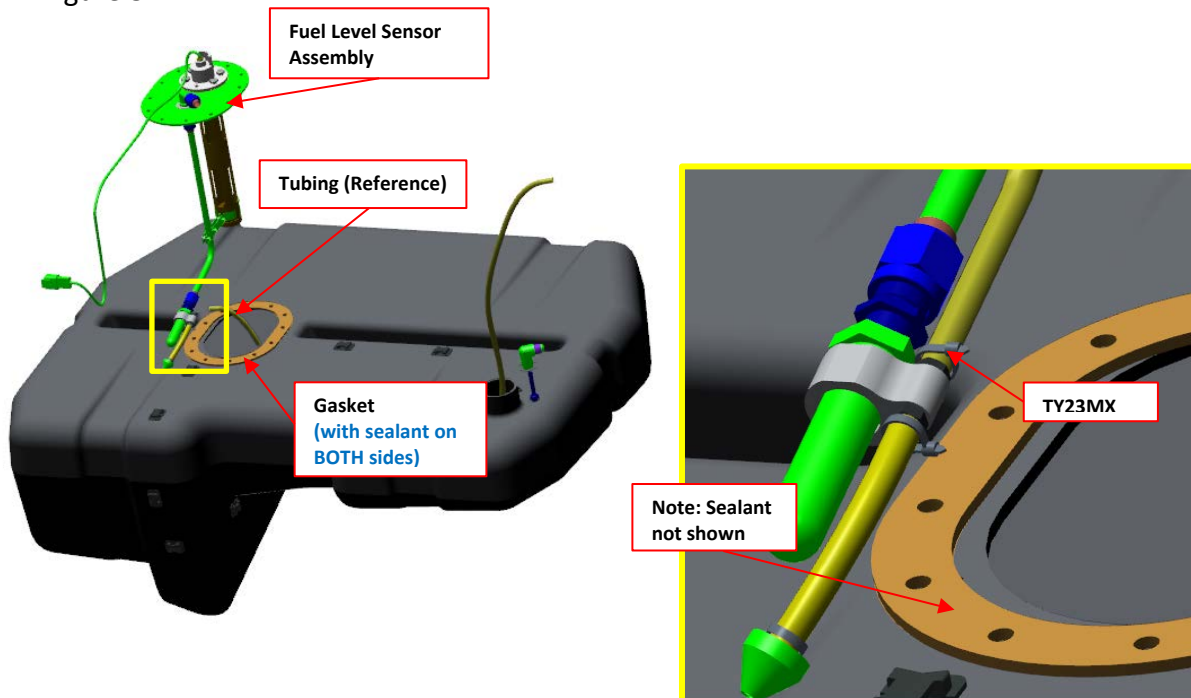
Figure 8: Sump line routing and connection

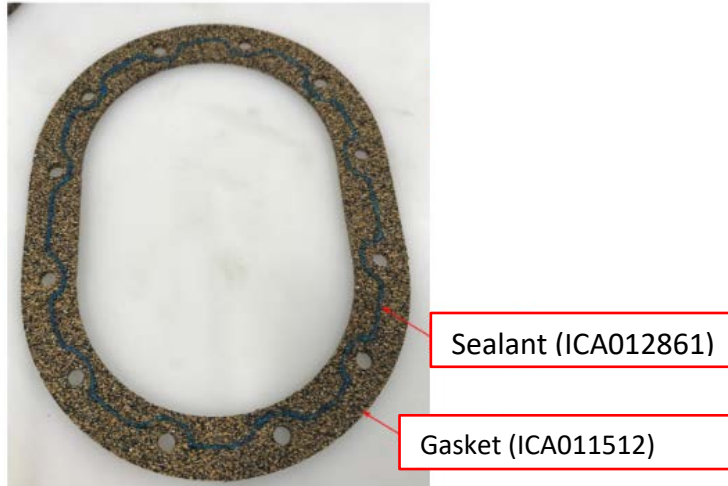
Figure 2: Fuel tank gasket sealant pattern (apply to both sides of gasket)

7. Clean gasket surface of fuel tank with isopropyl alcohol and reinstall the fuel tank access plate. Use a new cork gasket and apply sealant (ICA012861) to the gasket in one continuous bead approximately 0.030 to 0.060 inches thick to both sides of the gasket in the pattern shown below. Loctite 243 and torque fasteners to 25-30 inch-lb. Ensure the clunk falls to the lowest part of the tank.
