SERVICE BULLETIN

SB-090817 REV E

DATE ISSUED: 4/11/2018
DATE EFFECTIVE: 4/11/2018
SUPERSEDES NOTICE: SB-090817 Rev D
SUBJECT: Lower Roll Control cable wear at wing fold socket
AIRCRAFT AFFECTED: **MODEL:** ICON A5
S/N: All
REQUIRED ACTION: 1) Inspect lower roll control cable at the socket and the inboard rod end of the inboard aileron pushrod for indications of wear.
a. If there **is** evidence of wear continue inspecting every 10 hours of flight time to the limits described and replace if necessary. See attached Log Entry table.
b. If there is **no** evidence of wear, there is no further action required with reference to this notice.

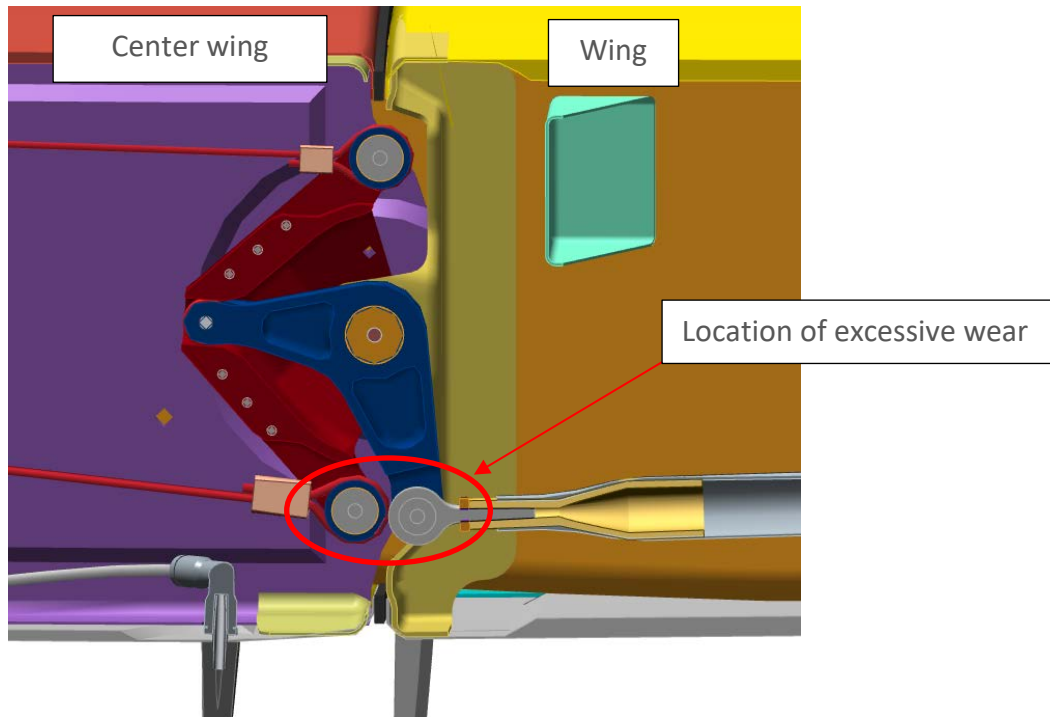
Figure 1: Section view of the BL38 intersection at the roll socket to roll bell-crank interface.

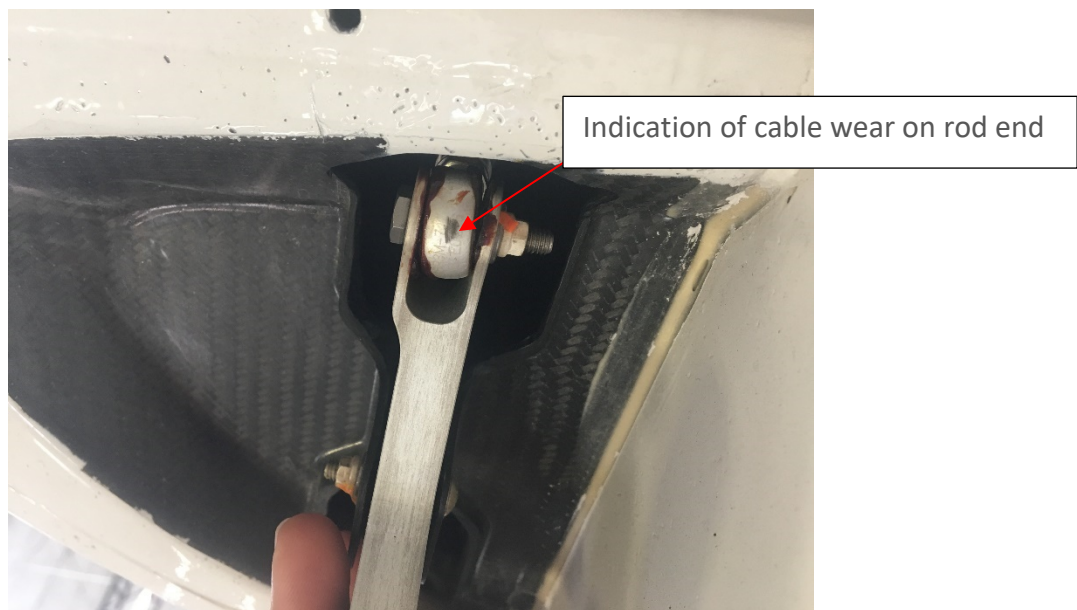
ICON is committed to designing, manufacturing, delivering, and supporting a high quality Light Sport Aircraft, providing a level of safety well beyond expectations. During routine maintenance of the aircraft, it was discovered that the lower roll control cable and inboard rod end on the inboard aileron control pushrod showed signs of excessive wear. The contact location is shown in the figures 1 and 2. On three aircraft, this condition has resulted in wear of the roll control cable beyond acceptable limits (figures 3 and 4). This Service Bulletin provides details on an initial inspection and, if required, a progressive inspection schedule along with instructions for repair if needed for Continued Airworthiness.

Figure 2: Indication of wear between the control cable and the inboard rod end of the inboard pushrod (wing side).

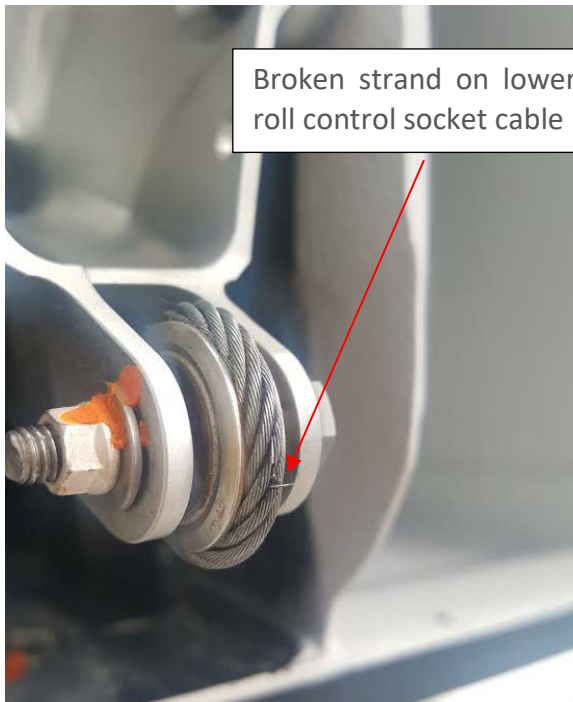
Figure 3: Broken strand of lower roll control cable

1. Fold each wing and visually inspect both the inboard rod end of the inboard pushrod on the wing and the lower roll control cable terminal at the bottom of the roll socket at the wing fold joint.
 - a. If there **is** evidence of wear on the rod end as shown in figure 3 or the roll control cable as shown in figure 4 carefully inspect the end of the roll control cable for any broken strands as shown in figure 3.
 - i. If there are any broken strands – Replace the cable following the instructions below.
 - ii. If there is wear but no broken strands – Continue to inspect the roll control cable for broken strands every 10 hours.
 - b. If there is **no** evidence of wear on the rod end or roll control cable – no further action with respect to this bulletin is required.

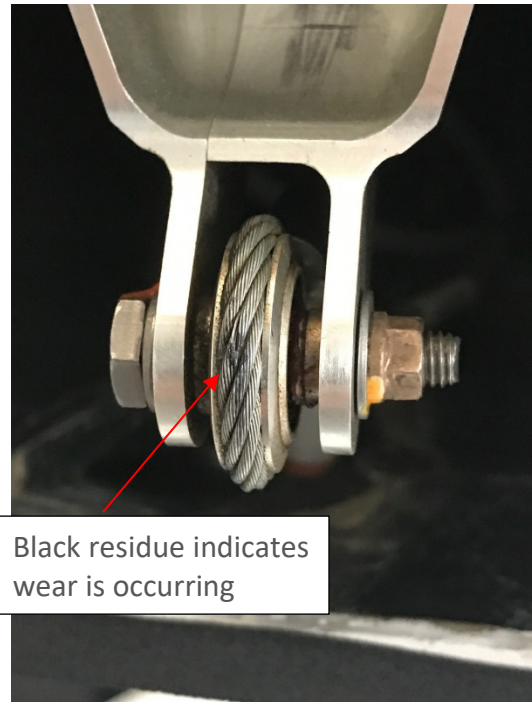
Figure 4: Black residue indicating wear

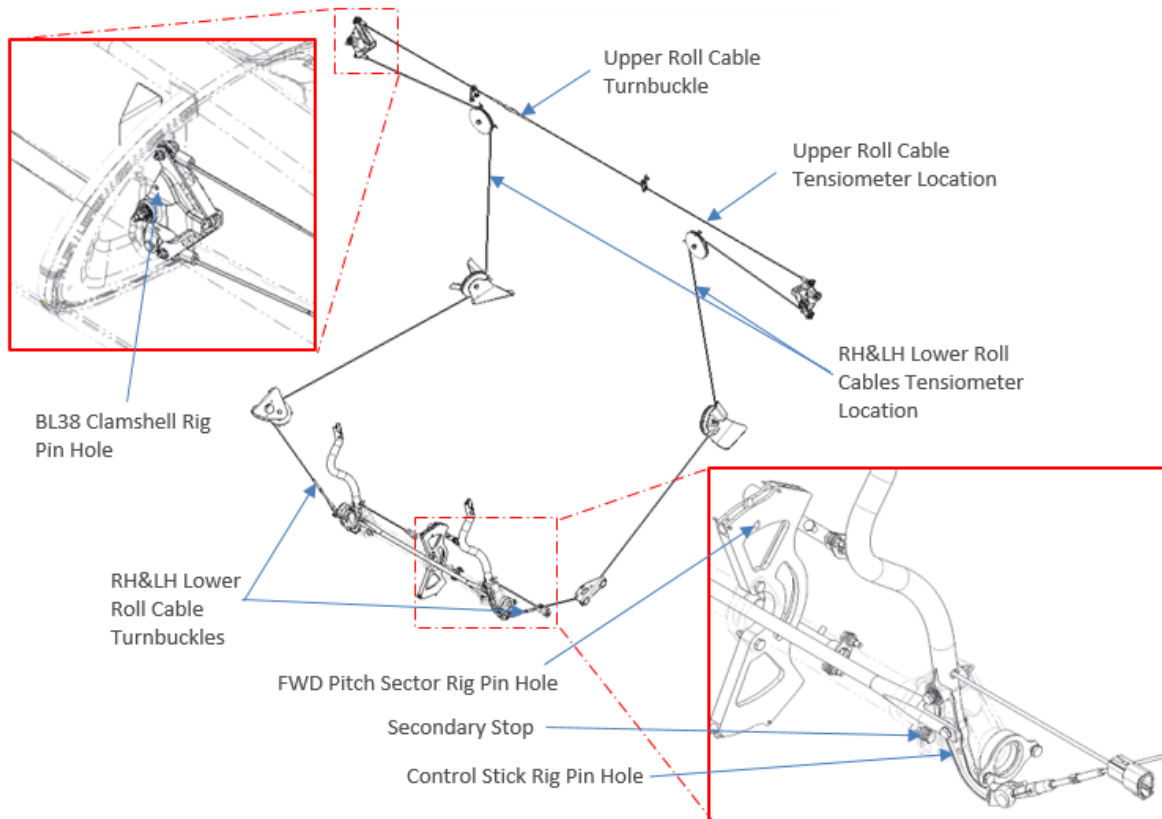
Figure 5: Roll control system overview

1. Disassemble the aircraft as required to permit accessibility, inspection, adjustment, maintenance, and repair in accordance with the latest release of the Aircraft Maintenance Manual, ICA000833.
 - a. This will require removal of:
 - i. Baggage floors,
 - ii. Both seat backs and seat bases
 - iii. Cockpit interior side panels
 - iv. Baggage side panels, and headliner
2. De-tension the affected lower flight control cable by removing safety wire or turnbuckle clips and loosen the turnbuckle located at the torque tube entrance shown in figure 5 below.

1. Starting from the center wing loosely route new lower roll cable from the roll socket to the torque tube bearing. Use figure 5 for routing path.
2. If the roll pulleys were removed, reinstall the bolts as shown and torque to 48 in-lb., if the safety pins were removed re-install with a new MS25665-151 cotter pins.

5. Install .1875" rig pins at both roll sockets, left side control stick base, and .250" rig pin in the center section pitch sector as shown in figure 5 above.

6. Slowly rotate the lower roll control cable turnbuckle (ensuring that the cable not wound up during the tension process) on the replaced cable until the cable tension is set at 25-30 lb. as measured in the locations shown in figure 5. Measure all three locations and adjust the other cables if they are not 25-30 lb. tension.

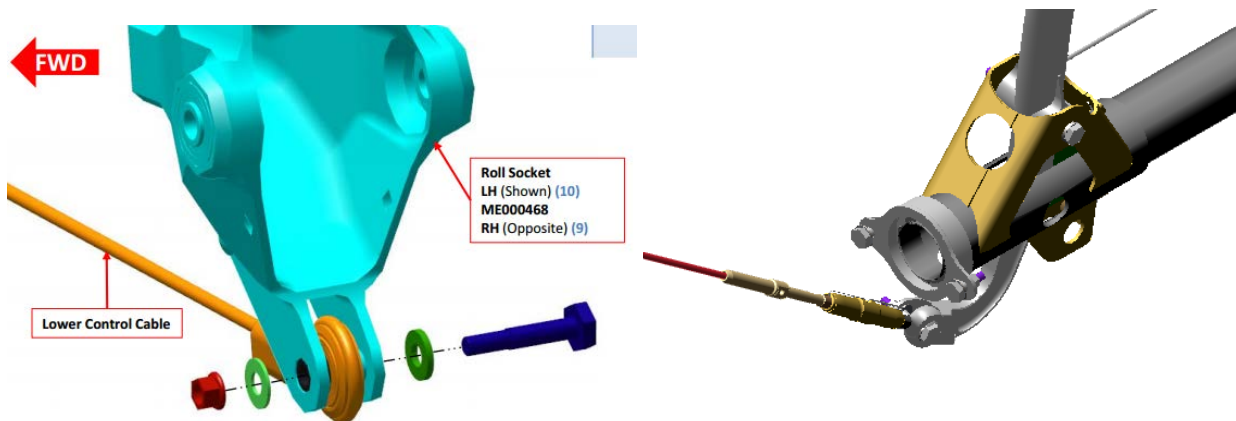
Figure 6: Roll Socket and torque tube connection points.

3. Disconnect the lower roll cable at the roll socket and at the turnbuckle at the stick. Ensure that cable is held while disconnecting the turnbuckle.

3. Connect the lower roll cable to the lower roll socket attachment point as shown in figure 6 above. Torque hardware to 20 in-lb.
4. Connect the roll cable to the rod end still attached to the cockpit control stick at the same time as connecting to the roll cable such that the threads are balanced. Ensure that when tightening the turnbuckle that the cable is held as to not wind the cable. Do not fully tension the cable system during this step.

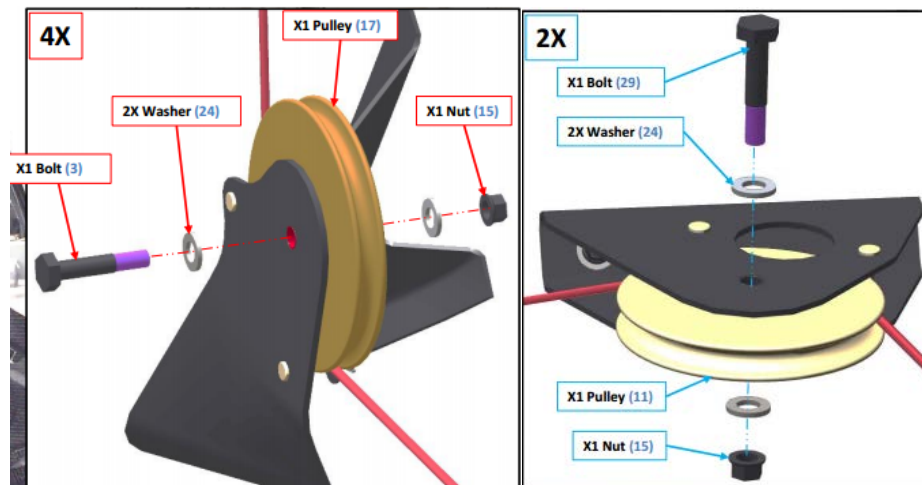
Figure 7: Roll pulley exploded views
