SERVICE BULLETIN

SB-090817 REV F

DATE ISSUED: 8/26/2024
DATE EFFECTIVE: 4/11/2018
SUPERSEDES NOTICE: SB-090817 Rev E
SUBJECT: Lower Roll Control cable wear at wing fold socket
AIRCRAFT AFFECTED: **MODEL:** ICON A5
S/N: 00001-00027

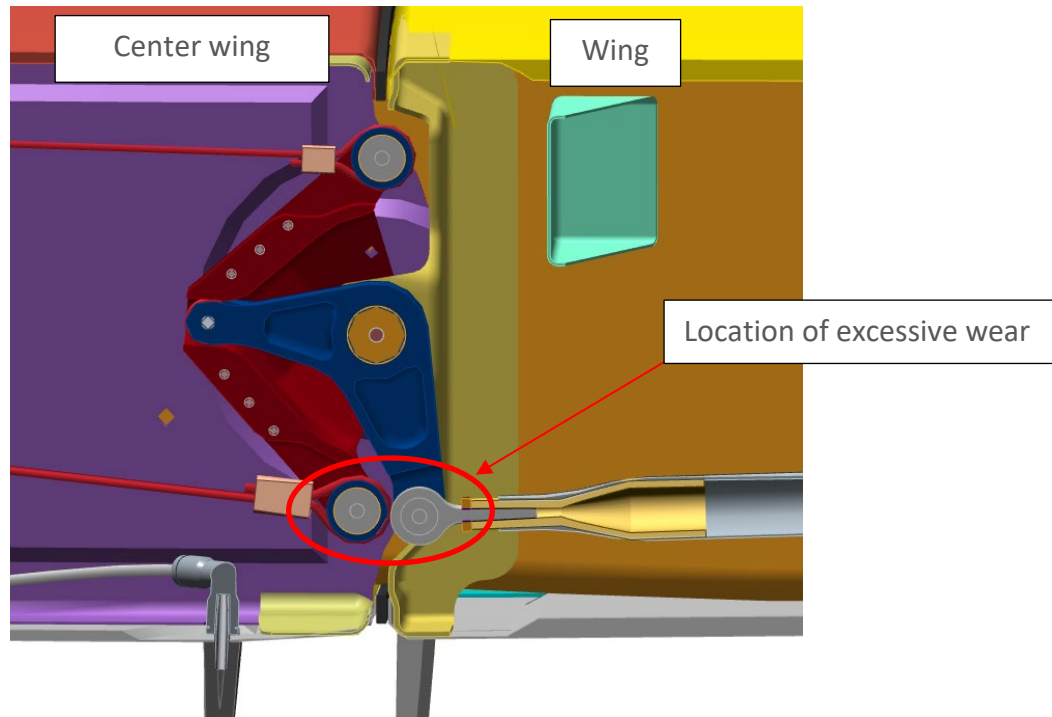
Figure 1: Section view of the BL38 intersection at the roll socket to roll bell-crank interface.

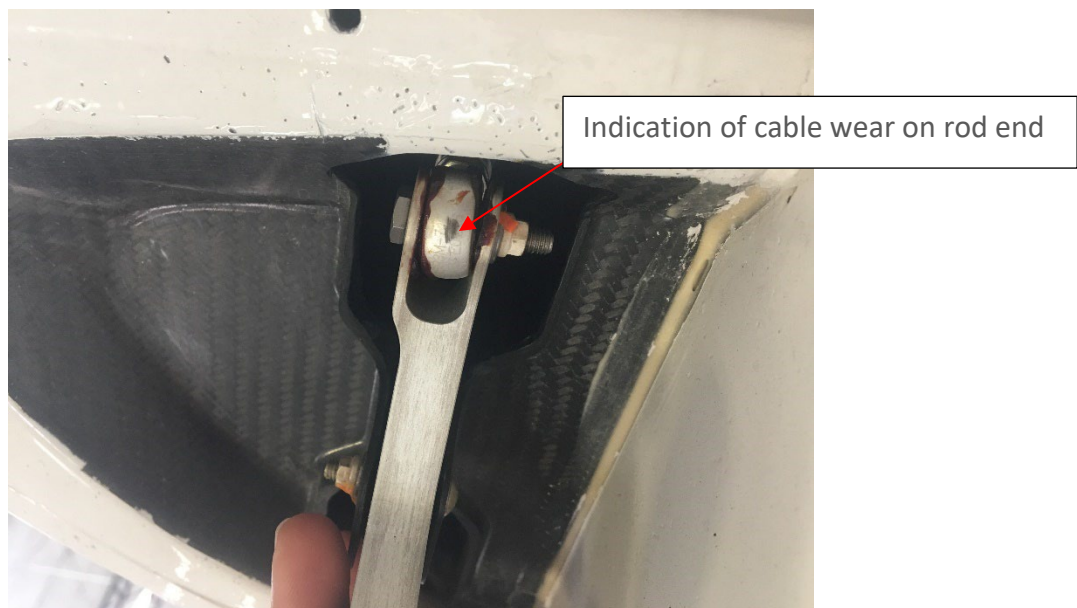
ICON is committed to designing, manufacturing, delivering, and supporting a high quality Light Sport Aircraft, providing a level of safety well beyond expectations. During routine maintenance of the aircraft, it was discovered that the lower roll control cable and inboard rod end on the inboard aileron control pushrod showed signs of excessive wear. The contact location is shown in the figures 1 and 2. On three aircraft, this condition has resulted in wear of the roll control cable beyond acceptable limits (figures 3 and 4). This Service Bulletin provides details on an initial inspection and, if required, a progressive inspection schedule along with instructions for repair if needed for Continued Airworthiness.

Figure 2: Indication of wear between the control cable and the inboard rod end of the inboard pushrod (wing side).

- 1) Inspect lower roll control cable at the socket and the inboard rod end of the inboard aileron pushrod for indications of wear.
 - a. If there is evidence of wear continue inspecting every 10 hours of flight time to the limits described and replace if necessary. See attached Log Entry table.
 - b. If there is no evidence of wear, there is no further action required with reference to this notice.

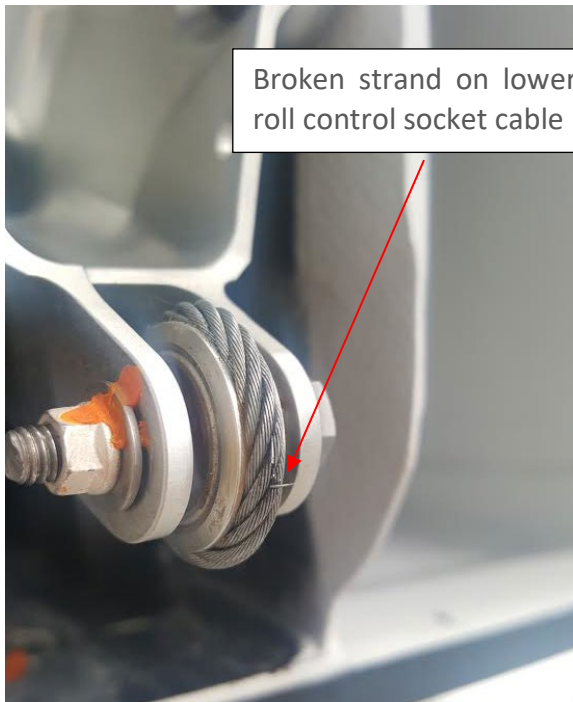
Figure 3: Broken strand of lower roll control cable

1. Fold each wing and visually inspect both the inboard rod end of the inboard pushrod on the wing and the lower roll control cable terminal at the bottom of the roll socket at the wing fold joint.
 - a. If there **is** evidence of wear on the rod end as shown in figure 3 or the roll control cable as shown in figure 4 carefully inspect the end of the roll control cable for any broken strands as shown in figure 3.
 - i. If there are any broken strands – Replace the cable following the instructions below.
 - ii. If there is wear but no broken strands – Continue to inspect the roll control cable for broken strands every 10 hours.
 - b. If there is **no** evidence of wear on the rod end or roll control cable – no further action with respect to this bulletin is required.

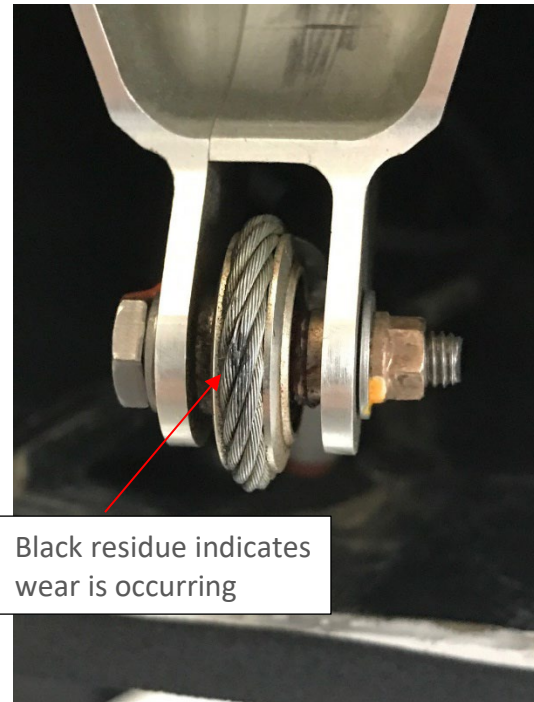
Figure 4: Black residue indicating wear
