SAFETY DIRECTIVE/ALERT

SD-101419 REV A

DATE ISSUED: 11/27/2019
DATE EFFECTIVE: 11/27/2019
SUPERSEDES NOTICE: SD-101419
SUBJECT: Compliance with Rotax ASB-912 i-011iS
AIRCRAFT AFFECTED: **MODEL:** A5
S/N: 00008,00033,00034,00042,00080-00085,
00088 thru 00116 (inclusive)
REQUIRED ACTION: Inspect fuel pump in compliance with Rotax ASB-912 i-011iS and replace fuel pump if affected.
TIME OF COMPLIANCE: Prior to Next Flight
REVISION HISTORY REV A: Modified Torque under Installation Step 5 from 22 in-lbs to 30-35 in-lbs and added torque for fuel line B-nuts. Altered Option 2 logbook entry.

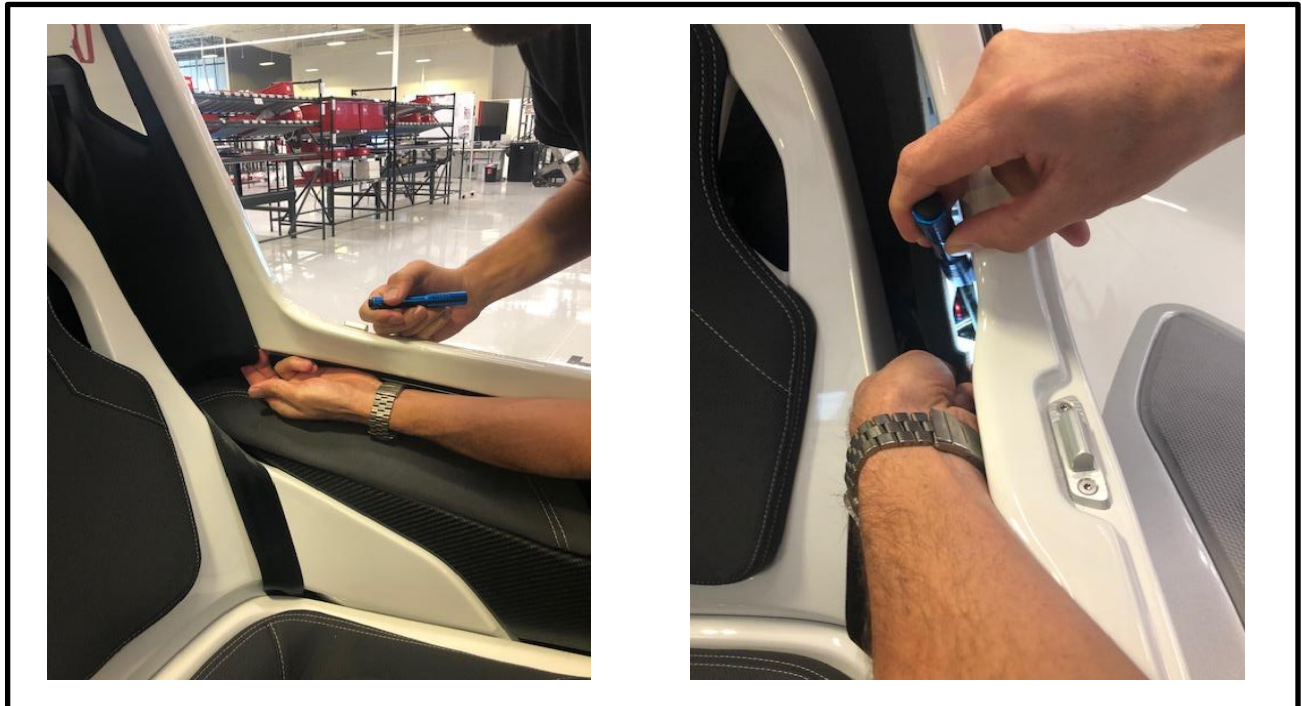
Figure1: Hook the left side cabin liner with fingers as shown and carefully flex liner inboard enough to insert a small flashlight.

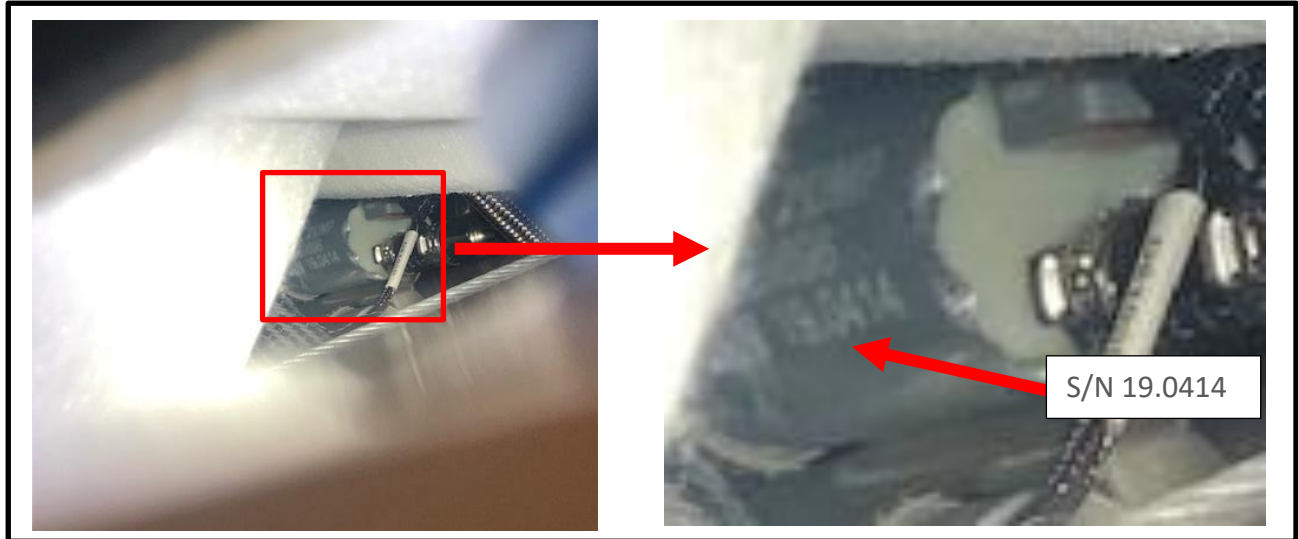
Figure2: Sight down the opening identifying the fuel pump on one of the pump modules as shown.

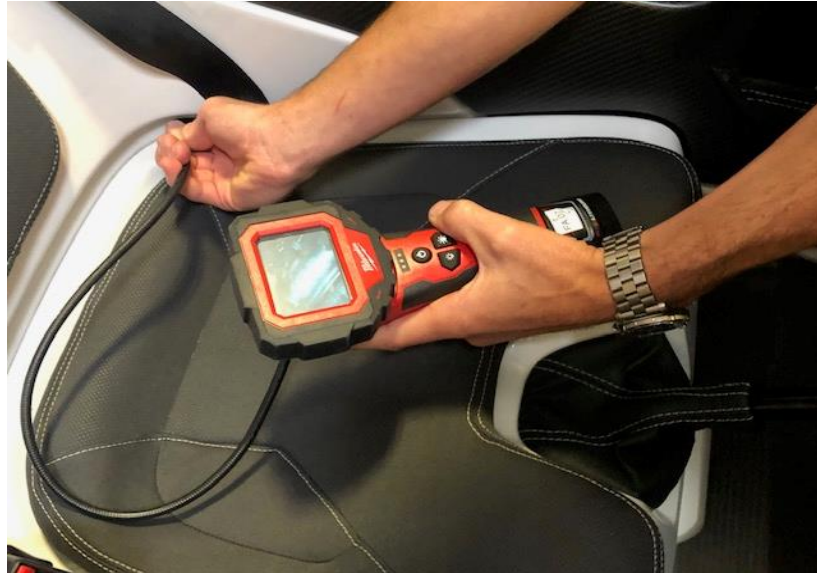
Figure 3: Borescope inspection technique through the pilot side lap belt pass through

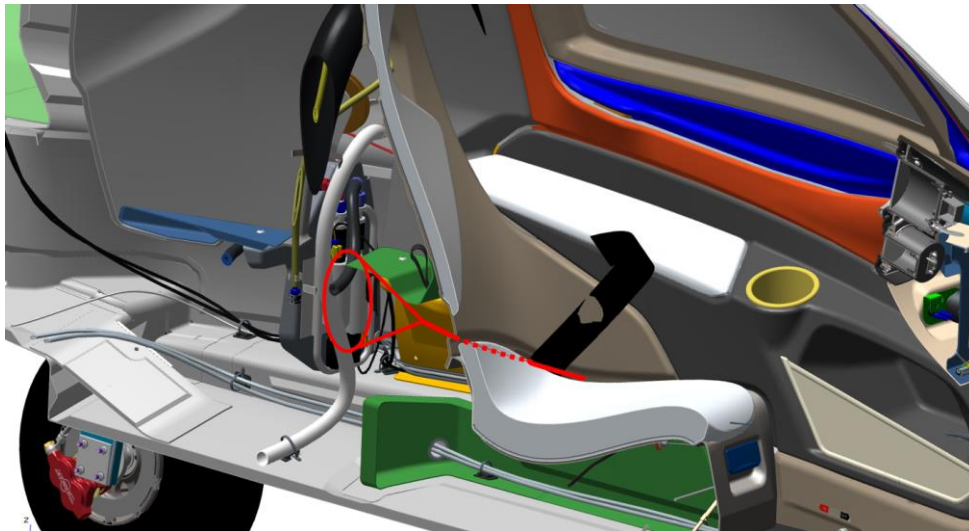
Figure 4: Cut away with parts remove for clarity of the approximate path of the borescope to view the fuel pump serial number

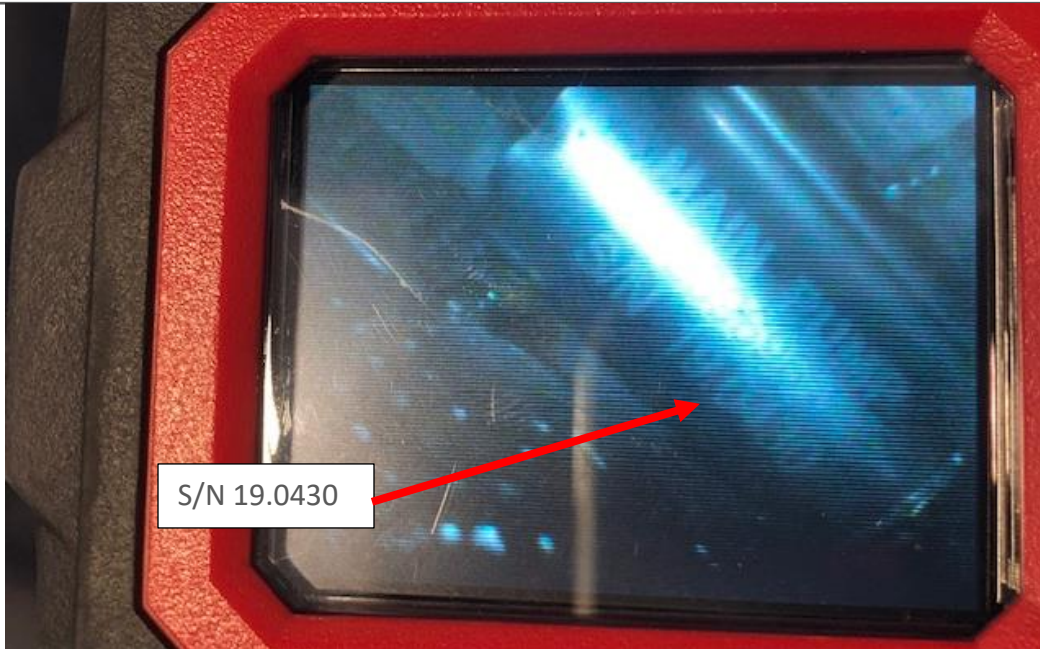
Figure 5: View of the borescope screen showing the fuel pump serial number.

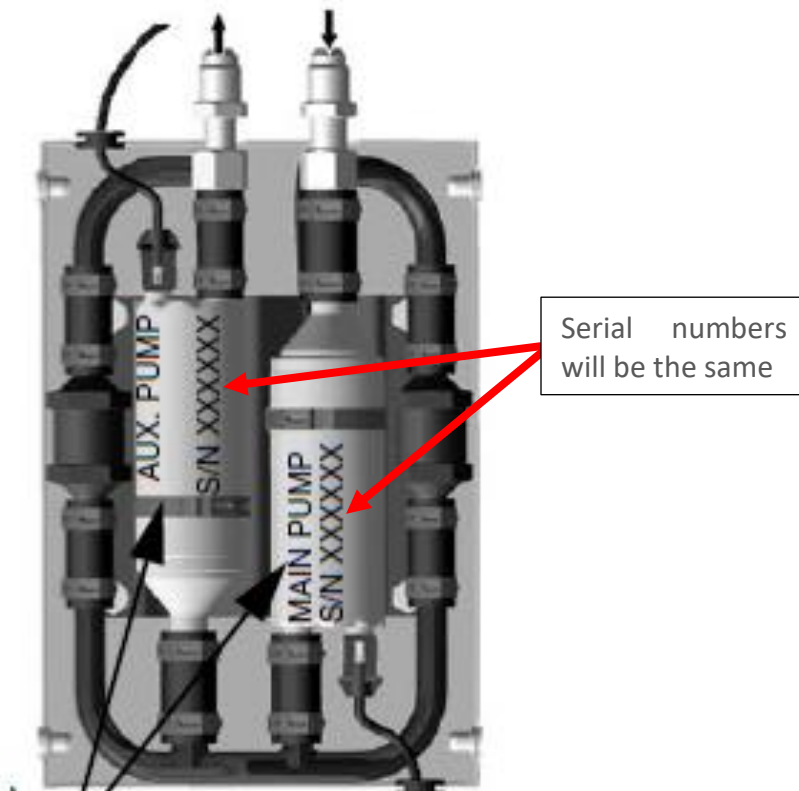
Figure 6: Graphic of approximate location of serial number markings on the fuel pump assembly.

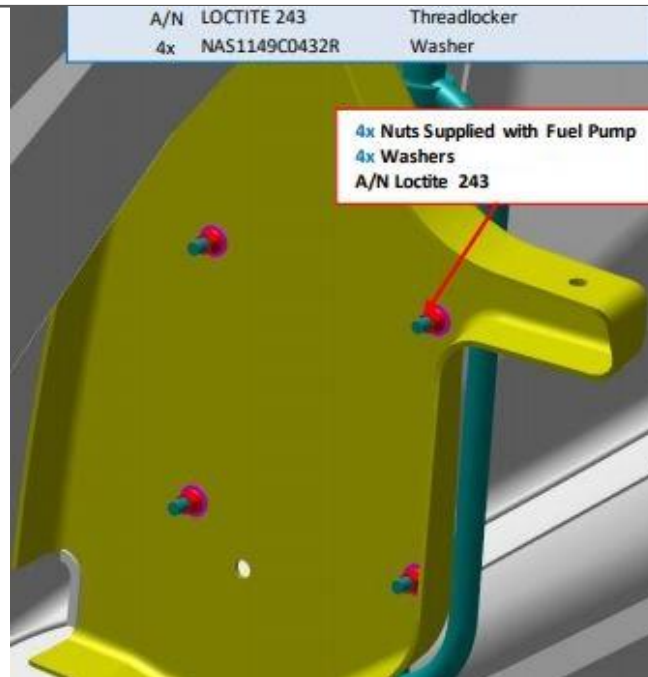
Figure 9: Install washers, nuts and Loctite 243 on to the mount studs

5. Apply Loctite 243 to studs and torque 4x nuts and 4x washers to 30-35 inch-lbs. Apply torque stripe as shown in figure 9.
