SAFETY DIRECTIVE/ALERT

SD-111521-B

DATE ISSUED: 11/15/2021
DATE EFFECTIVE: 11/15/2021
SUBJECT: Slipping Autopilot Bridle Cable Clamps
AIRCRAFT AFFECTED: **MODEL:** A5
S/N: 00139-00149
REQUIRED ACTION: Disable autopilot system.
TIME OF COMPLIANCE: Complete before next flight

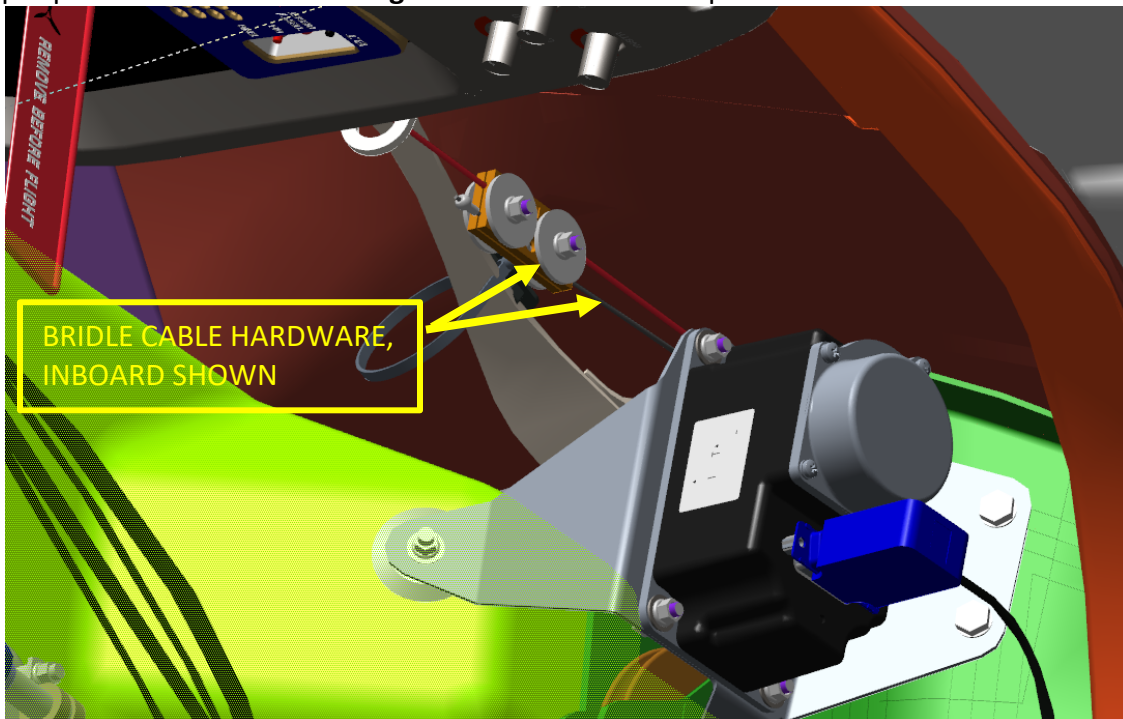
Figure 1: Remove inboard bridle cable clamp.

4. Loosen and remove the screws, nuts, and washers that secure the inboard bridle cable clamp to the upper roll cable. See **Figure 1**. Discard the clamp halves and the hardware.

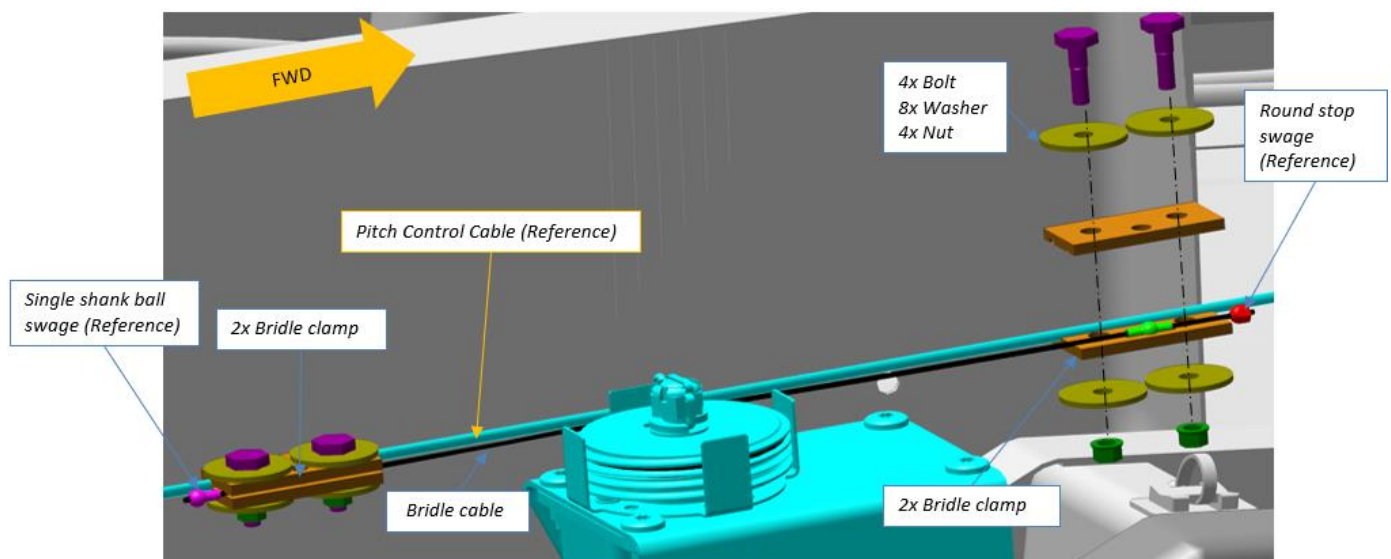
Figure 2: Remove bridle cable clamps.

6. Loosen and remove the screws, nuts, and washers that secure the outboard bridle cable clamp to the upper roll cable. Discard the clamp halves and the hardware.
7. Loosen and remove the screws, nuts, and washers that secure the bridle cable clamps to the upper pitch control cable. See **Figure 2**. Discard the clamp halves and the hardware.

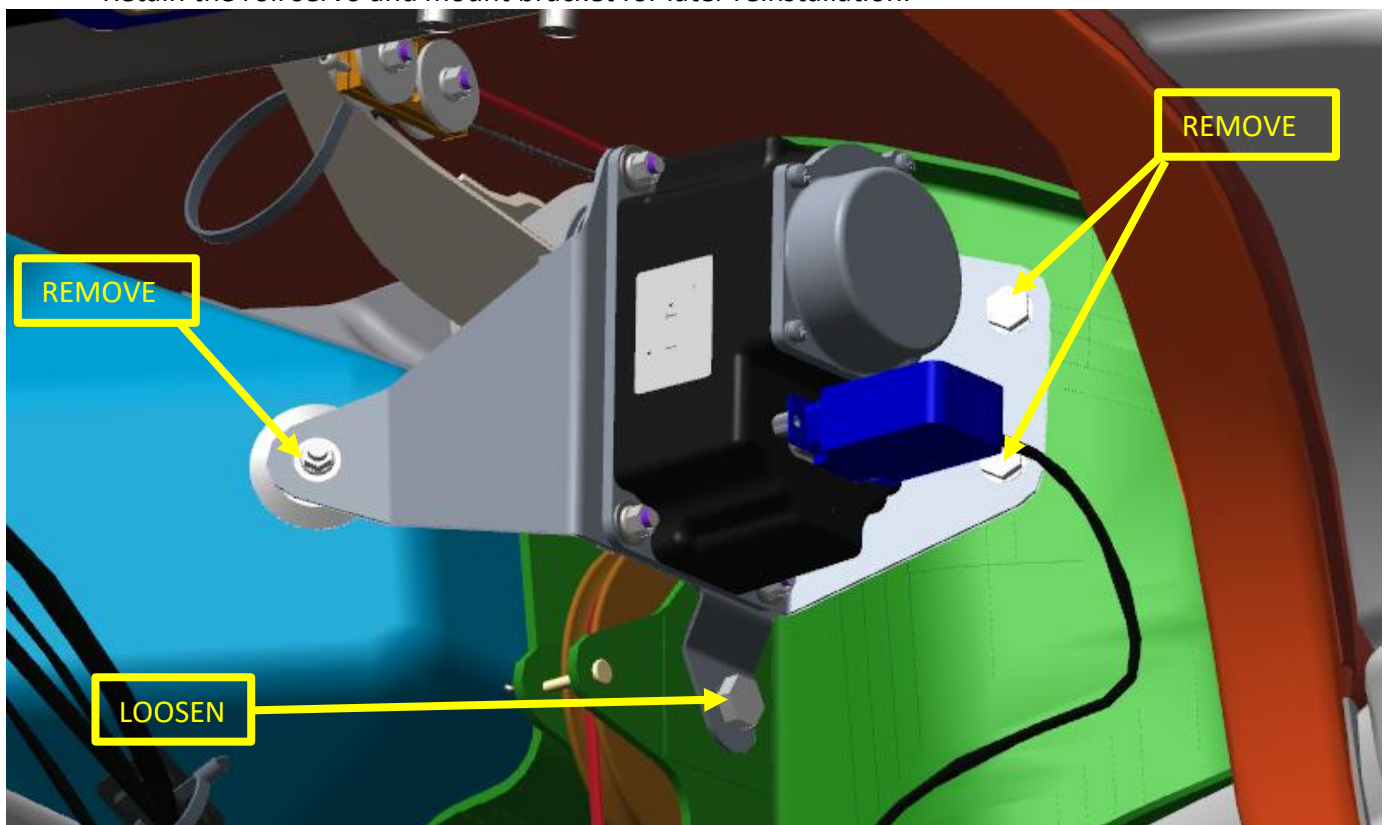
Figure 3: Loosen and Remove hardware

8. Disconnect the control harness connector, D9140P, from the roll servo
9. Disconnect the control harness connector, D9148P, from the pitch servo.
10. Remove the 2 bolts that secure the roll servo bracket to the left-hand center wing root rib. Retain hardware for reinstallation. See **Figure 3**.
11. Remove the nut and washer that secure the roll servo bracket to the stud bonded to the center wing spar. Retain hardware for reinstallation. See **Figure 3**.
12. Loosen the nut and bolt securing the upper roll cable pulley just enough so that the roll servo and the mount bracket can be removed as the bracket is slotted in this location. See **Figure 3**. Retain the roll servo and mount bracket for later reinstallation.

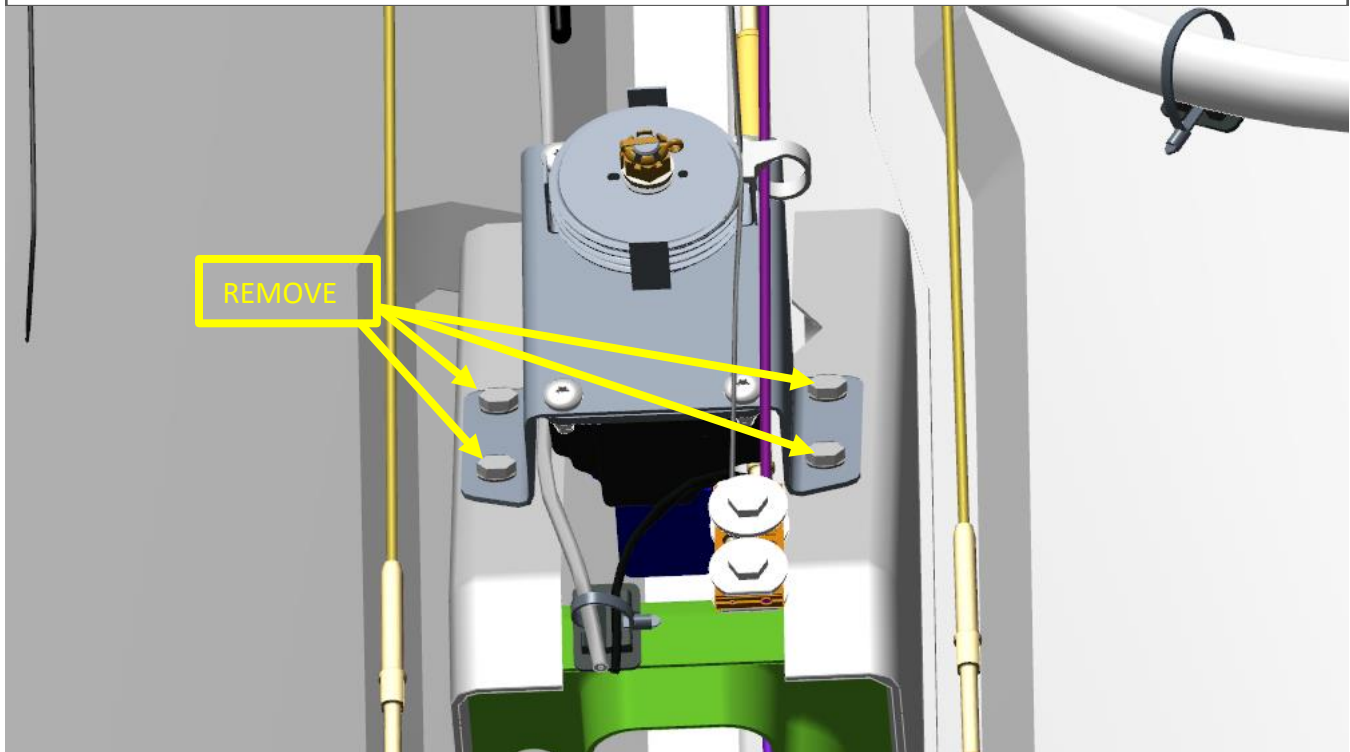
Figure 4: Remove hardware

13. Remove the four screws and washers that secure the pitch servo and its mount bracket to the keel of the aircraft and remove the pitch servo and bracket. Retain the servo, bracket, and mounting hardware for later reinstallation. See **Figure 4**.
14. Remove the 5 Amp "AUTOPILOT" fuse located at the front of the fuse panel on the co-pilot side of the overhead console. Retain for later reinstallation.

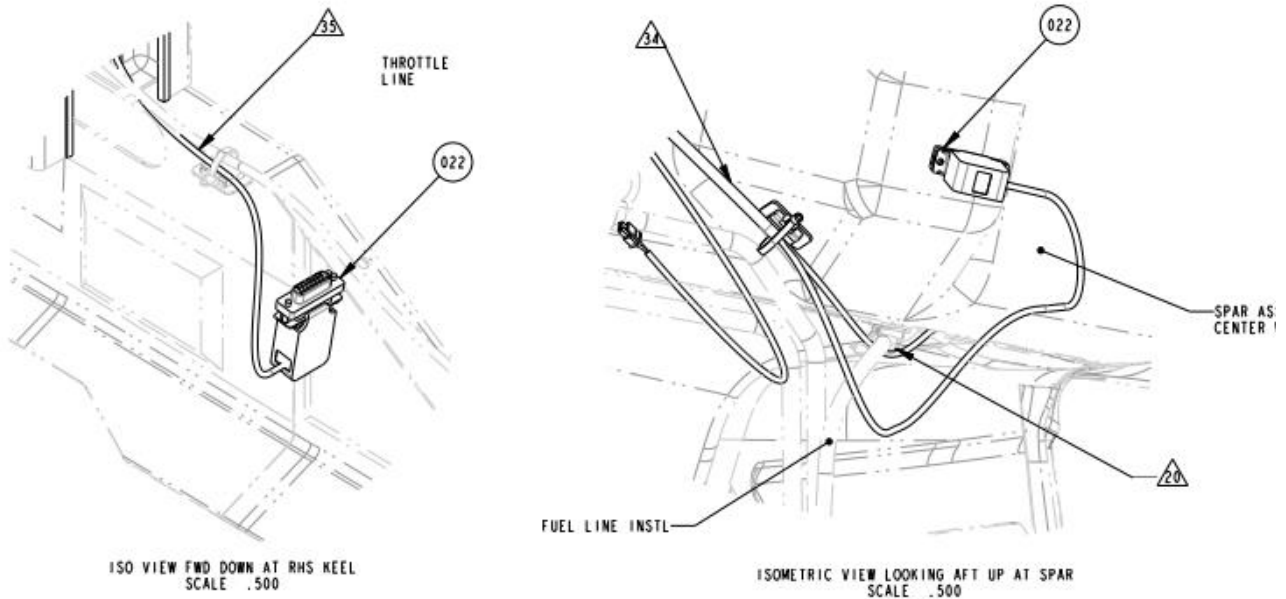
Figure 5: Cap and stow servo connectors

1. Obtain 2 each Garmin GSA28 Removal Adapters (ICA014693) and remove both locknuts and female screwlocks from each adapter. Discard the locknuts and screwlocks.
2. Remove both screws from the pitch servo connector, D9148P.
3. Install ICA014693, Removal Adapter (find number 22), onto servo connector, D9148P and secure in place with 2 each TY23MX cable ties. See **Figure 6**. Stow branch to wire harness using 1 each TY24MX in the approximate area indicated by flag note 35 in **Figure 5**.
4. Remove both screws from the roll servo connector, D9140P.

5. Install ICA014693, Removal Adapter (find number 22), onto servo connector, D9140P and secure in place with 2 each TY23MX cable ties. See **Figure 6**. Stow branch to wire harness using 1 each TY24MX in the approximate area indicated by flag note 34 in **Figure 5**.

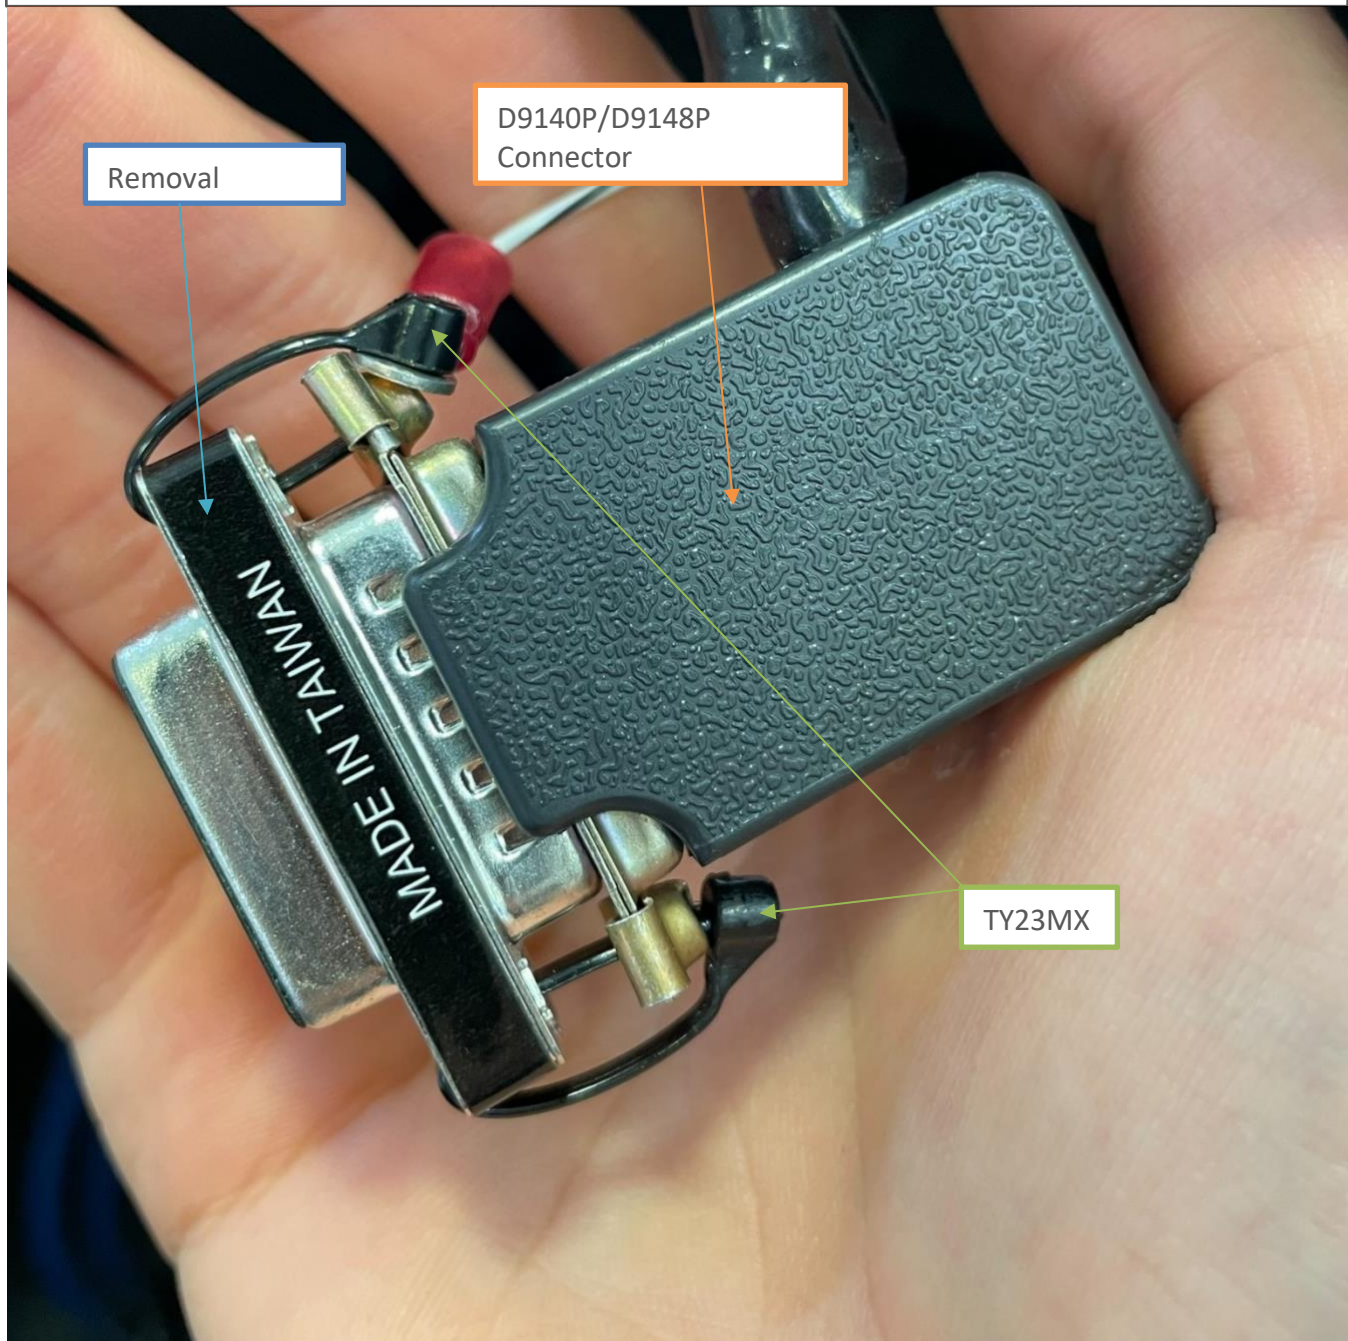
Figure 6: Cap connectors with F4 tape

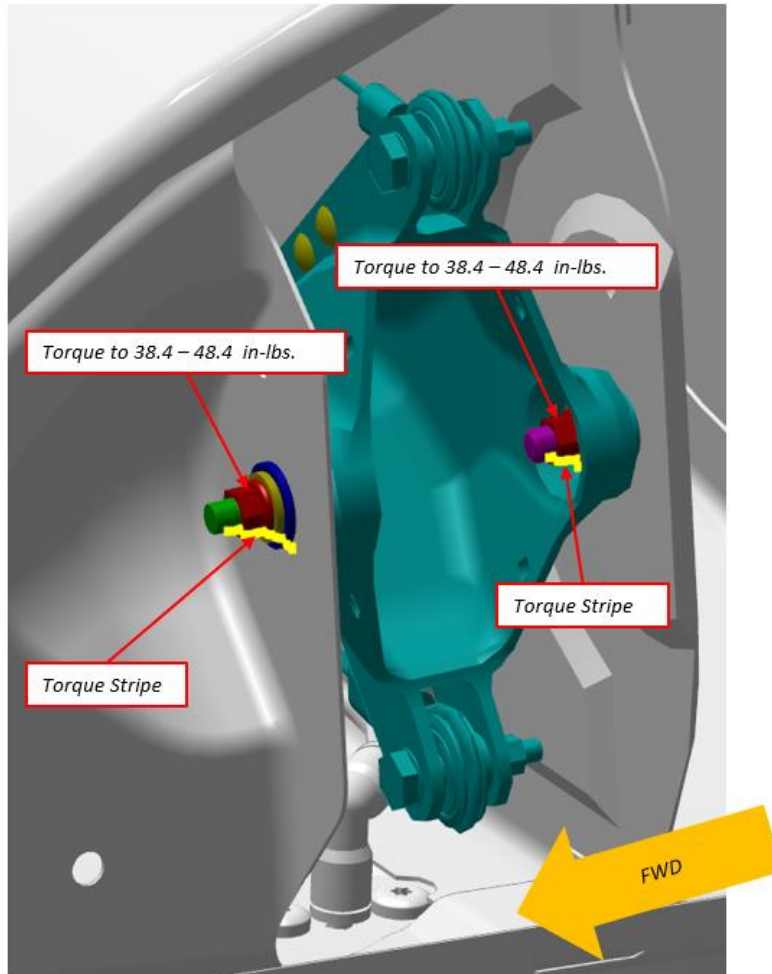
Figure 7: Roll socket reassembly.

15. Tighten the nut and bolt that were loosened in step 12 to 38.4-48.4 in-lbs.
16. If removed, reposition the pilot side roll socket in place at the pilot-side end of the center wing and reinstall the mounting hardware removed in step 5. Torque and apply inspector's lacquer as shown in Error! Reference source not found.7. If the removal step 5 alternative method was used, reposition the upper roll cable bearing in the roll socket and reinstall the screw, washers, and

nut. Torque to 16.4-19.4 in-lbs.

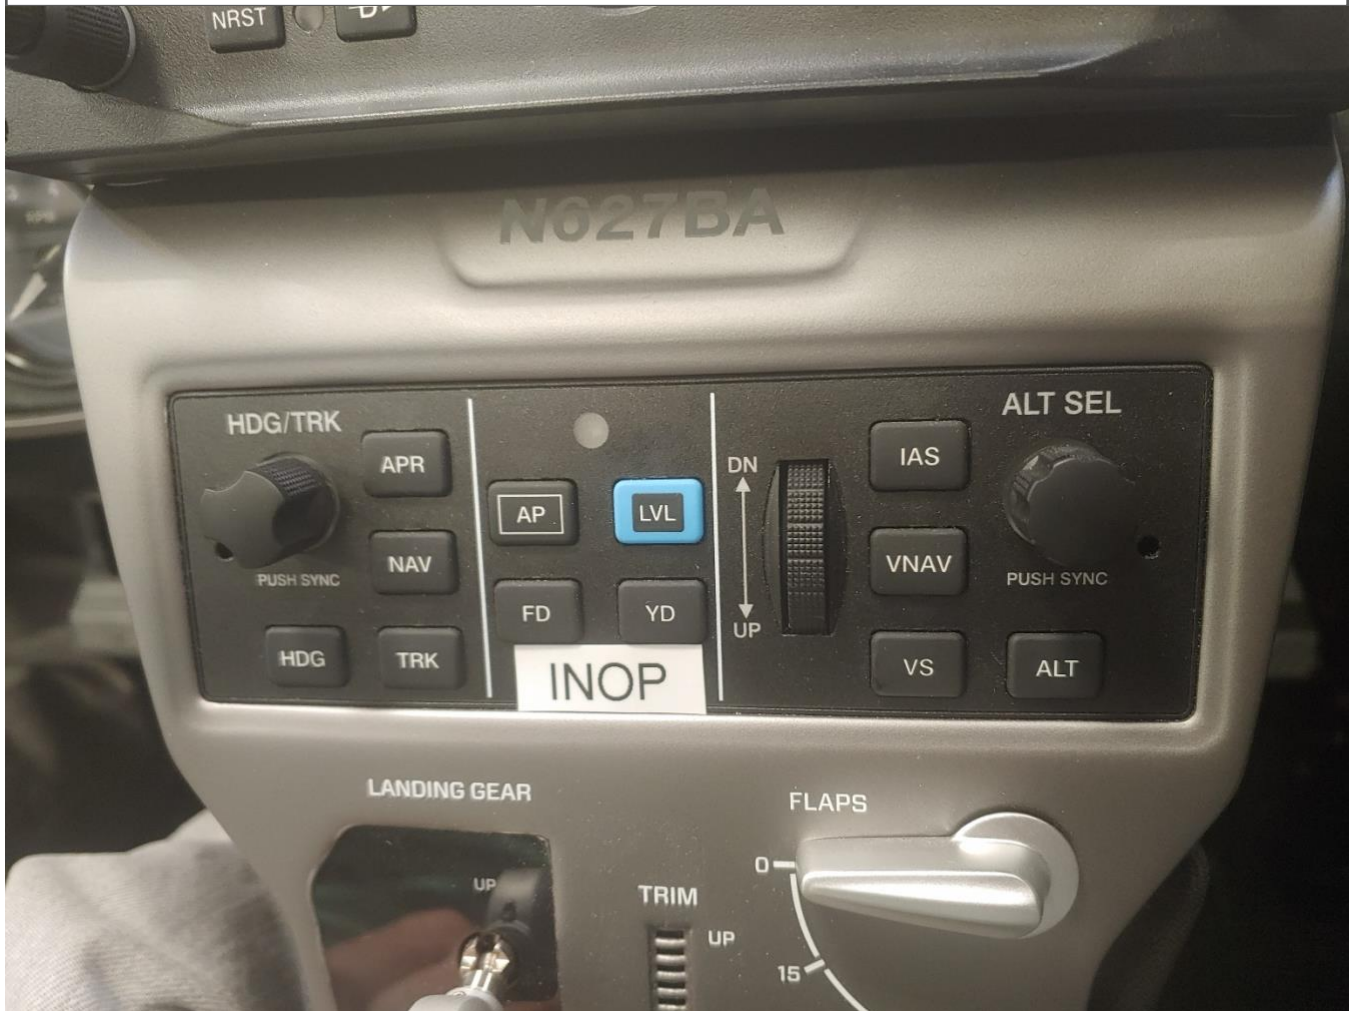
Figure 8: "INOP" label installation

21. Apply a label displaying "INOP" to the center stack as shown in Figure 8.
