SERVICE BULLETIN

SB-062322 REV A

DATE ISSUED: 06/23/2022
DATE EFFECTIVE: 06/23/2022
SUBJECT: Air Rudder Hinge Pin Under Torque
AIRCRAFT AFFECTED: **MODEL:** A5
S/N: 00001 – 00137, 00139, 00141 – 00146, 00148 – 00149, 00151, and 00153

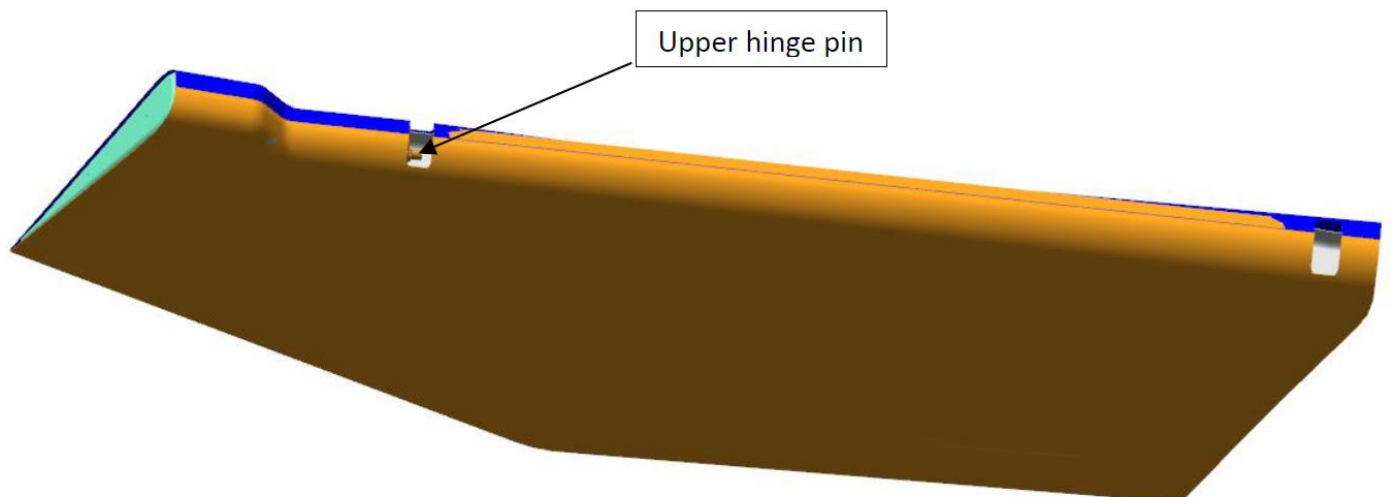
Figure 1 Upper Air Rudder Hinge Pin

ICON Aircraft has identified that the air rudder upper hinge pin may have been under torqued during manufacturing. Torque values below 48.7 in-lbs may cause loss of rudder effectivity during normal flight operations. However, loss of the air rudder control surface during flight is unlikely due to the locking nature of the hinge pin and nut plate. In addition, the presence of the lower hinge pin and control cable attachment should prevent separation under normal flight conditions.

1. Set torque to 58 in-lbs and torque the air rudder hinge pin. Apply torque stripe so it will be visible when air rudder is reinstalled.
2. Install Air Rudder in accordance with the latest release of the Aircraft Maintenance Manual, ICA000833.
3. Create a logbook entry in the airframe logbook (see “Logbook Entry A” below).
