SERVICE BULLETIN

SB-111721 REV B

DATE ISSUED: 06/29/2022
DATE EFFECTIVE: 06/29/2022
SUPERSEDES NOTICE: SB-111721 REV A
SUBJECT: Oil Tank Quick Drain Valve Torque Verification
AIRCRAFT AFFECTED: **MODEL:** A5
S/N: 126-132, 134, 135, 139, 141, 142
REQUIRED ACTION: Check the Torque Value of the Quick Drain Valve and Correct as Necessary
TIME OF COMPLIANCE: Before further flight if there is evidence of oil leaking from the subject drain valve as described in the inspection below. Otherwise, within 5 flight hours as required to ferry the aircraft to an approved maintenance facility for corrective action.

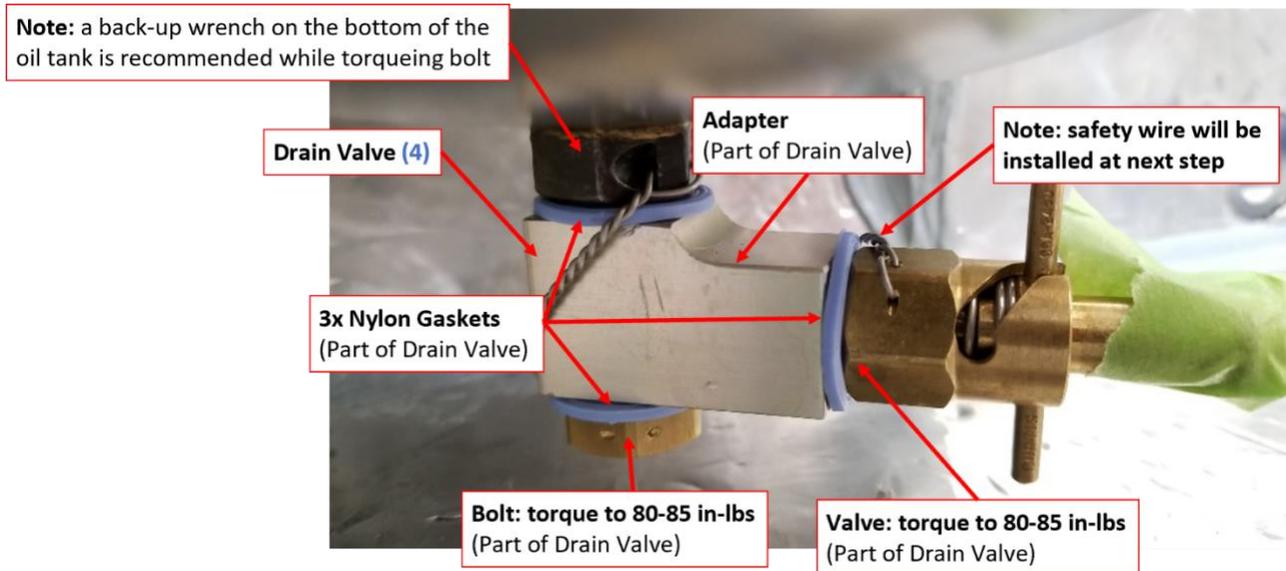
Figure 1 – Oil Tank Drain Valve and Bolt Location and Torque Specification

PURPOSE: Aircraft in the affected range may have had an under-torqued oil tank quick drain valve from production. The drain valve is safety wired; however, the under-torqued condition could lead to oil leakage, and if left un-checked over time, could lead to engine seizure.

1. Remove the oil tank in accordance with ICA000833 (A5 Maintenance Manual) Section 16.1.8.3.1 instructions.
2. Cut the safety wire securing the bolt and the tank valve assembly to the tank (shown in Figure 1) and discard.

3. Replace the nylon washers.
4. Check that the torque of the lower bolt and valve are within 80 to 85 in-lbs and correct as required.
5. Apply torque seal as required.

6. Ensure the drain valve is in the closed position as shown in Figure 1.
7. Install safety wire onto valve and adapter. After securing valve to adapter, install safety wire to secure bolt to oil tank. A separate piece of safety wire secures the bolt to the oil tank and a second piece of safety wire secures the valve to the adapter as shown in Figure 1. Ensure not to loosen the oil drain when installing the safety wire.
