SAFETY DIRECTIVE/ALERT

SD-092122-A

ID NUMBER & REVISION: SD-092122-A
SUBJECT: 4 AWG Wire Harness Crimp Inspections
RELEASE DATE: 09/22/2022
EFFECTIVE DATE: 09/22/2022
SUPERSEDES NOTICE: N/A
AIRCRAFT AFFECTED: **MAKE & MODEL:** A5
SERIAL NUMBERS: ASN 00135 to ASN 00136
ASN 00139 to ASN 00146
ASN 00148 to ASN 00150
ASN 00152 to ASN 00159

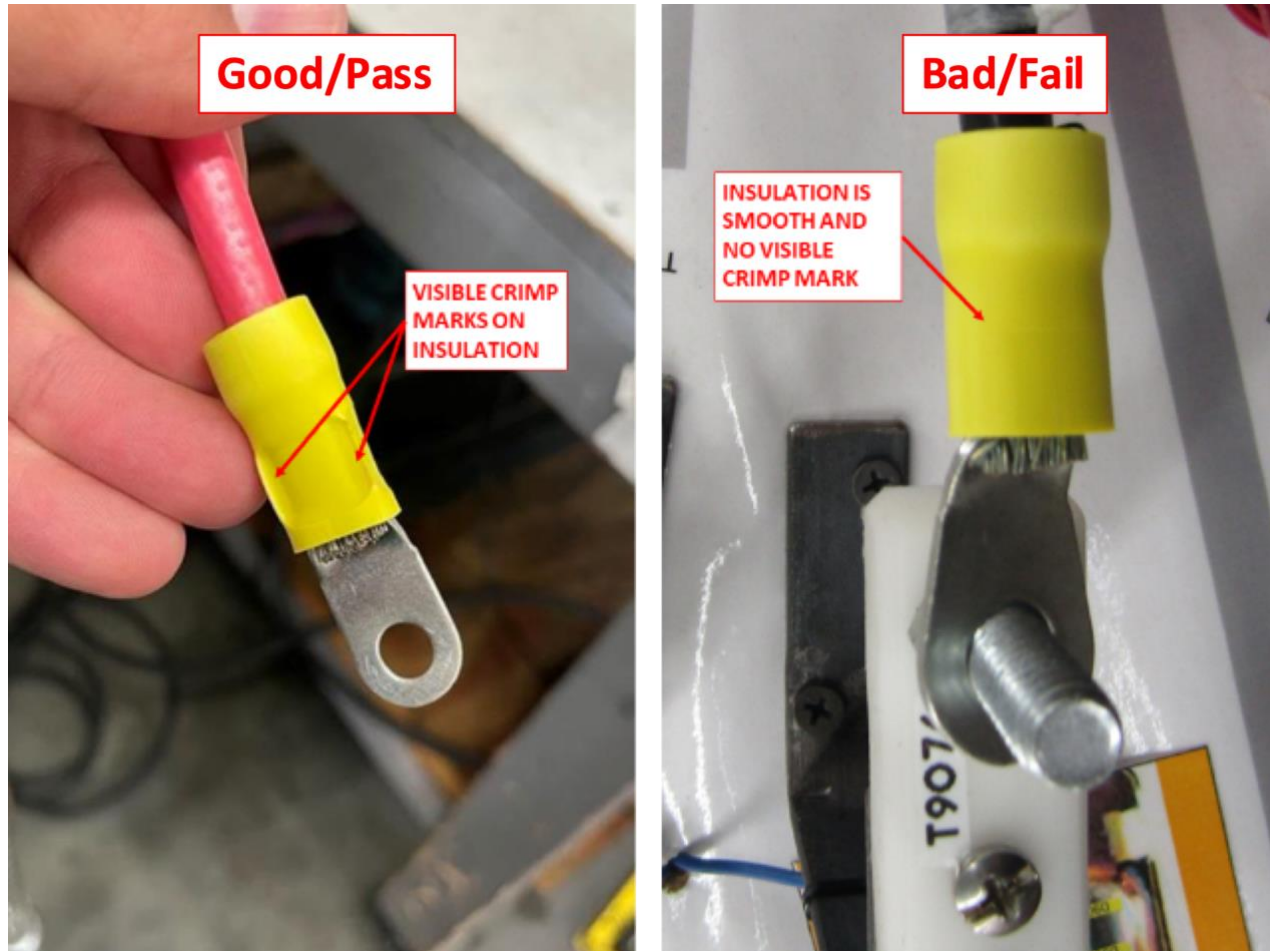
Figure 2 Terminal Inspection Criteria (Good/Pass and Bad/Fail)

ICON has identified that some of the 4 AWG wire harness to terminal connections in the affected aircraft do not meet the required tensile pull force of 140lbs due to improper crimping of the wire harness to the terminal. Therefore, the crimp on certain connections needs to be visually inspected and re-crimped (or replaced) if found to be improperly crimped.

Inspection criteria (See Figure 2)

Good/Pass: Visual crimp marks seen on insulation

Bad/Fail: Insulation is smooth and no visible crimp marks

- a. If the terminal crimps are found to be Good/Pass, then no action is required for the specific terminal.
- b. If a terminal crimp is found to be Bad/Fail, re-crimp or replacement of the failed terminal is required. Refer to Section C "Crimping Instructions" below.

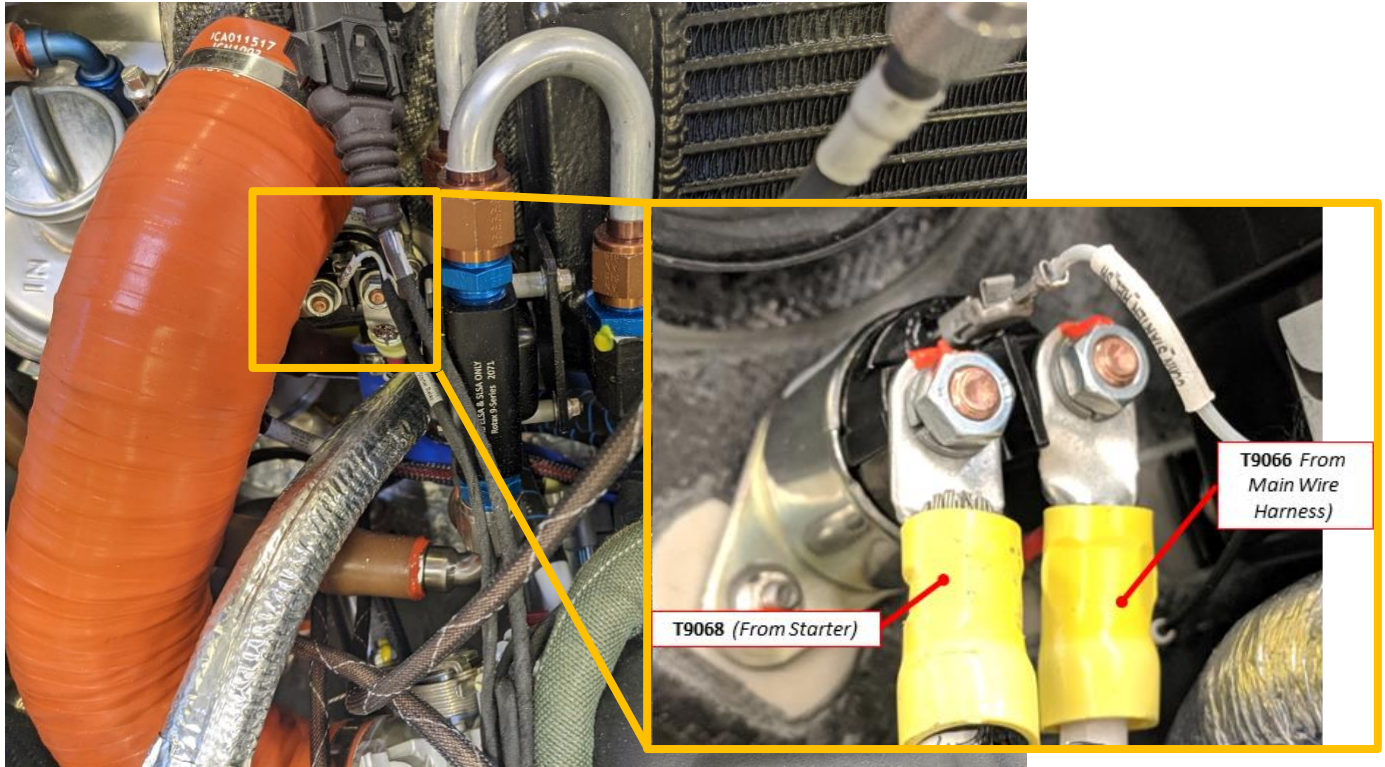
Figure 3 Starter Solenoid (T9068 & T9066)

- i. T9066 (Connected to RH terminal of the Starter Solenoid) See Figure 3
- ii. T9068 (Connected to LH terminal of the Starter Solenoid) See Figure 3
- iii. T9075 (Connected to Lower FWD Engine block GND) See Figure 4
- iv. T9067 (Connected to Engine Starter Motor) See Figure 5

3. Once all affected terminals are re-crimped or replaced, re-install each terminal using the following instructions:
 - a. **T9066** and **T9068**:
 - i. Connect electrical connections to starter relay with retained hardware, see Figure 3.

- ii. Using isopropyl alcohol, clean surfaces where thread locker will be applied. Apply LOCTITE 243 to threads of nuts.
 - iii. **T9068** ring terminal **from starter** to **LH ring terminal** on **starter relay** as shown with supplied hardware see Figure 3.

- iv. **T9066** ring terminal **from main wire harness** to **RH ring terminal** on **starter relay** as shown with supplied hardware see Figure 3.
 - v. Torque hardware to 33-39 in-lbs.

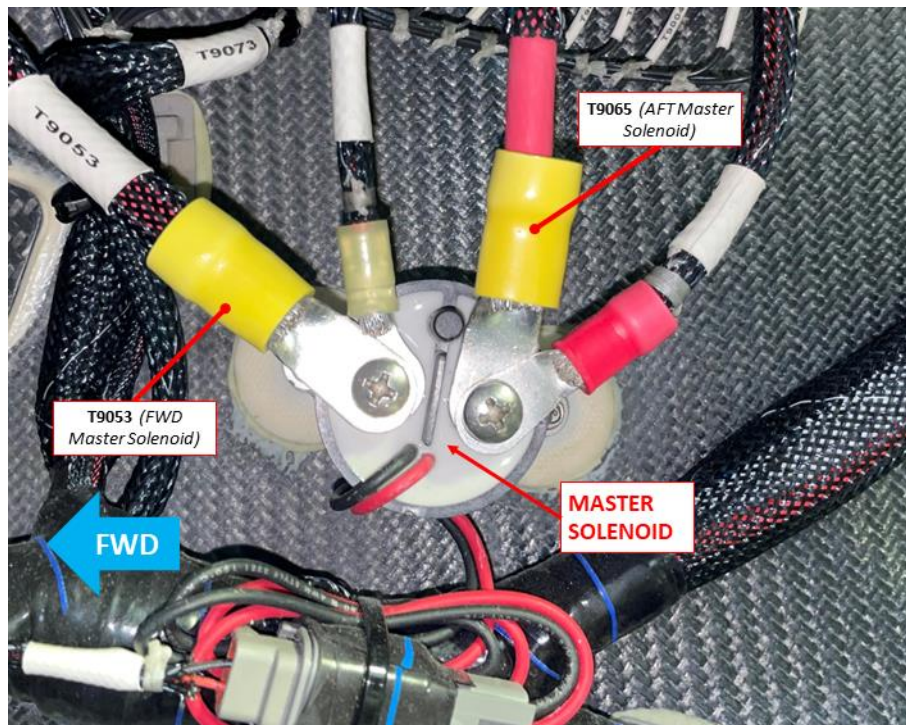
Figure 6 Aircraft Master Solenoid (T9053 & T9065)

- i. T9053 (FWD Master Solenoid) Reference Figure 6
- ii. T9065 (AFT Master Solenoid) Reference Figure 6
- iii. T9054 (Positive Battery Terminal) Reference Figure 7

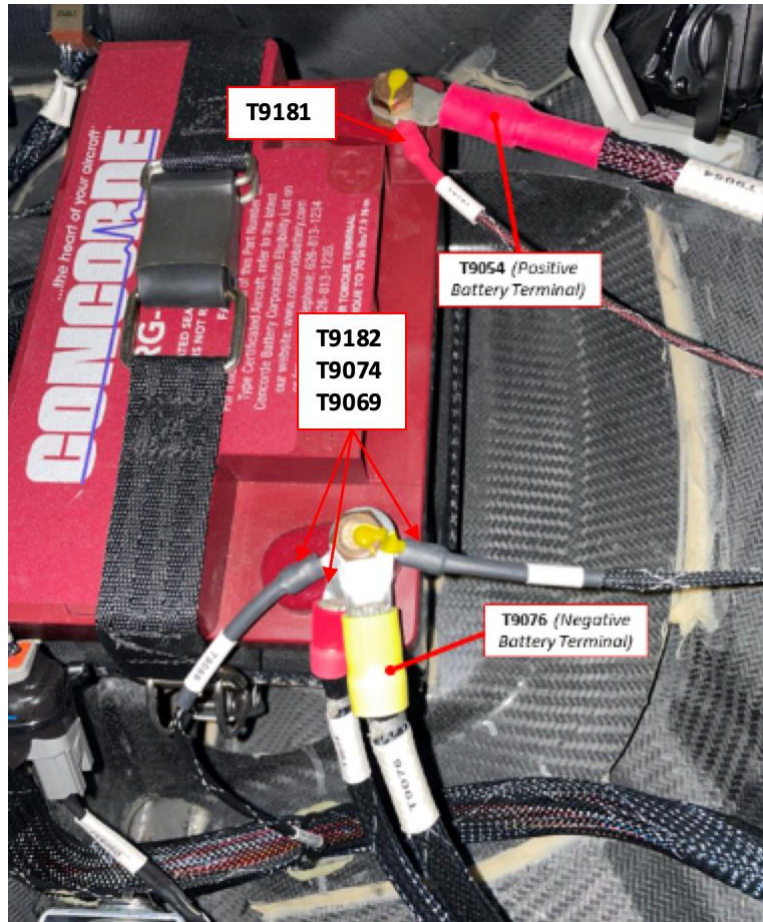
Figure 7 Battery (T9054 & T9076)

- iv. T9076 (Negative Battery Terminal) Reference Figure 7

- i. Connect ring terminal **T9181** (Positive Battery Jumper) and **T9054** (Master Relay Jumper) to the positive terminal of the battery.
- ii. Torque the Positive Battery Terminal to 66 to 74 in-lb.
- iii. Using isopropyl alcohol, clean surfaces where inspector lacquer will be applied.
- iv. Apply inspector's lacquer (ICA012079) to the bolt head and onto the adjacent structure.

- i. Connect ring terminal **T9182** (Negative Battery Jumper), **T9076**, **T9074** (Main wire harness) and **T9069** (Bow hook battery jumper) to the negative terminal of the

- battery.
 - ii. Torque the negative Battery Terminal to 66 to 74 in-lb.
 - iii. Using isopropyl alcohol, clean surfaces where inspector lacquer will be applied.

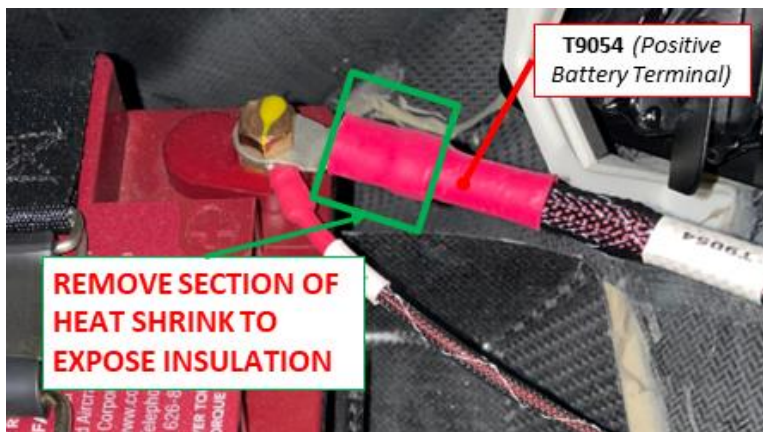
Figure 8 T9054 Heat Shrink

NOTE: The insulation T9054 may have heat shrink impeding the inspection. It is permissible to carefully cut away the heat shrink. Reference Figure 8
