## SERVICE BULLETIN

SB-122722-B

**ID NUMBER & REVISION:** SB-122722-B  
**SUBJECT:** NLG Actuator Rod End Torque  
**RELEASE DATE:** 31 October 2025  
**EFFECTIVE DATE:** 27 December 2022  
**SUPERSEDES NOTICE:** SB-122722-A  
**AIRCRAFT AFFECTED:** **MAKE & MODEL:** ICON A5  
**SERIAL NUMBERS:** 00004 – 00015, 00017 – 00024, 00026 – 00074,  
00076 – 00137, 00139, 00141 – 00142, 00144 –  
00145, 00148 – 00150, 00152 – 00159, 00161,  
00163, 00166

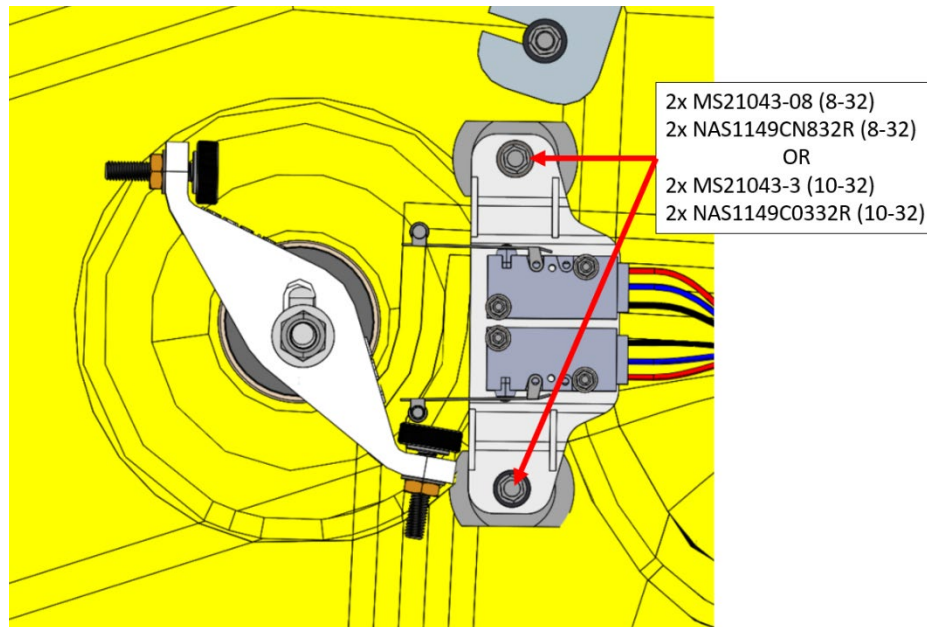
Figure 7 Mechanical Limit Switches

**CAUTION:** Failure to remove the switch assembly prior to releasing the NLG leg may result in damage to the limit switch arms.

2. Remove the MLG fuse.
3. For aircraft with mechanical limit switches, loosen the two nuts securing the limit switch bracket assembly to the studs. Remove the switch and bracket assembly.

13. If applicable, reinstall limit switch bracket assembly (*Figure 7*):
  - a. Using isopropyl alcohol, clean surfaces where lubricant will be applied.

- b. Apply ICA012078 Tef-Gel to the threads of the studs.
  - c. Install limit switch assembly onto studs with 2x NAS1149CN832R washers and 2x MS21043-08 nuts torqued to 14 in-lb (for 8-32 studs), or with 2x NAS1149C0332R washers and 2x MS21043-3 nuts torqued to 20 in-lb (for 10-32 studs).

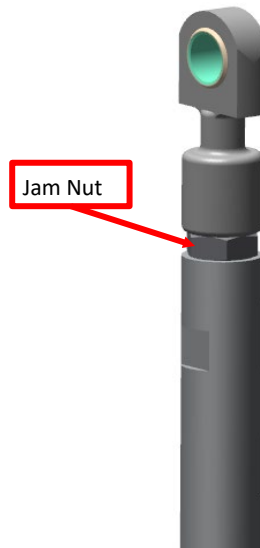
*Figure 5 NLG Actuator Rod End Jam Nut*

ICON Aircraft has identified an issue with the torque value of the Nose Landing Gear (NLG) jam nut on the rod end of the NLG actuator. ICON discovered that the jam nut may have been under torqued during manufacturing. This Service Bulletin provides inspection and adjustment instructions to correct the issue.

9. If the torque level of the jam nut is outside the allowable range (95-110 in-lbs) then:
  - a. Bottom the rod end onto the thrust tube. See Figure 5.
  - b. Torque the jam nut to 95-110 in-lbs.
