SERVICE BULLETIN

SB-022323-A

ID NUMBER & REVISION: SB-022323-A
SUBJECT: Throttle Cable Chaffing
RELEASE DATE: 13 March 2023
EFFECTIVE DATE: 13 March 2023
SUPERSEDES NOTICE: N/A
AIRCRAFT AFFECTED: **MAKE & MODEL:** ICON A5
SERIAL NUMBERS: 00001 – 00136, 00139 – 00146, 00148 – 00150,
00152 – 00159, 00161, 00163, 00166
REQUIRED ACTION: Adjust the position of the throttle cable to provide clearance between the
throttle cable and lower intake plenum mount.
TIME OF COMPLIANCE: At the next service interval
REVISION HISTORY: A Initial Release

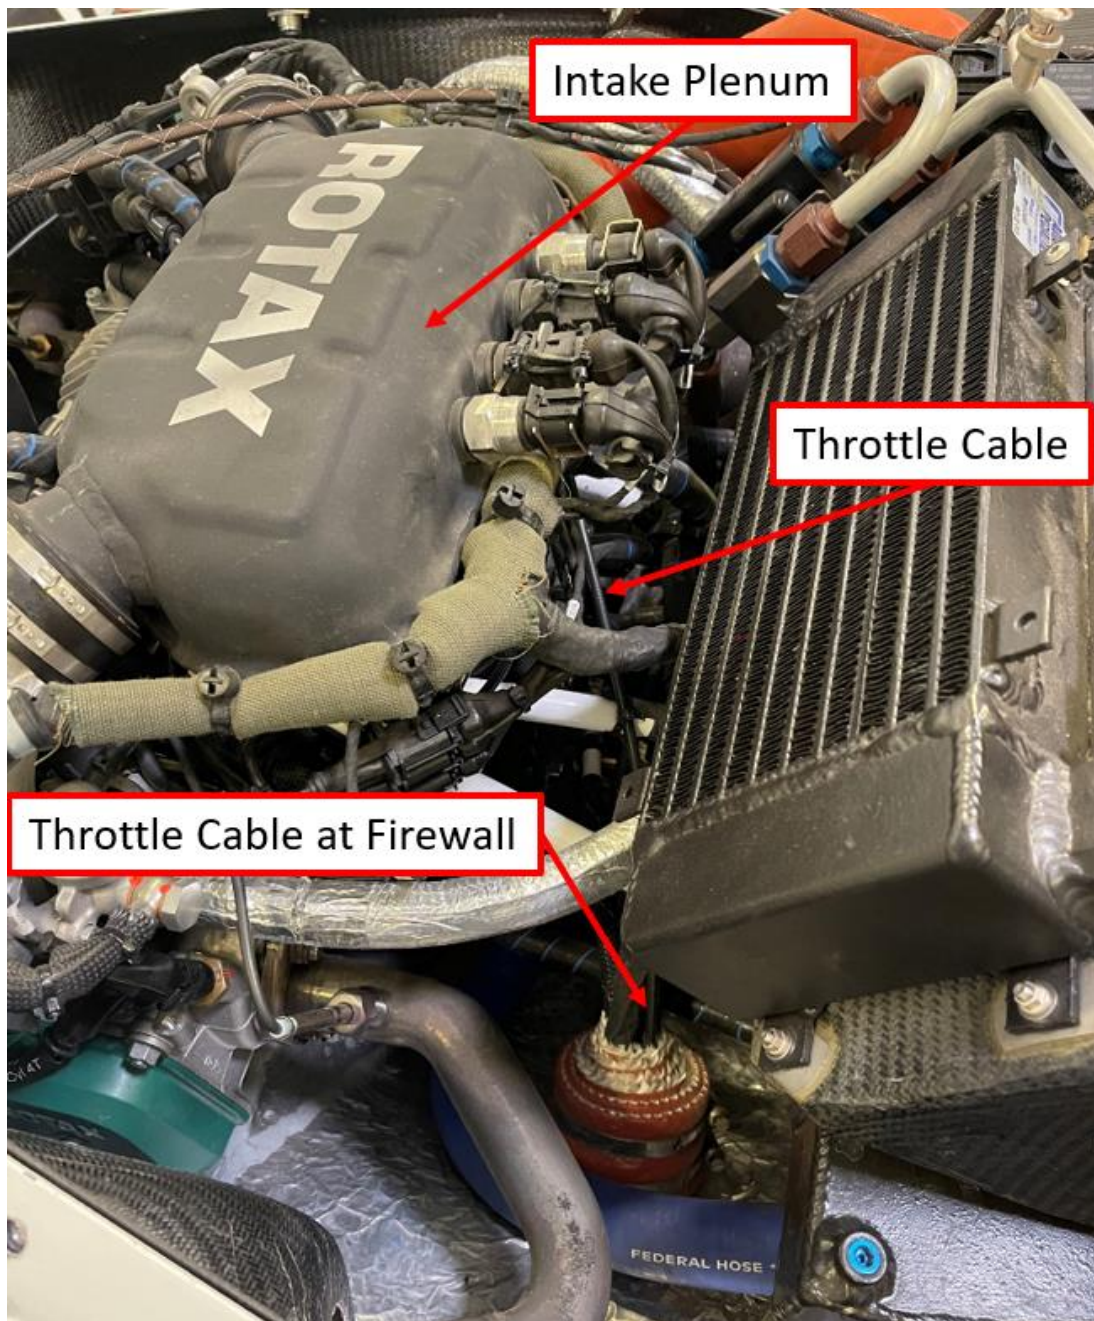
1. Remove the engine cowlings.
 - a. ICON Aircraft Maintenance Manual: Remove Engine Cowlings ([100497](#)).
2. Locate the throttle cable at the lower intake plenum mount.
 - a. See Figures 1 and 2.

Figure 1 Throttle Cable Location

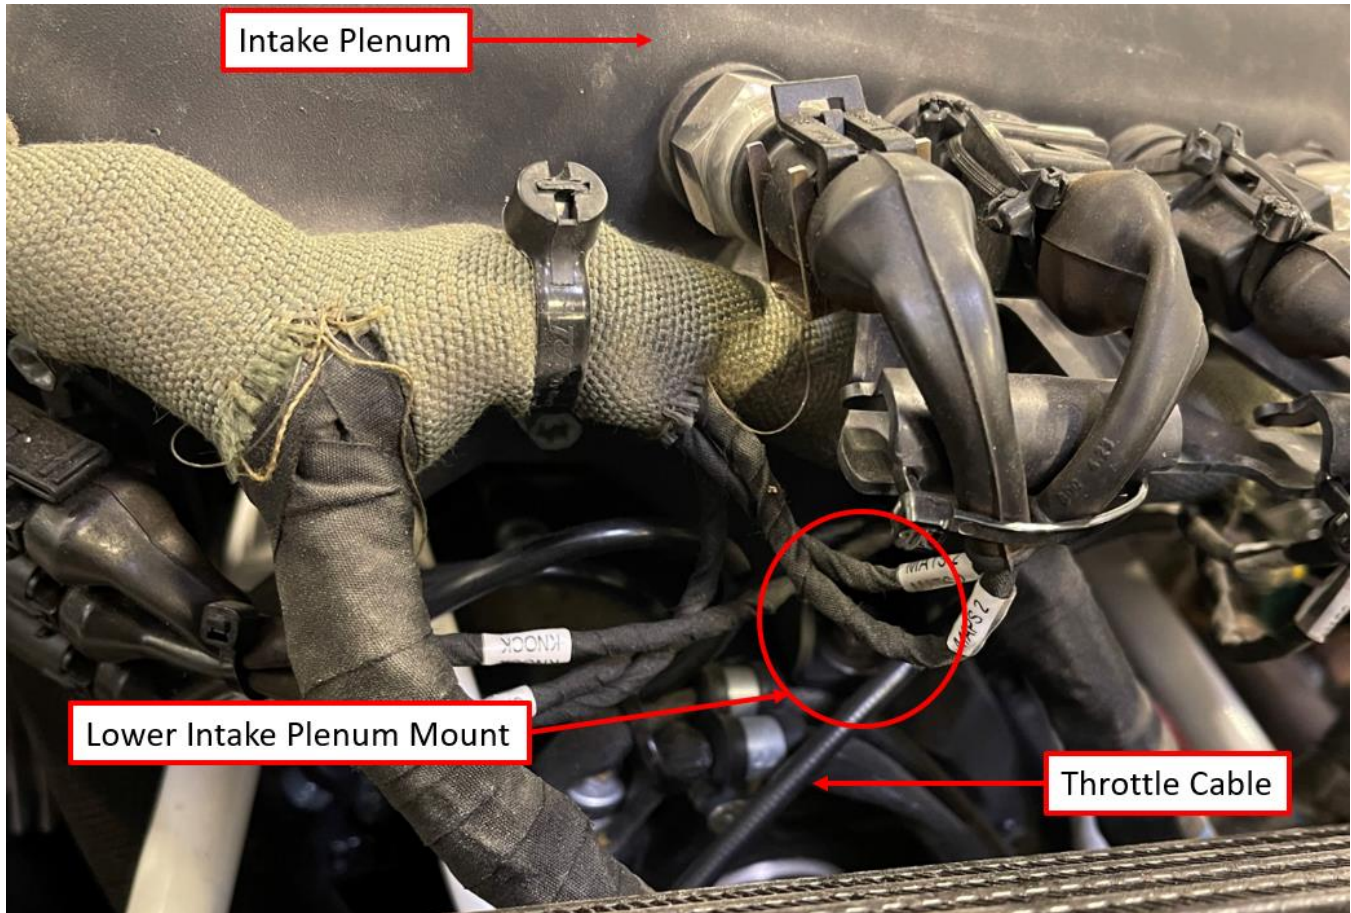
It has been identified that the throttle cable has been mounted on the engine in such a way that there will be little to no clearance between the throttle cable and lower intake plenum mount. The lack of proper clearance can cause the cable to chafe and potentially become damaged. Sustained damage to the throttle cable could lead to throttle cable failure and the inability of the pilot to control engine power.

Figure 2 Throttle Cable at Lower Intake Plenum Mount

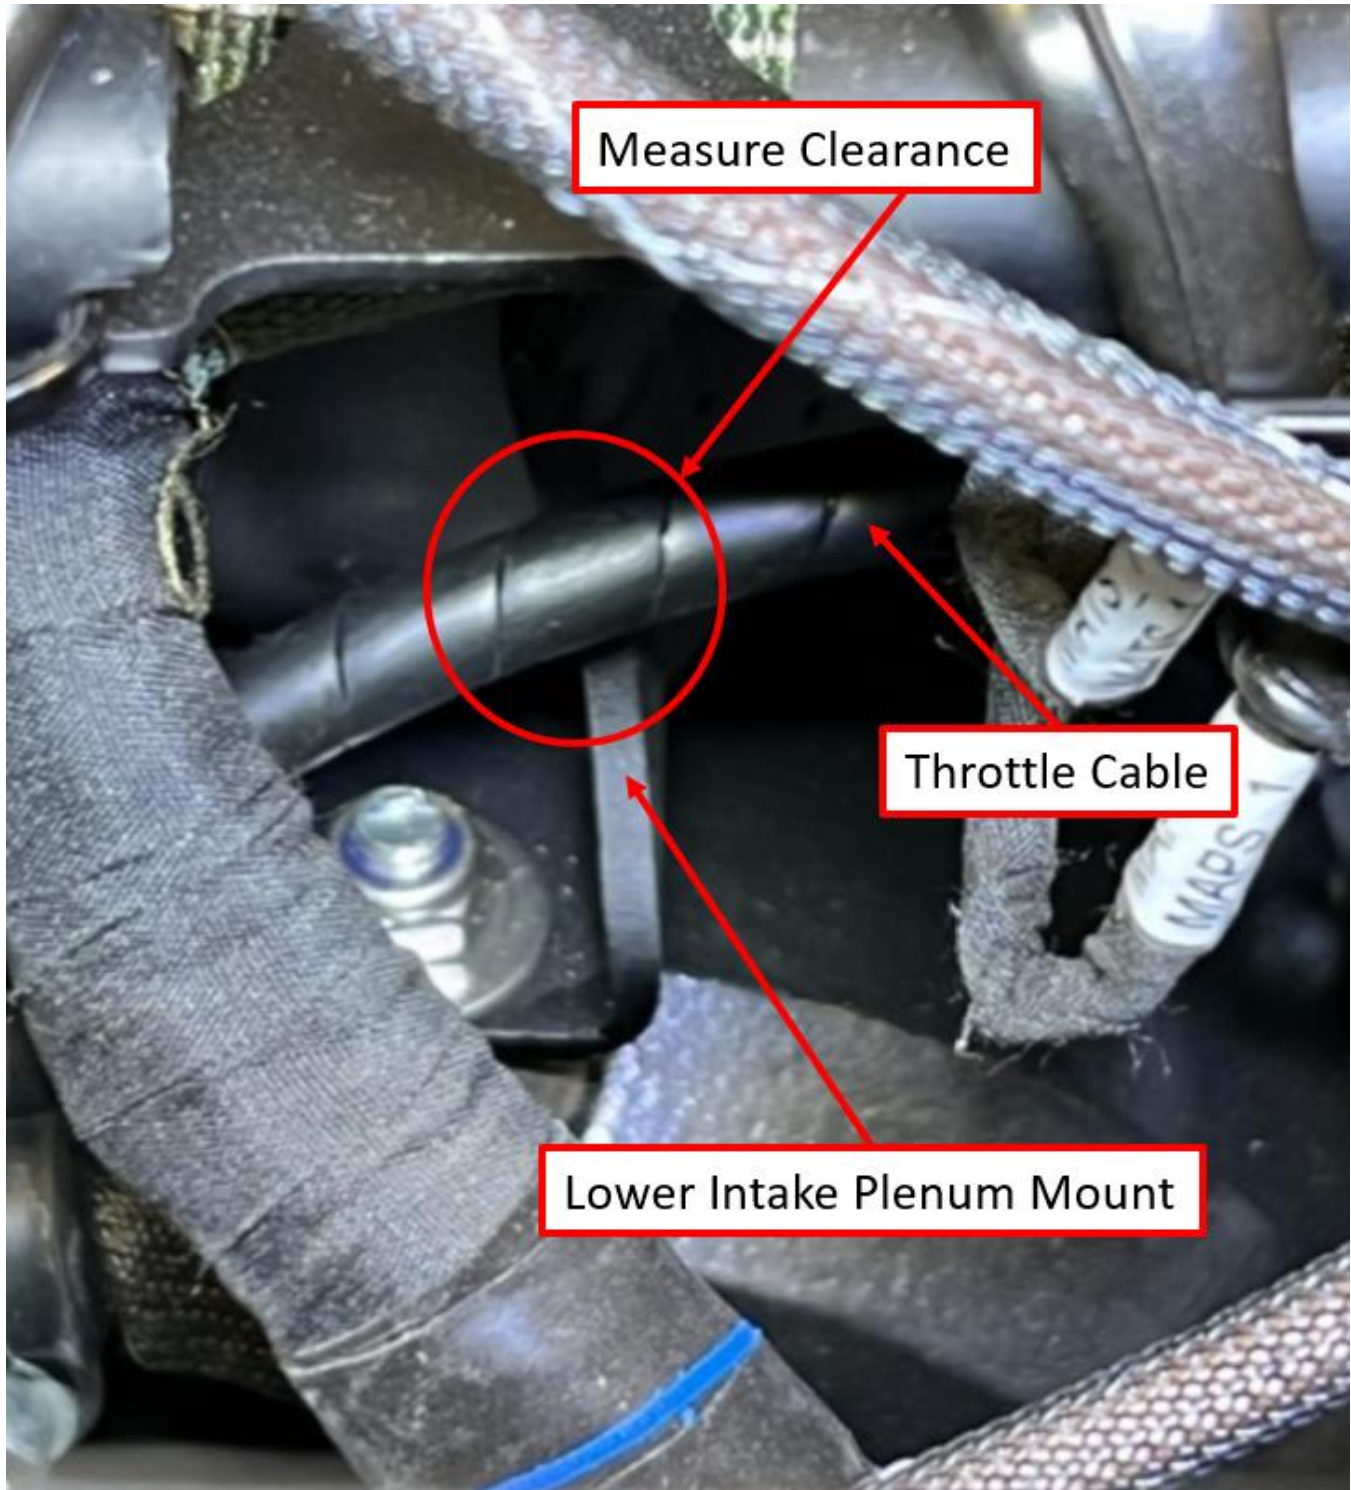
3. Measure the clearance between the throttle cable and the lower intake plenum mount.
 - a. There should be a minimum of $\frac{1}{4}$ " clearance.
 - b. See Figure 3.
4. If the clearance is greater than $\frac{1}{4}$ ", proceed to steps 12 and 13 of the "Repair" section in this Service Bulletin.
5. If the clearance is less than $\frac{1}{4}$ ", proceed to step 1 of the "Repair" section of this Service Bulletin.

*Figure 3 Clearance at the Intake Plenum Mount*

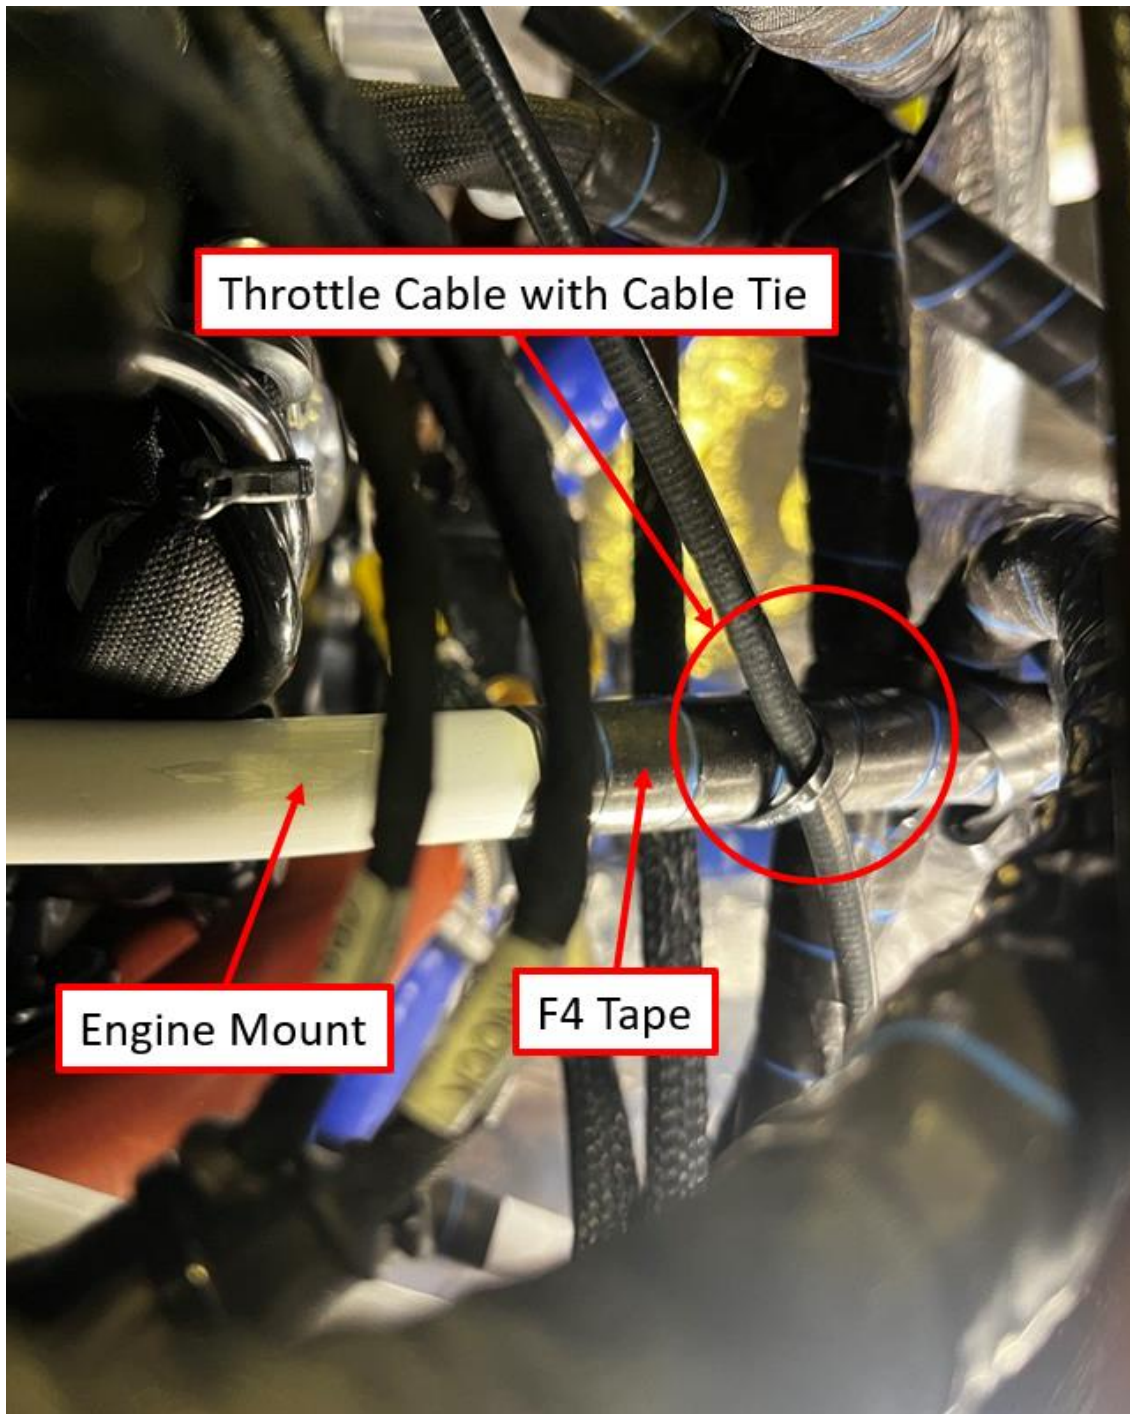
*Figure 4 Throttle Cable Tie at Engine Mount*

1. Remove the cable tie at the throttle cable and engine mount.
 - a. See Figure 4.

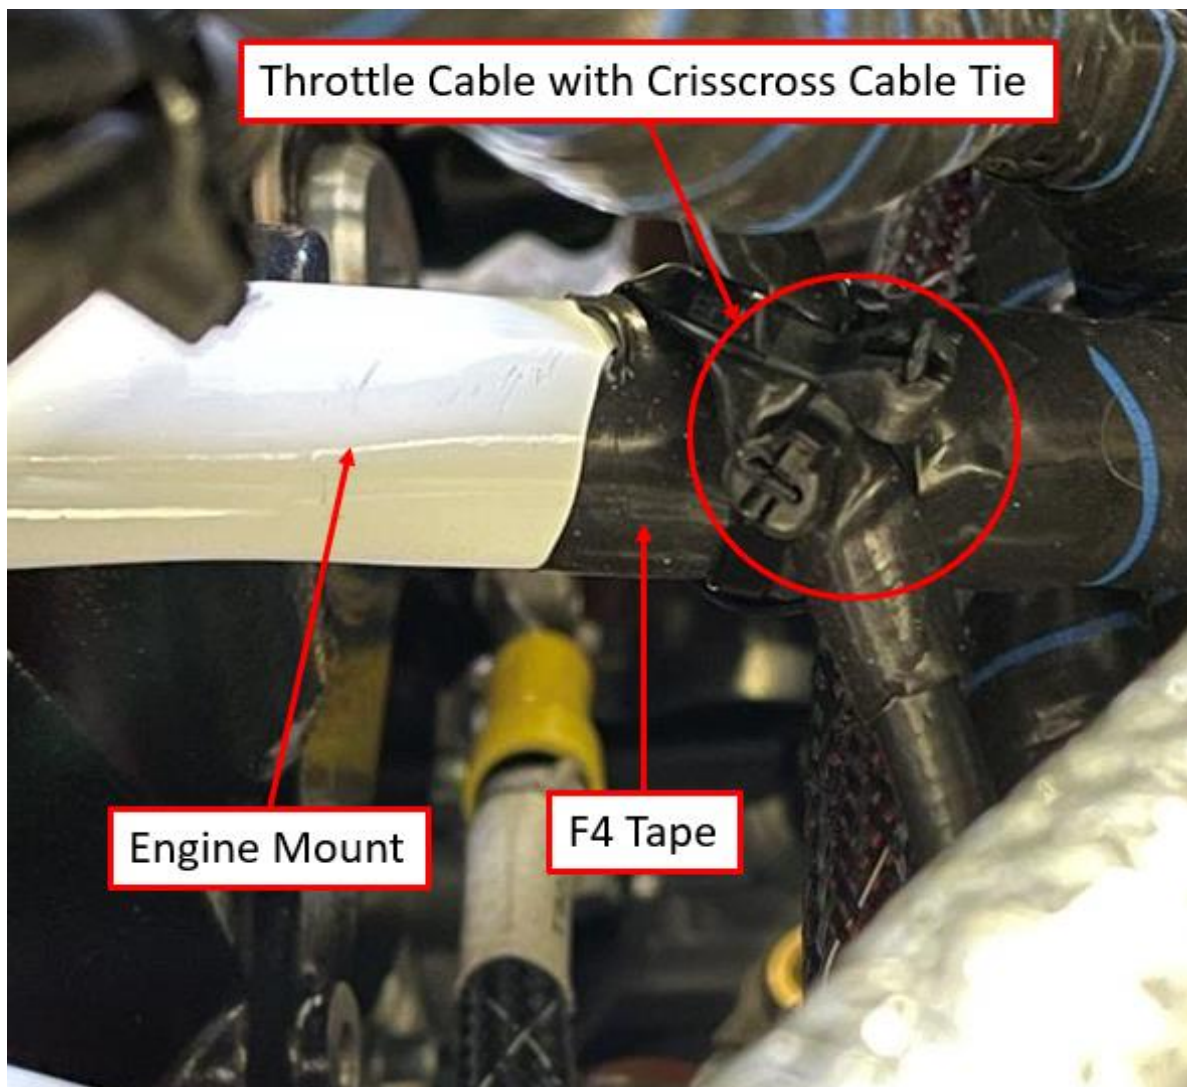
Figure 5 Crisscross Cable Tie Mount

2. Verify F4 Tape is installed on the engine mount where the throttle cable is intended to be secured.
 - a. Install F4 tape if there is none where the throttle cable is intended to be secured.
3. Re-locate the throttle cable, along the engine mount, until a $\frac{1}{4}$ " or greater clearance is achieved between the throttle cable and lower intake plenum mount.
4. Ensure that the throttle cable remains over the F4 tape on the engine mount.
5. Install F4 tape onto the throttle cable where the throttle cable will be secured to the engine mount.
6. Secure the repositioned F4 wrapped throttle cable onto the F4 wrapped engine mount with two TY23MX cable ties in a crisscross pattern.
 - a. See Figure 5.
