SERVICE BULLETIN

SB-030223-A

ID NUMBER & REVISION: SB-030223-A
SUBJECT: CPS Wire Chafing
RELEASE DATE: 31 March 2023
EFFECTIVE DATE: 31 March 2023

AIRCRAFT AFFECTED: MAKE & MODEL: A5

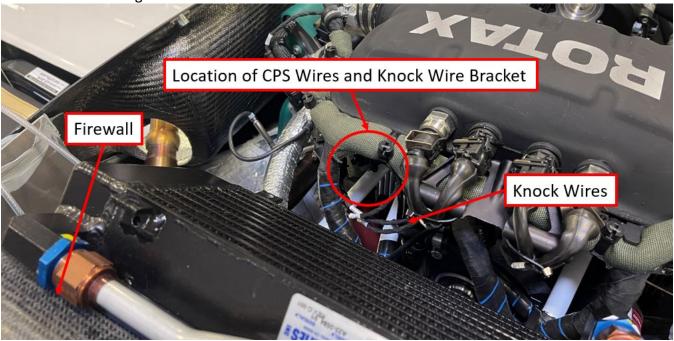
Figure 1 CPS Wire Location

- 2. Locate the CPS wires, near the Knock Wire Bracket, on the front of the engine.
 - a. See Figures 1 and 2.
- 3. Identify any evidence of wire chafing.
 - a. See Figure 7.
- 4. If there is no evidence of wire chafing, then:
 - a. Proceed to the "Repair" section of this Service Bulletin.
- 5. If there is evidence of wire chafing, but no wires are exposed through the insulation then:
 - a. Wrap the chafed area with F4 tape.
 - b. Proceed to the "Repair" section of this Service Bulletin
 - c. See Figure 7.
- 6. If there is evidence of wires exposed through the insulation, contact ICON Aircraft Service for further repair instructions.
 - a. Do not proceed to the "Repair" section of this Service Bulletin

- 1. Locate the CPS wires at the front of the engine, closest to the firewall.
 - a. See Figures 1 and 2

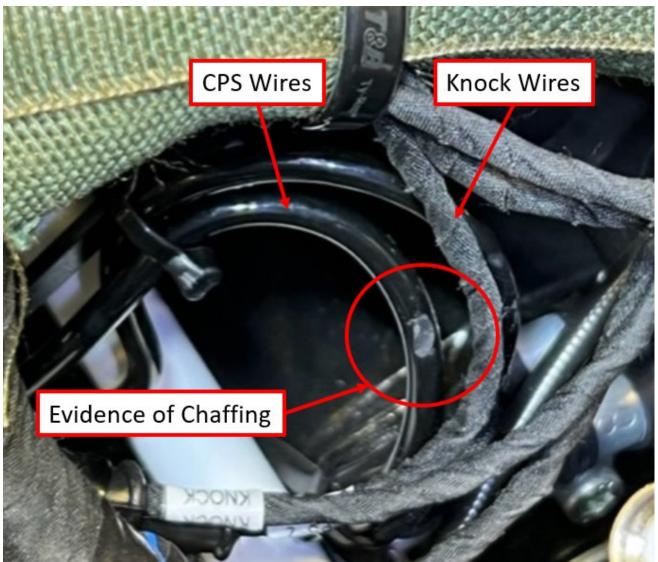
It was discovered that there exists a potential for the ROTAX 912iS CPS wires to experience chafing from the wrapped knock sensor wires and/or free edge of CPS/Knock Sensor bracket due to the vibration of the engine. It is necessary to properly secure the CPS wires to the knock sensor bracket.

Figure 7 CPS Wire Chafing
