SAFETY DIRECTIVE/ALERT

SD-071323-A

ID NUMBER & REVISION: SD-071323-A
SUBJECT: Flap Hardware Wing Damage
RELEASE DATE: 16 August 2023
EFFECTIVE DATE: 16 August 2023
SUPERSEDES NOTICE: N/A
AIRCRAFT AFFECTED: **MAKE & MODEL:** ICON A5
SERIAL NUMBERS: 00184, 00186, 00187
REQUIRED ACTION: Internally and externally inspect the left and right wings for wing skin damage caused by the left-hand and right-hand flap brackets.
TIME OF COMPLIANCE: Before the next flight. The owner/operator may fly up to 15 hours to relocate the aircraft for repairs if outer wing inspection below is performed and there are no findings.
REVISION HISTORY: A Initial Release

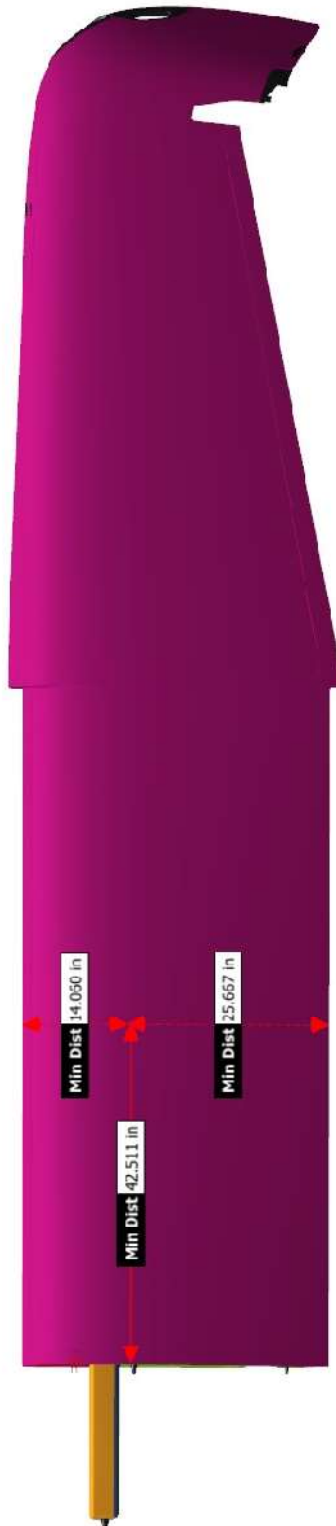
Figure 1 Location of Bulge

- a. See Figure 1 for dimensions.
- b. For the left wing, the bulge may be around the “5” of the “ICON A5” decal.
- c. For the right wing, the bulge may be in the same location as described for the left wing (step 1a).
- d. It is possible to “feel” the bulge at the above locations.
2. If there is a bulge, the aircraft will need to be grounded.
 - a. Do not perform further flight operations until a repair can be made.
3. If there is no bulge, the aircraft may be flown up to 15 hours to relocate the aircraft for repairs.

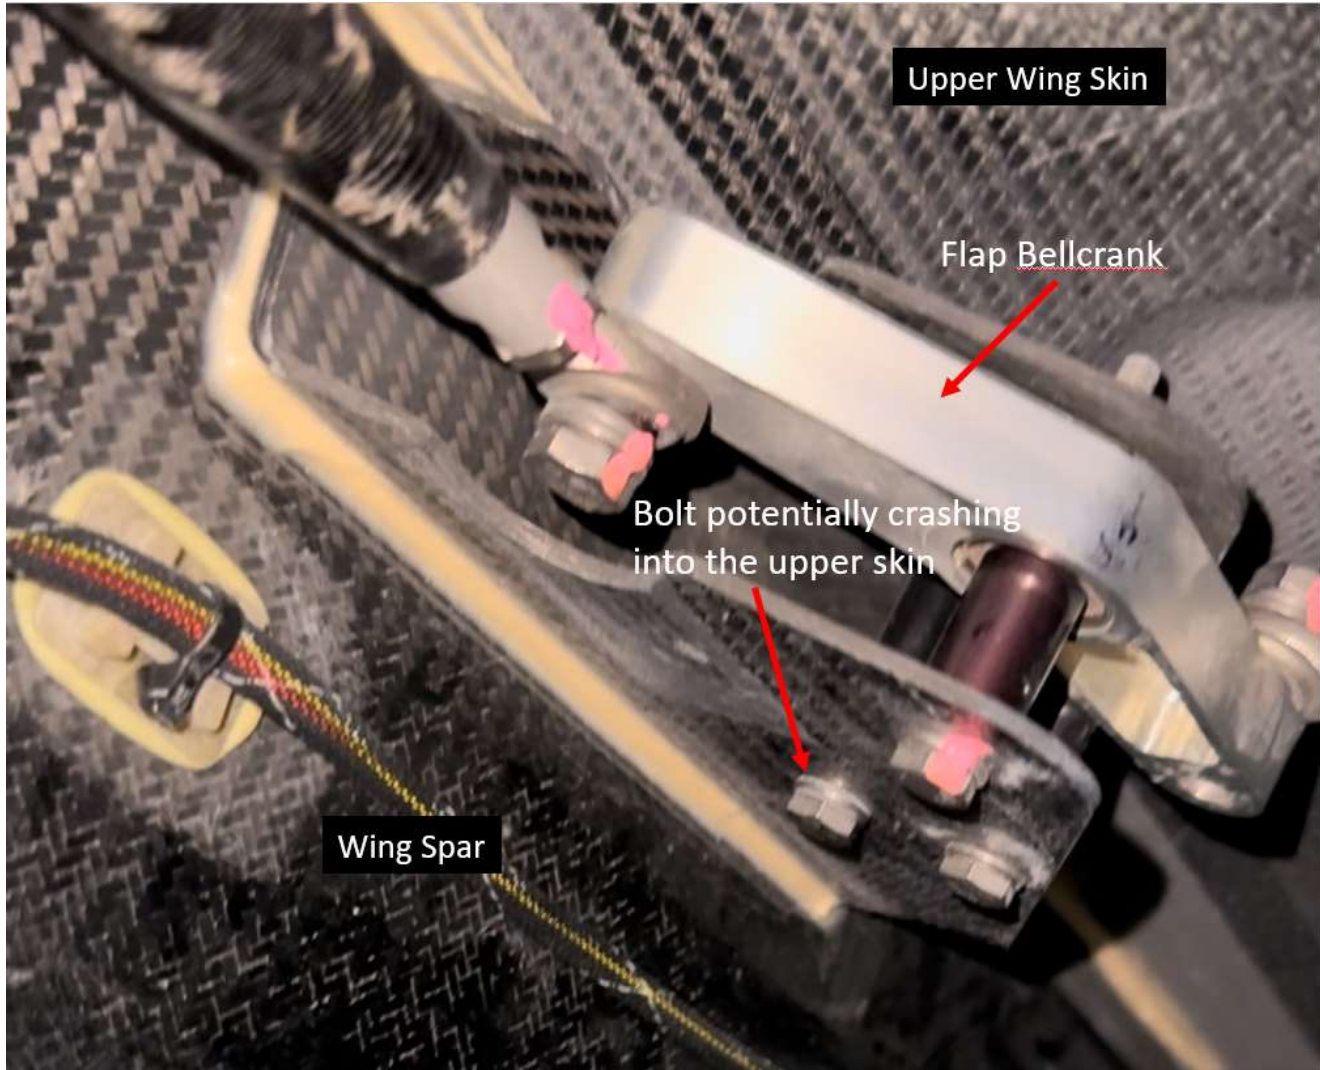
Figure 2 Flap Bracket and Bell Crank Location

1. Fold the left and right wing in accordance with the wing folding procedures in the online ICON Aircraft Maintenance Manual ([ICA000833](#)).
 - a. ICON Aircraft Maintenance Manual: [100629](#)
2. Remove the large Aileron Access panels on the left and right wing.
 - a. ICON Aircraft Maintenance Manual: [100223](#)
3. Locate the flap bracket, which is mounted on the wing spar.
 - a. The flap bracket has the push pull tube for the flap system.
4. Identify the hardware flap bracket.
 - a. The flap bracket has three bolts, one for the bell crank, and two stops.
 - b. The flap stop nearest the wing spar is the affected bolt.
 - c. See Figure 2
5. With a Borescope and a flashlight, you should be able to see the hardware crashing against the upper wing skin.
 - a. *You may be able to use a mirror, but it is more difficult to judge if there is any space.*
 - b. See Figures 3 and 4.

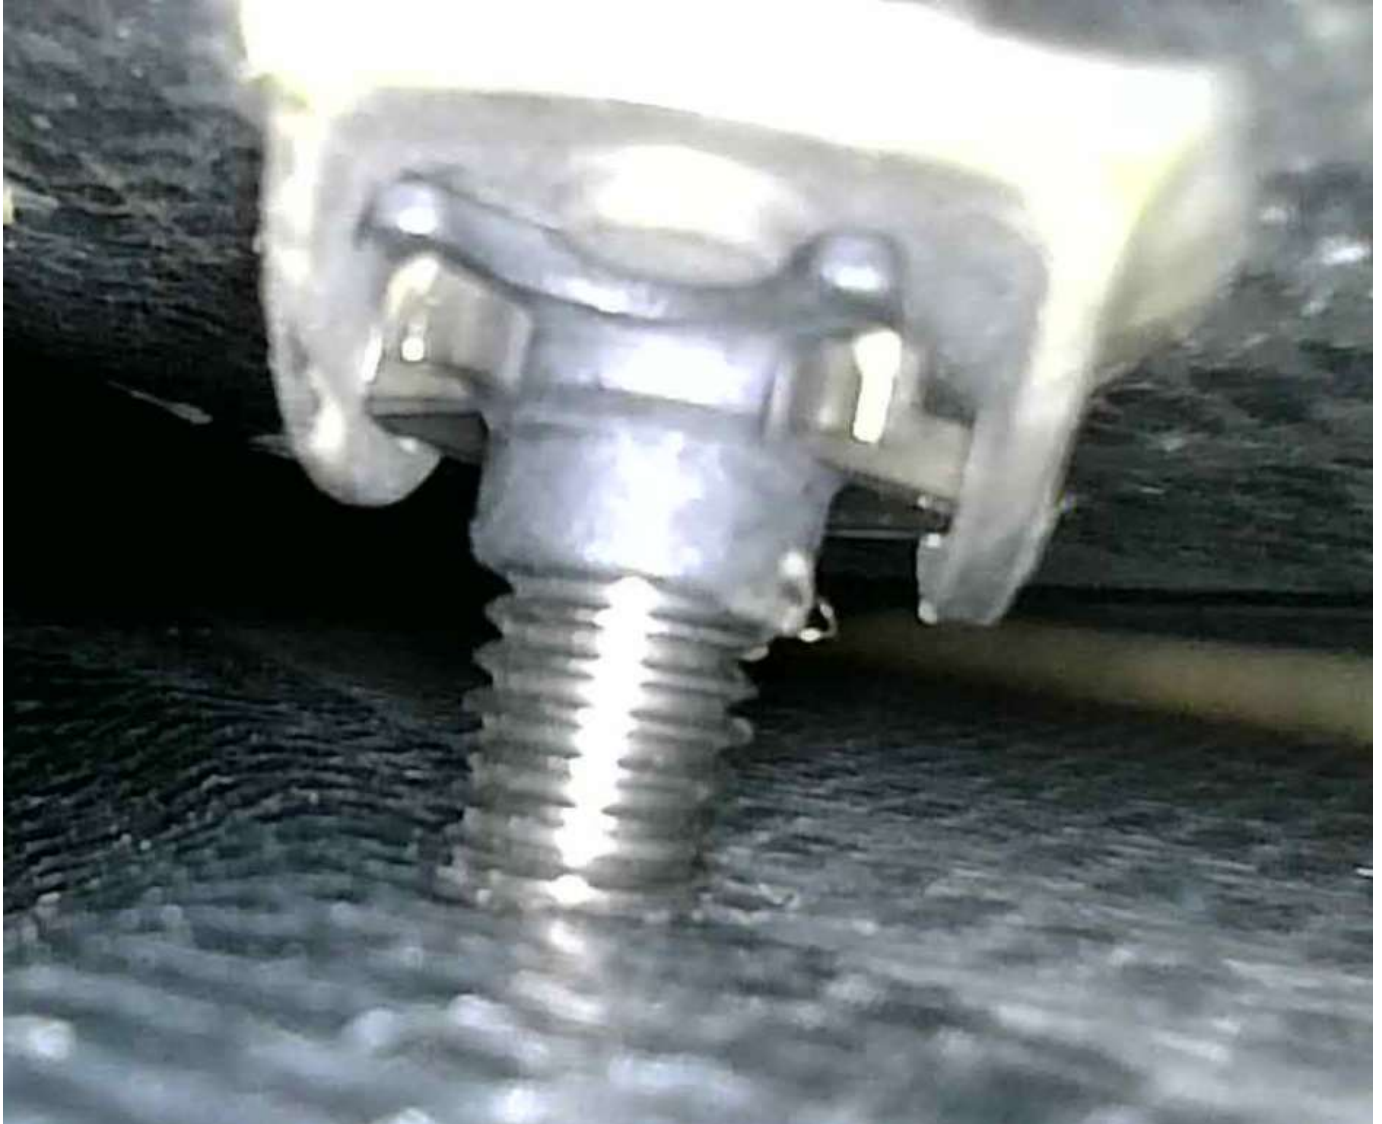
Figure 4 Flap Bracket Bolt Crashing Into Wing Skin

It has been discovered that there is a potential for wing skin damage of the left and right wings. Damage can occur from the flap nut plate bolt as it extends beyond the nut plate. The extension could be of a length that contacts the inner carbon fiber wing skin and core during flap operations. This damage could affect the left wing, right wing, or both.

If there is damage to the outer, inner, or both wing skins, proceed to the “Repair” instructions of this Safety Directive.

1. Contact ICON Aircraft Customer support for repair instructions.
