SERVICE BULLETIN

SB-041323-B

ID NUMBER & REVISION: SB-041323-B
SUBJECT: ELT Antenna Corrosion
RELEASE DATE: 7 September 2023
EFFECTIVE DATE: 7 September 2023
SUPERSEDES NOTICE: SB-041323-A
AIRCRAFT AFFECTED: **MAKE & MODEL:** ICON A5
SERIAL NUMBERS: 00001 – 00185

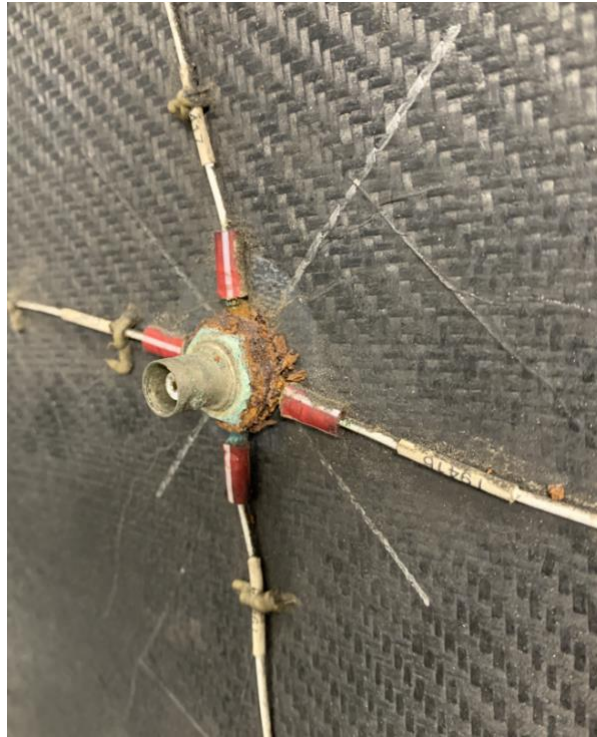
1. Remove the top engine cowling.
 - a. ICON Aircraft Maintenance Manual: Remove Engine Cowlings (100497).
2. Inspect the antenna connectors and grounding wires underneath the top cowling (non-painted side) for evidence of corrosion.
 - a. See Figure 1 for an example of corrosion.
 - b. If there is corrosion, proceed to “Repair – Corrosion” section of this Service Bulletin
 - c. If there is no corrosion, proceed to “Logbook Entry”.
3. Inspect the steel wire located on the ACK ELT Whip Antenna, on top of the cowling (painted side) for evidence of corrosion.
 - a. See Figure 2 for inspection location.

Figure 1 Evidence of Corrosion Underneath the Cowl

NOTE: If the base of the ACK ELT Whip Antenna and/or the steel wire at the top of the ACK ELT Whip Antenna is corroded, then the entire antenna assembly will have to be removed and replaced.

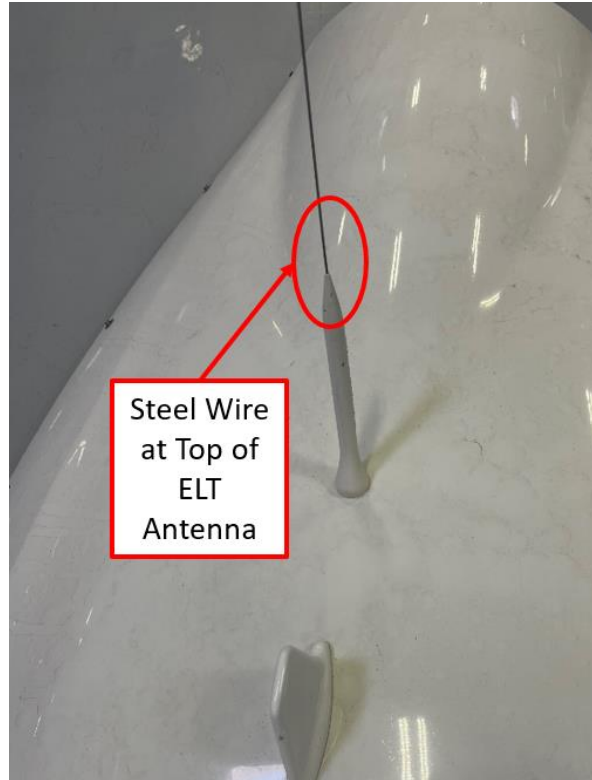
Figure 2 Steel Wire at Top of ELT Antenna

- a. See Figures 5, 6, and 7.
21. Using isopropyl alcohol, thoroughly and carefully clean the top of the ACK ELT Whip Antenna:
 - a. See Figure 2.
22. Install the top engine cowl.

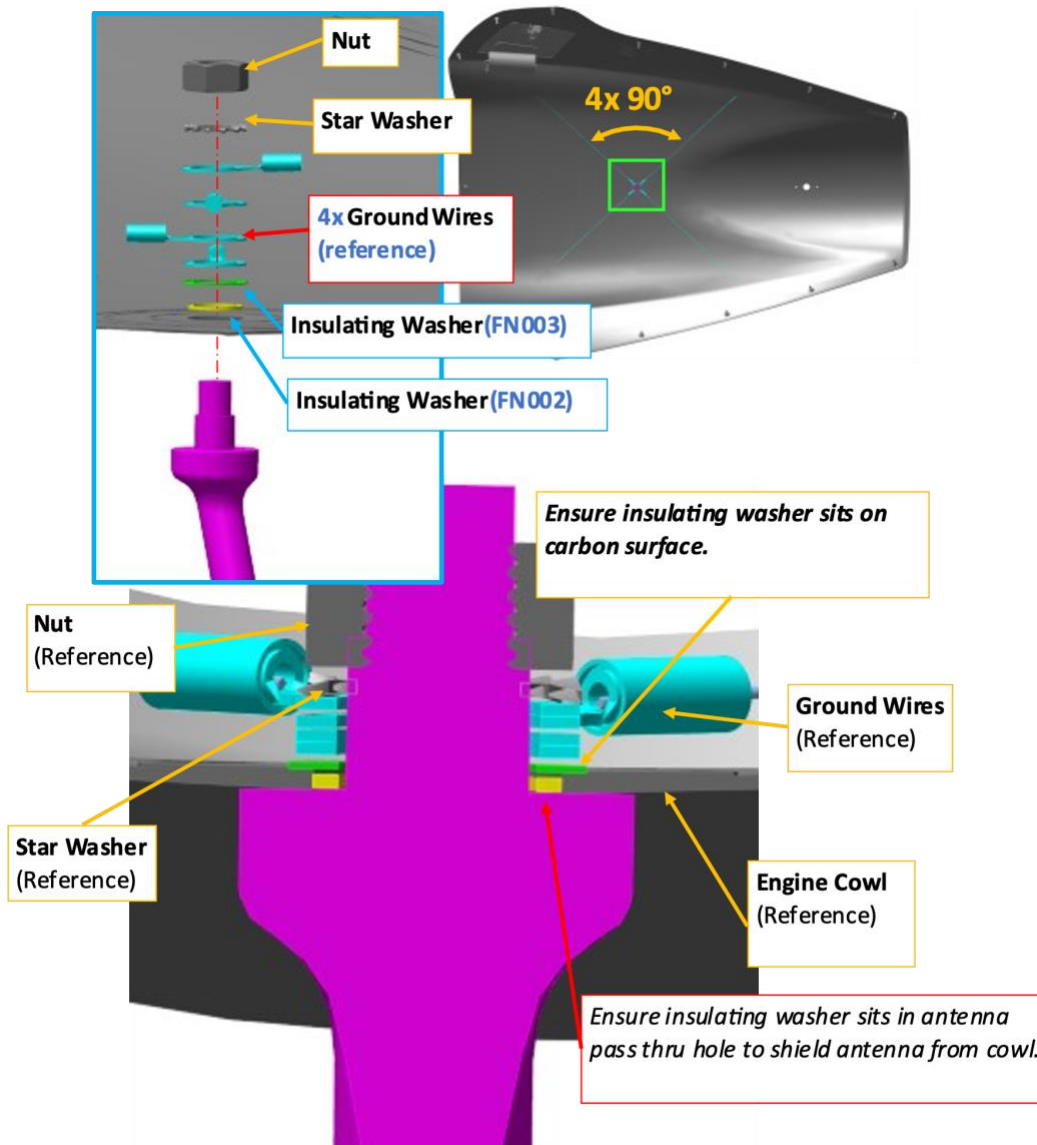
Figure 3 Installation of ACK ELT Whip Antenna

- a. Install insulating washers (ICA015003 (FN003) and ICA015004 (FN002)) and ELT ground wires (4 terminals) on lower unpainted side of cowl and secure using star washer and nut as shown in Figure 3.

- b. Ensure that each ring terminal is at a 90° angle from one another.
 - c. Ensure the 4x ground wires are 90° from one another as shown in Figure 3.

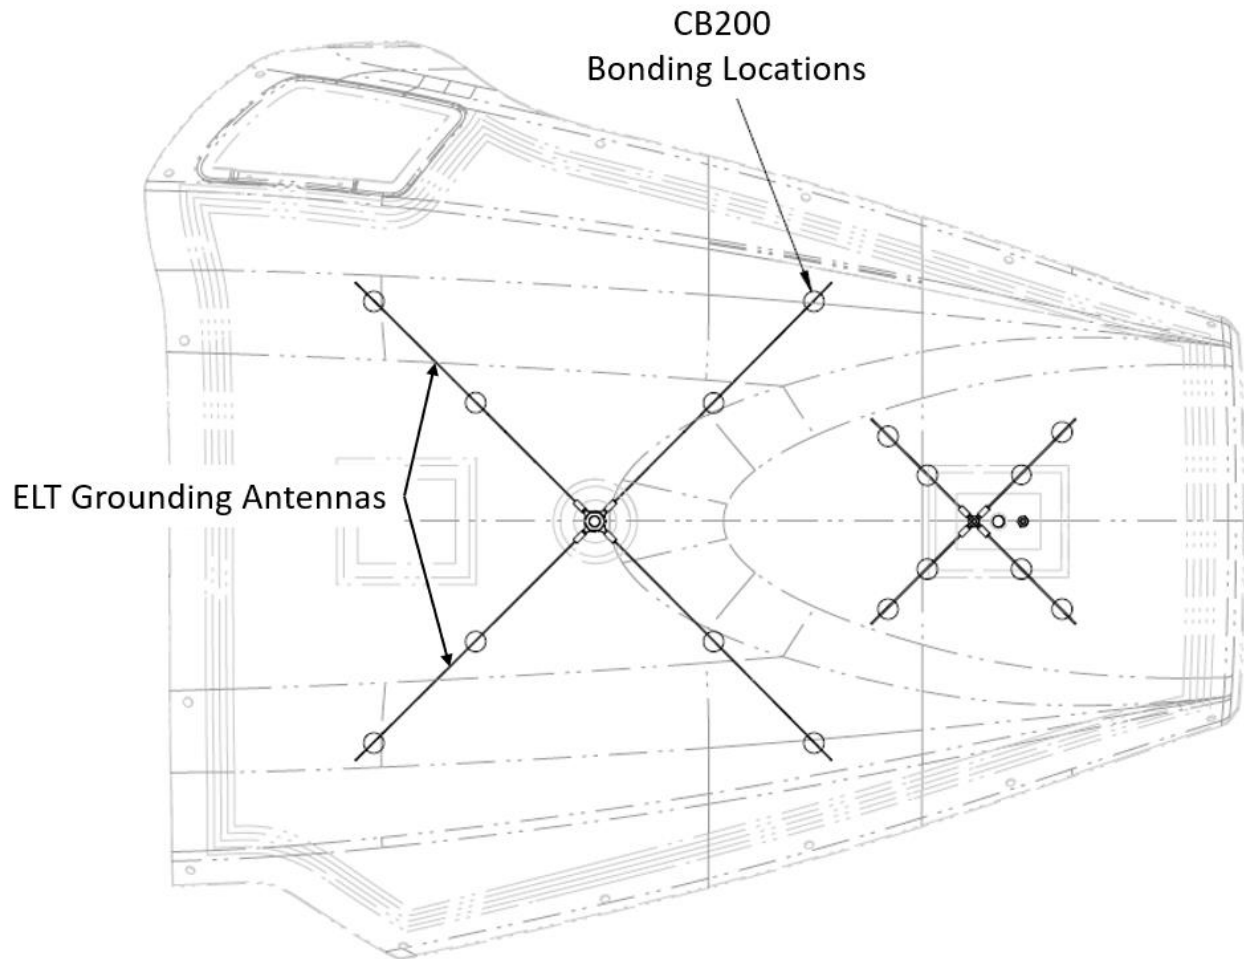
*Figure 4 Bottom of Cowling, Bonding Locations*

15. Verify all connectors have their locking features engaged.
16. See Figure 4 for placement of the adhesive and re-bond using CB200 at those locations.

17. Prepare the CB200 in accordance with the manufacturer’s instructions.
 - a. Note application time, handling time, and cure time.
18. Apply 8x 0.50” diameter dollops of CB200 at the bonding locations.

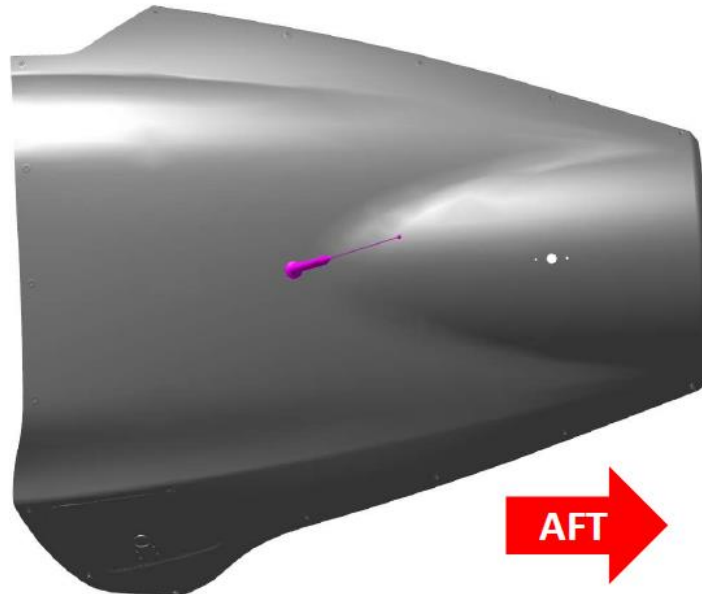
*Figure 5 ACK ELT Top View*

19. On the top, painted, side of the cowl, verify the ACK ELT Whip Antenna is installed tightly.
20. Ensure that the ACK ELT Whip Antenna is straight pointing AFT after installation.

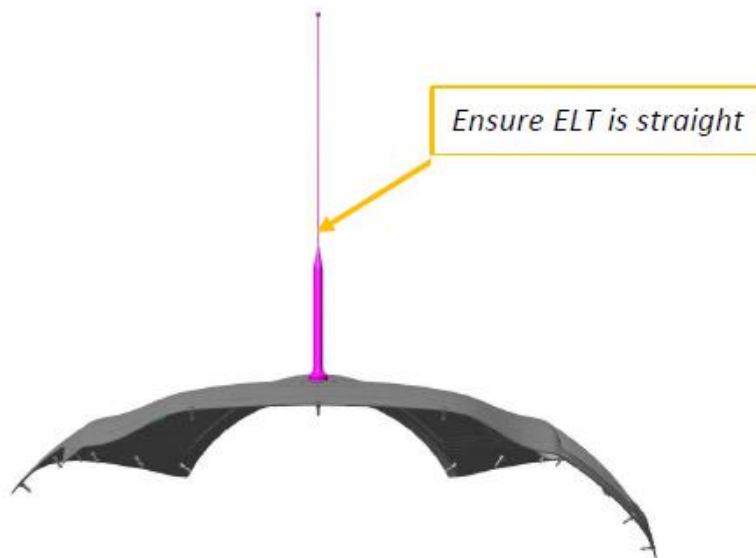
*Figure 6 ACK ELT Forward Looking Aft*

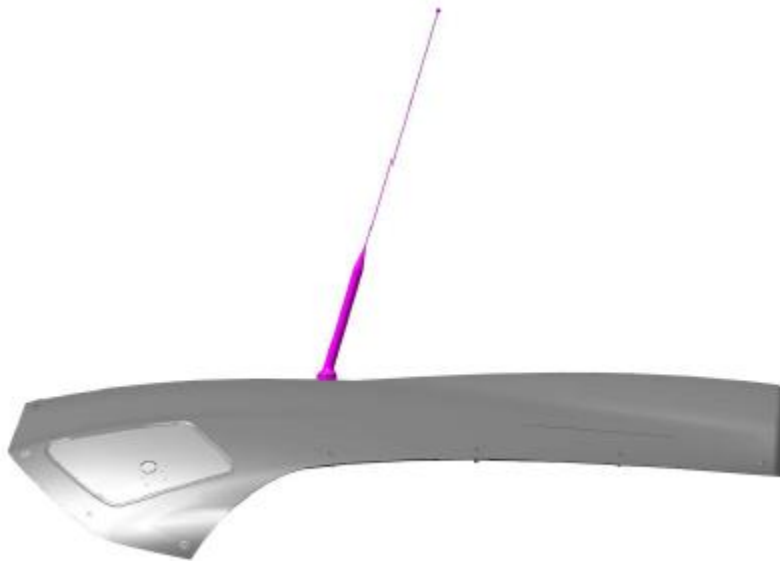
Figure 7 ACK ELT Side View
