SERVICE BULLETIN

SB-080323-A

“I hereby certify the inspection and/or repair has been completed in accordance with Service Bulletin (SB-080323-A, Nose Gear Collapse) and all referenced documents. Potentially unclear procedures have been clarified with ICON Aircraft. (ref. FAA Exemption 10829C)”.

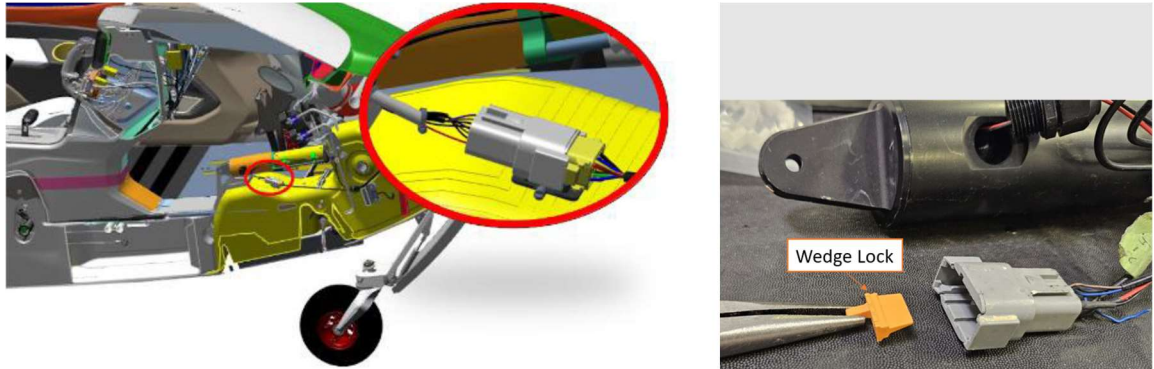
Figure 1. NLG Connector D9024J, Wedge Lock (orange)

1. If replacing actuator, disconnect bolts, worm drive hose clamp, and boot in accordance with Aircraft Maintenance Manual section 100425. Cut zip tie around NLG connector and disconnect the NLG connector D9024J. (Reference **Figure 1.**) Skip to Repair step 7.
2. Remove the instrument panel top(s) (See Aircraft Maintenance Manual, Section 100514 or 100547/100397).
3. Modify the NLG actuator harness as follows:
 - a. Cut zip tie around NLG connector and disconnect the NLG connector D9024J. (Reference **Figure 1.**)
 - b. Remove Wedge lock from actuator-side connector body. (Reference **Figure 1.**)

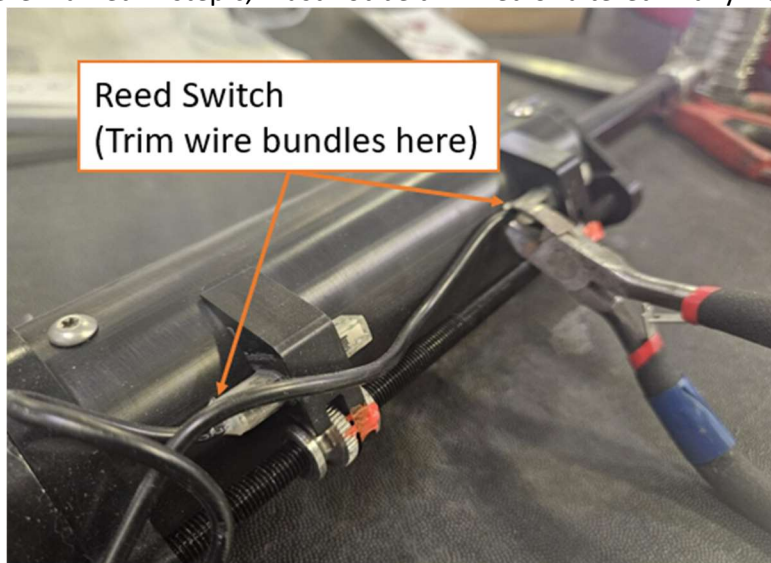
Figure 2. Trim wires at reed switches

- c. Mark wires pinned to connector positions 1 and 8 with masking tape. Remove all electrical connector pins/wires in the existing NLG connector PN D9024J, (located on the actuator side).
- d. Remove sleeving from the actuator wire bundle and pull the wires out of the bundle that leads to the magnetic reed switches located on the connector body. Note: The reed switch wires are encased in larger black insulation. Trim the reed switch wires where they exit the reed switches as shown in **Figure 2**. Discard these trimmed wires. Note: the wires that were located in connector positions 1 and 8, the red and black wires that enter the actuator body and were marked in step c, must not be trimmed or altered in any way.

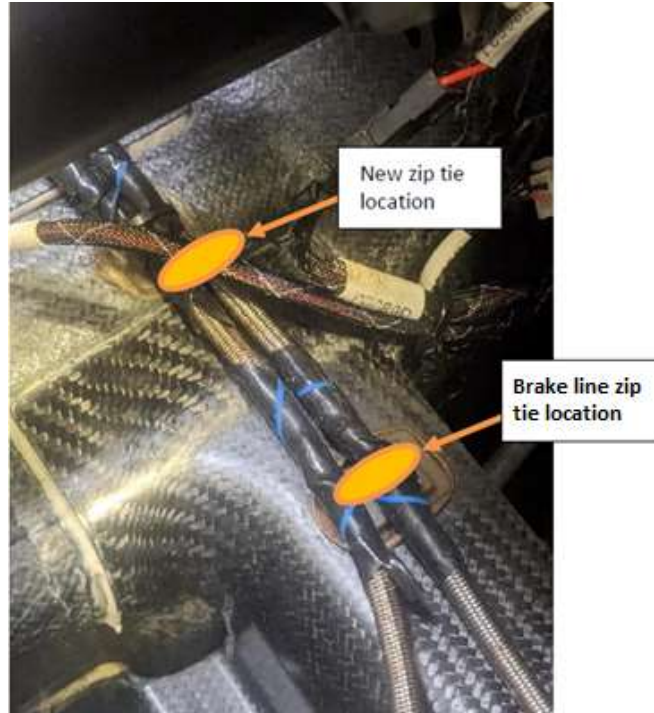
*Figure 3. Zip-tie Locations*

4. (1.0 config only) Remove zip- tie securing the wiring harness to the brake line (**Figure 3**.)
NOTE: If additional slack for harness is needed, it is permissible to also relocate the zip- tie shown in **Figure 15**.

22. (1.0 config only) Secure brake line with 1 each zip-tie (TY23MX) at brake line zip-tie location. Secure harness with 1 each zip-tie (TY23MX) at harness location (See **Figure 3**). Reinstall the removed zip-tie that secures actuator connector.
23. Reinstall MLG 15A fuse.

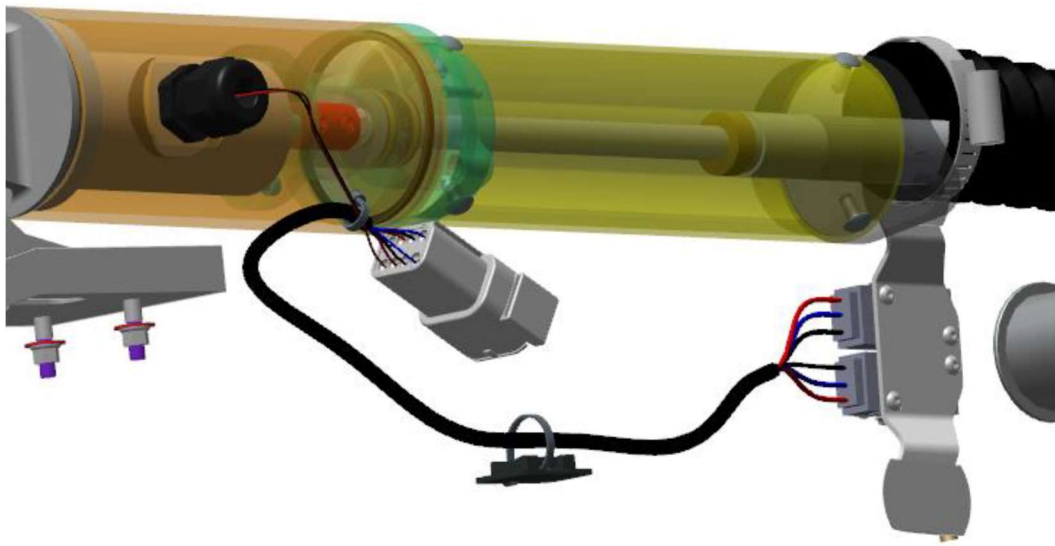
*Figure 4. Limit switch assembly with modified NLG harness*

5. Remove wedge lock from limit switch assembly (ICA015711) connector D9024J. Insert the RED and BLACK power/ground wires, previously removed, into the limit switch assembly (ICA015711) connector PN D9024J, positions 1 and 8. Secure actuator wire within 0.500 inch of limit switch assembly sleeving end D9024J with a cable tie (TY23MX). Reference **Figure 4**.
6. Re-insert wedge lock into D9024J.

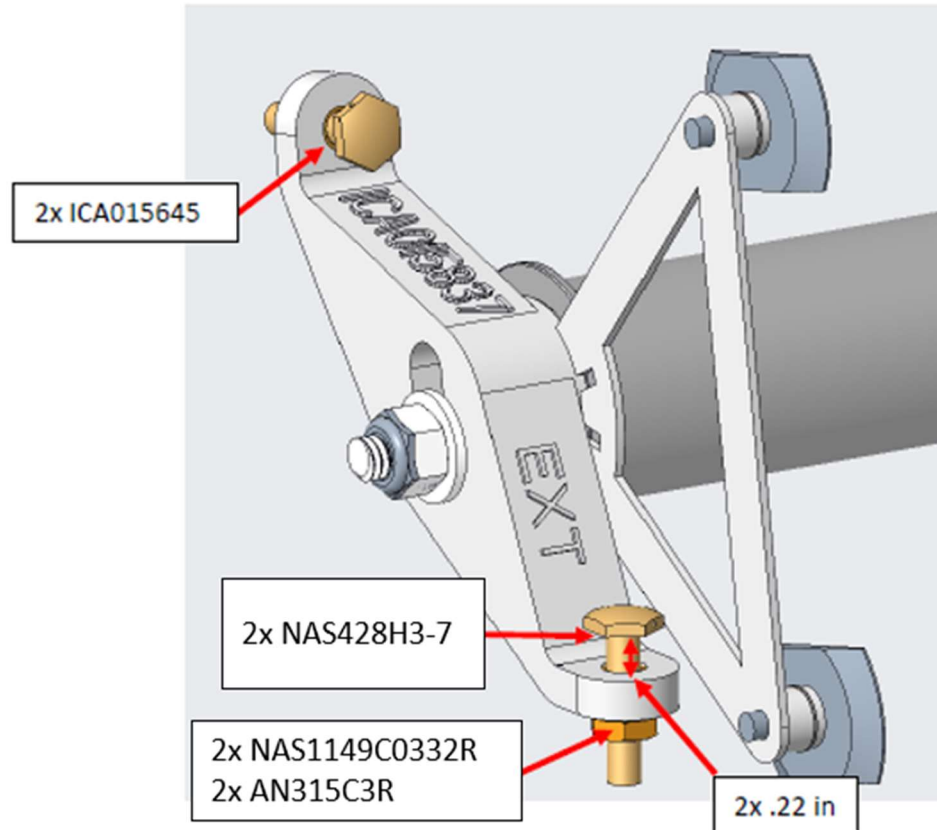
Figure 5. Limit switch bracket sub assembly

- Install 2 each bolt (NAS428H3-7), 2 each washer (NAS1149C0332R) and 2 each nut (AN315C3R) as shown in **Figure 5** onto 1 each the new retrofit NLG Limit Switch Bracket assembly. Set pre-gap (.22 in) as specified below. Pre-install jam nut (AN315C3R) finger tight but do not torque.

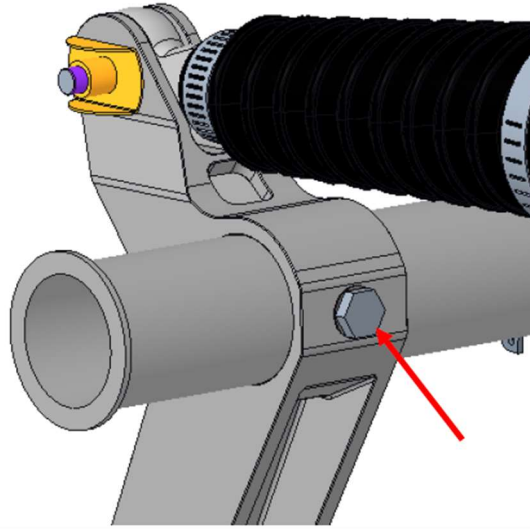
Figure 6. NLG Bell crack Shaft bolt

- Preinstall the new retrofit Limit Switch Bracket sub-assembly into the bell crank shaft. Orient the assembly so it slides over the bell crank shaft bolt shown in **Figure 6**.
- If needed, identify any areas of interference between the Limit Switch Bracket and ECS heater bracket by pre-installing 1 each of the CLICKBOND studs (CB4000G08CRA8P750) approximately as shown in **Figure 7**. Mark the area of interference with ECS heater bracket with a permanent black marker. Loosen from each CLICKBOND stud, shim the gap and cut away interference area with a hand cutting tool. Be careful not to damage the surrounding area. Clean working area to remove all FOD, including carbon dust, with a shop vac.

10. Insert ICA015837 Limit Switch Retrofit Bracket into the bell crank shaft, orient it so it slides over the bell crank shaft bolt shown in **Figure 6** above. Remove zip-tie from hold down bolt assembly, remove and retain the washer and nut. Insert hold down bolt from co-pilot side of NLG box, and secure with 1 each retained washer and 1 each locking nut (95615A120) on the pilot side of the NLG Box. Torque to 17±2 in-lbs. (Reference **Figure 9**)

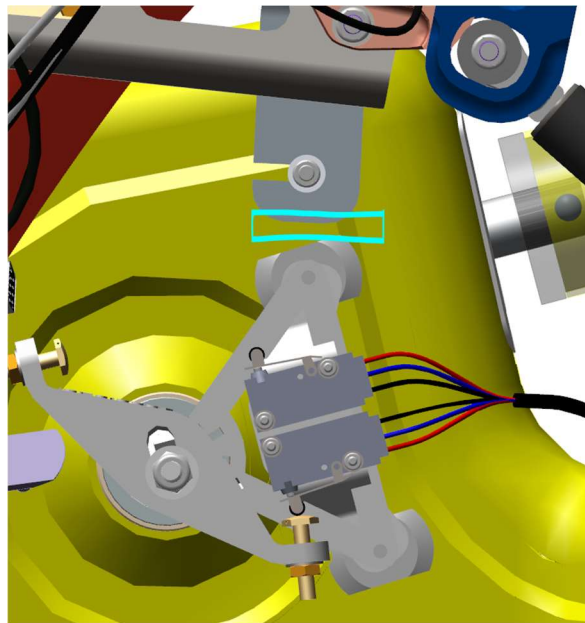
Figure 7. Gap between ECS heater bracket and trimmed CLICKBOND stud

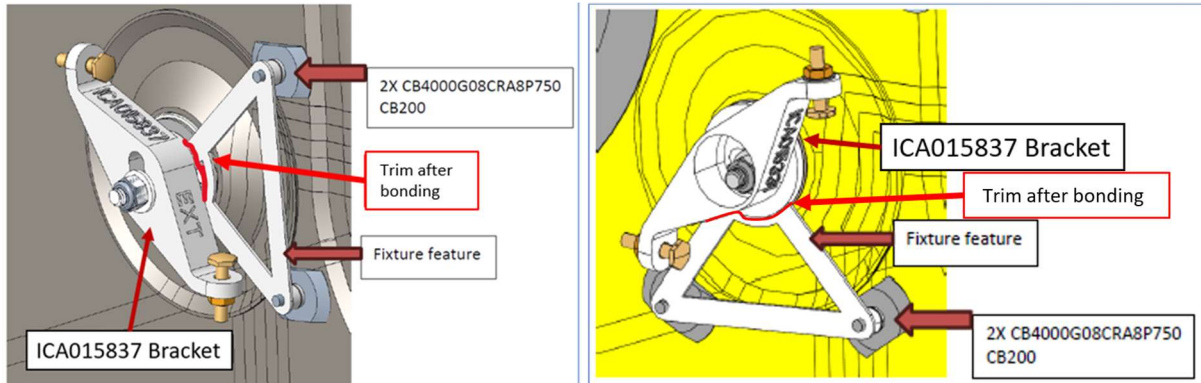
Figure 8. NLG limit switch bracket assembly installed; (1.0 configuration: orient as shown on right)

13. With rig pin still installed, or using ITL001714-B if no rig pin hole is available, bond CLICKBOND studs (CB4000G08CRA8P750) in the place oriented by the fixture (Reference **Figure 8**). Bond using CB200 in accordance with manufacturer recommendations. Backfill as needed with CB200 where stud overhangs core.
14. After allowing to adequately cure, use a razor knife to carefully trim away the fixture close to the base as shown in red line in **Figure 8**.
15. (1.0 config only) Install edging (MS21266-1N Grommet Edging)) with CB200 at location shown in **Figure 10** and route harness as shown.

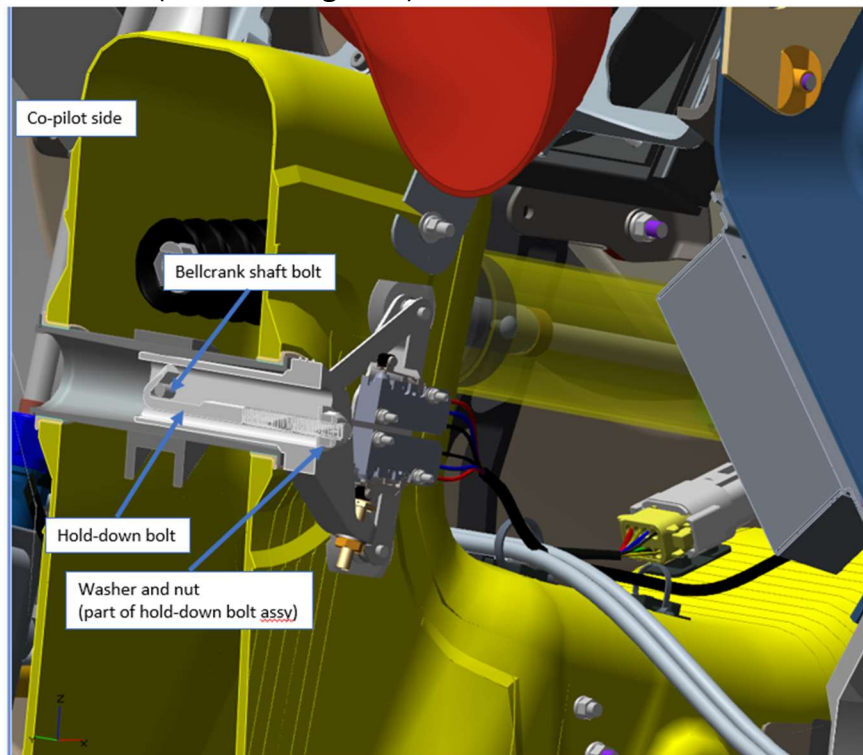
Figure 9. Cross-section view of installed bracket

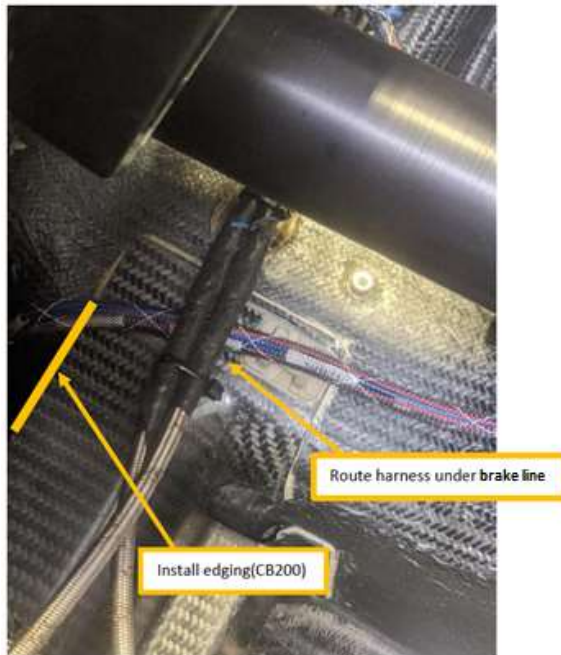
Figure 10. Harness routing and edging

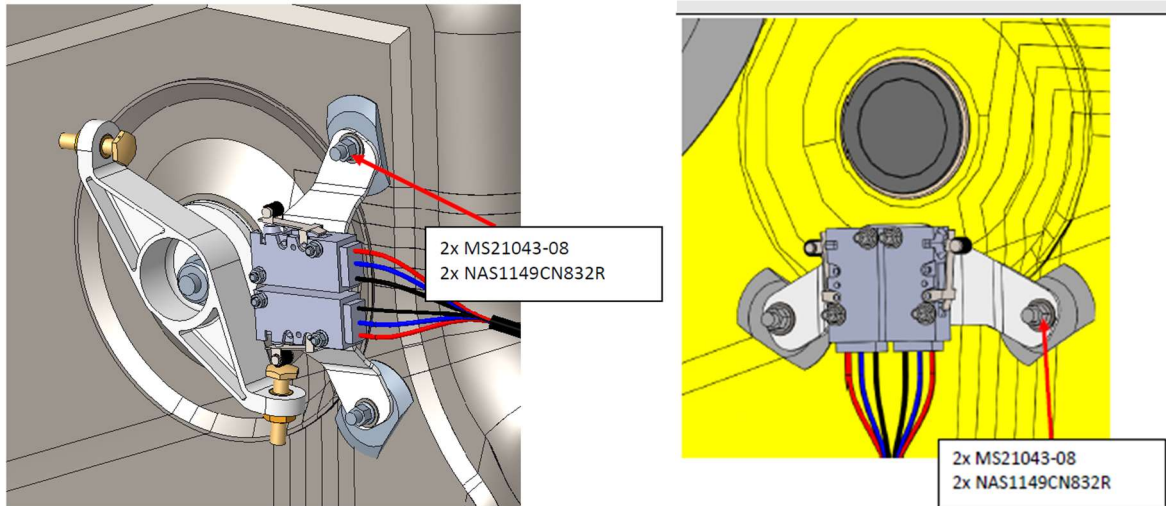
Figure 11. Installed limit switch subassembly; (1.0 config: Orient as shown on right)

16. Install limit switch assembly onto studs with 2x MS21043-08 nuts and 2x NAS1149CN832R washers as shown in **Figure 11** below. Torque locknuts to 14 in-lbs.

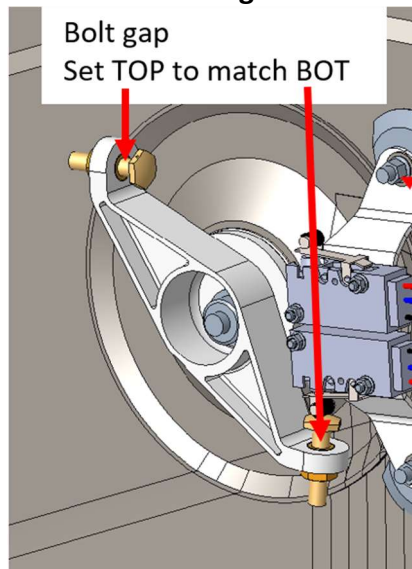
Figure 12. Adjust bolt gap

17. If the actuator was previously disconnected or replaced, loosen the clamp securing the NLG boot to the shaft of the actuator. Manually rotate the shaft of the actuator (clockwise to retract, when viewed from the front) for best rig pin or ITL001714 tool alignment. Reconnect the actuator and tighten the boot clamp (See Aircraft Maintenance Manual Section 100359-00).
18. Adjust bolt on limit switch retrofit bracket so bottom (“BOT”) extended limit switch is activated. Adjust bolt gap on limit switch retrofit bracket so that top (“TOP”) side has the same gap as the bottom. Torque jam nut to 15±2 in-lbs. Reference **Figure 12**.

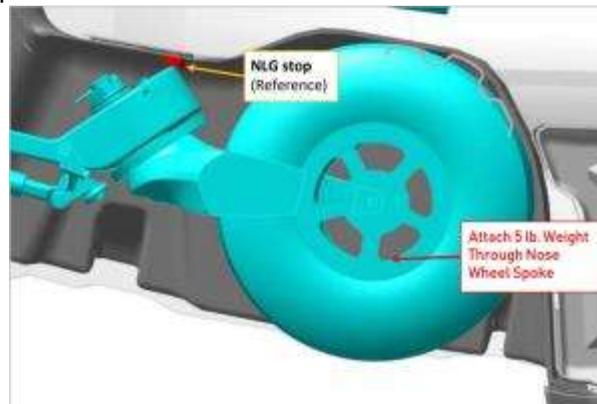
Figure 13. Rigging with gear up

- c. Confirm that 15A MLG fuse is removed. Verify MASTER switch is OFF and the landing gear is currently DOWN. Move LANDING GEAR switch to UP position then turn MASTER switch ON to allow the landing gear to retract fully. Turn MASTER switch OFF.
- d. When in the UP position a single sheet of paper should slide with minimal drag between the NLG strut and stop.

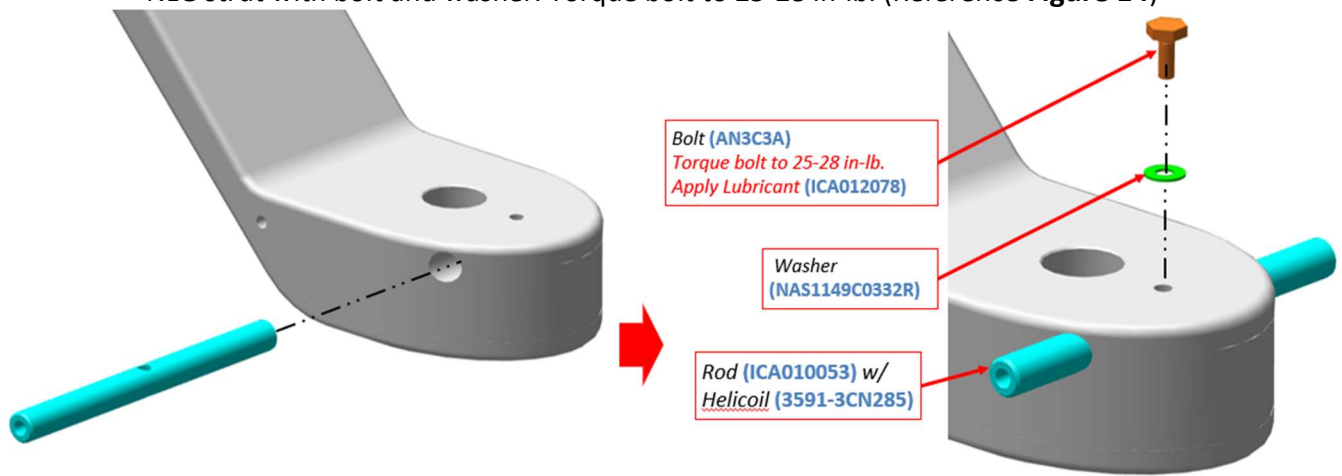
Figure 14. NLG Strut Hardware

19. Rig NLG system with gear UP.
 - a. Remove the bolt, washer, and rod which engage the doors from the NLG strut. (**Figure 14**)
 - b. Attach 5lb weight (ITL012297) to NLG wheel.

- e. Adjust rigging by loosening jam nut and adjusting crowned bolt for TOP bolt (NAS428H3-7) (**Figure**). Re-torque jam nut to 15±2 in-lbs.
- f. Verify MASTER switch is OFF and the landing gear is UP. Move LANDING GEAR switch to DOWN position then turn MASTER switch ON to allow the landing gear to extend fully. Turn MASTER switch OFF.
- g. Remove 5lb weight (ITL012297) from NLG wheel.
- h. Install rod into NLG strut: Using isopropyl alcohol, clean surfaces where lubricant will be applied. Apply lubricant (ICA012078) liberally to threads and shank of bolt. Install rod into NLG strut with bolt and washer. Torque bolt to 25-28 in-lb. (Reference **Figure 14**)

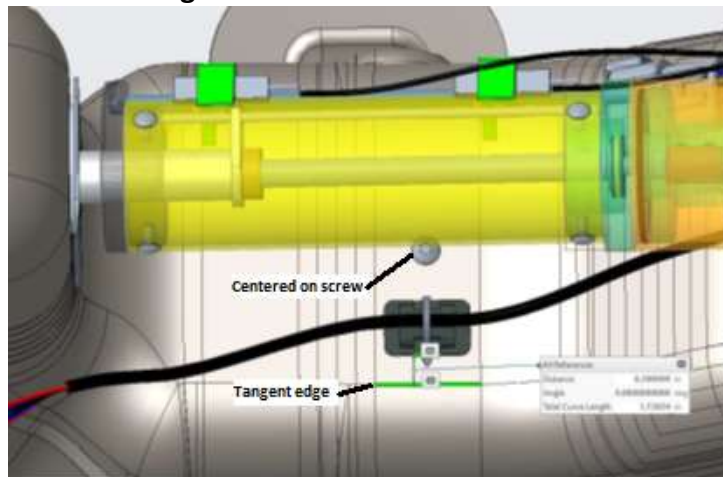
Figure 15. NLG retrofit Tie mount block

- a. Nose gear doors close fully against the fuselage skins with no gaps or looseness.
 - b. There are uniform gaps between the edges of the doors and the fuselage joggle.
 - c. The door flanges rest against each other.
 - d. Instrument panel position lights indicate correctly.
 - e. Normal gear function with no blown fuses.
 - f. .1625 rig pin (ITL002663) (or ITL001714 for 1.0 config) fits.
 - g. If adjustment of the extended position is necessary, adjust rigging by loosening jam nut and adjusting crowned bolts (NAS428H3-7). Re-torque jam nut to 15±2 in-lbs.
21. Install tie mount on the NLG box. Center the mount with screw and about 0.400 inch upwards from tangent edge as shown in **Figure 15** below.
