SERVICE BULLETIN SB-022723-A

ID NUMBER & REVISION: SB-022723-A SUBJECT: (Mandatory) Stator Wire Harness Chafing **RELEASE DATE:** 10 November 2023 **EFFECTIVE DATE:** 10 November 2023 SUPERSEDES NOTICE: N/A AIRCRAFT AFFECTED: MAKE & MODEL: A5 SERIAL NUMBERS: 00001 - 00136, 00139 - 00146, 00148 - 00150, 00152 - 00159, 00161, 00163, 00166, 00174 Inspect for stator wire harness chafing. If present, add F4 tape and/or **REQUIRED ACTION:** reposition wires. This is mandatory to maintain airworthiness. TIME OF COMPLIANCE: Next service interval **REVISION HISTORY:** Initial Release Α X A&P Pilot/Owner LEVEL OF CERTIFICATION REQUIRED (any level checked LSA Repairman – Inspection ☑ Certified Repair Station can perform task): \mathbf{X} LSA Repairman – Maintenance ⊠ Manufacturer

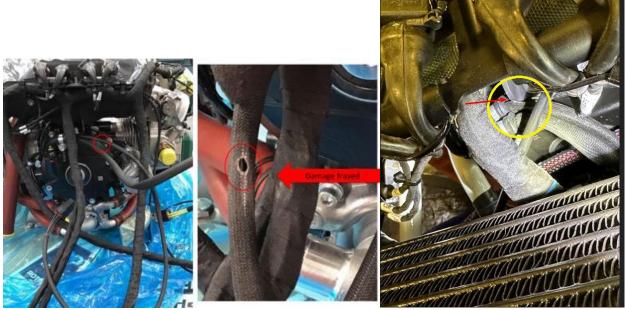
It has been identified that there exists a potential for insufficient clearance between the ROTAX 912iS Stator/Regulator wires at the forward side of the stator housing and the Intake Plenum. The lack of proper clearance can cause the cable to chafe and potentially become damaged.

- 3. Inspect the stator/regulator wires for contact with intake plenum and/or evidence of chafing (Figure 1).
- 4. If harness contacts the intake plenum, proceed to Repair Instructions. If no contact exists and there is no evidence of chafing, reinstall engine cowling in accordance with <u>Aircraft Maintenance</u> <u>Manual</u>, section 100335, and proceed to Logbook Entry.

Figure 1. Location of Damaged Sleeving

- 1. If necessary, loosen the Adel clamp (see Figure 2) using an Allen wrench.
- 2. Verify that the wires are free of any kind of damage. If wires are damaged, contact ICON for further instructions.
- 3. Install F4 Tape around the chafed/damaged sleeving.
- 4. Ensure clamp(s) are clocked so as to prevent contact with harness. Apply Loctite 243 over the screw threads. Tighten the clamp to 88 in-lb. (Figure 2)
- 5. Verify that harness is not contacting intake plenum.

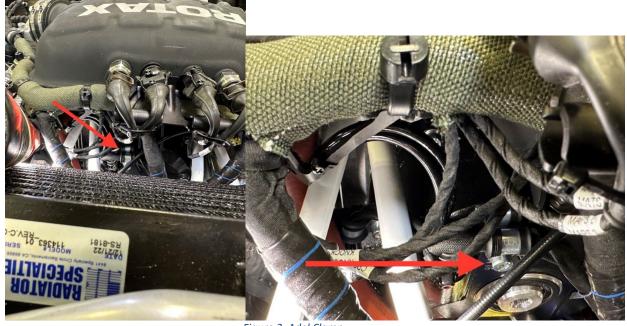
Figure 2. Adel Clamp
