SERVICE BULLETIN

SB-112723-A

ID NUMBER & REVISION: SB-112723-A
SUBJECT: Fuel Tank Leak at Low Level Sensor
RELEASE DATE: 20 March 2024
EFFECTIVE DATE: 20 March 2024
SUPERSEDES NOTICE: N/A
AIRCRAFT AFFECTED: **MAKE & MODEL:** ICON A5
SERIAL NUMBERS: 00159-00196, 00198, 00199, 00202, 00203
REQUIRED ACTION: Inspect tank and replace if nonconforming
TIME OF COMPLIANCE: Next condition (annual or 100-hr) inspection
 (If persistent fuel smell is detected, service aircraft immediately)
REVISION HISTORY: A Initial Release

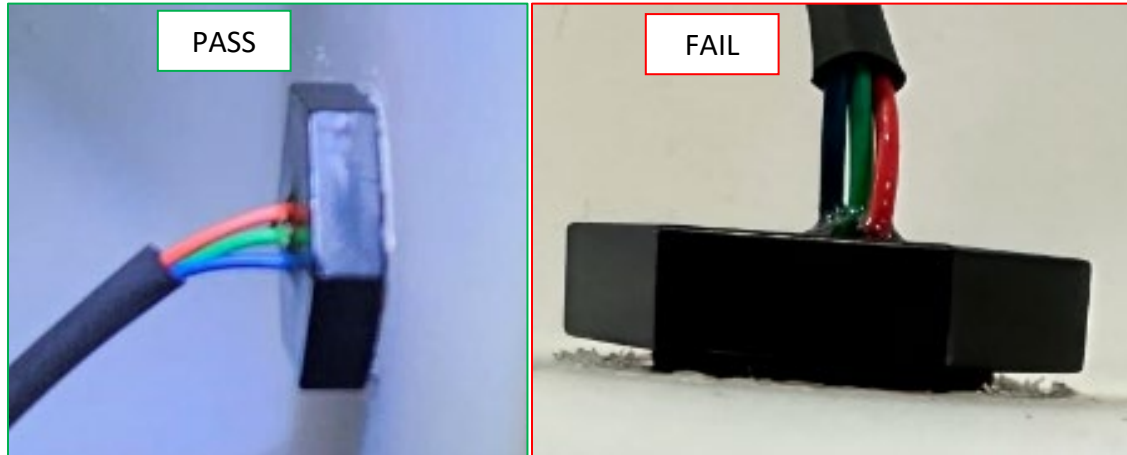
- Remove baggage floor and pilot seat back in accordance with the Aircraft Maintenance Manual, sections 100050 and 100564.
- Use a mirror to inspect the seating of the low level sensor against the fuel tank. *(Figure 1)*
 - If a gap is present and/or the O-ring is visible – FAIL.

Figure 1. Seating of Low Level Sensor, PASS (left) and FAIL (right)

1. Remove and disassemble failed fuel tank in accordance with the Aircraft Maintenance Manual, section 100508.
2. Assemble and install new fuel tank in accordance with the Aircraft Maintenance Manual, section 100344.
3. Reinstall pilot seat back and baggage floor in accordance with the Aircraft Maintenance Manual, sections 100536 and 100049, and proceed to LOGBOOK ENTRY.

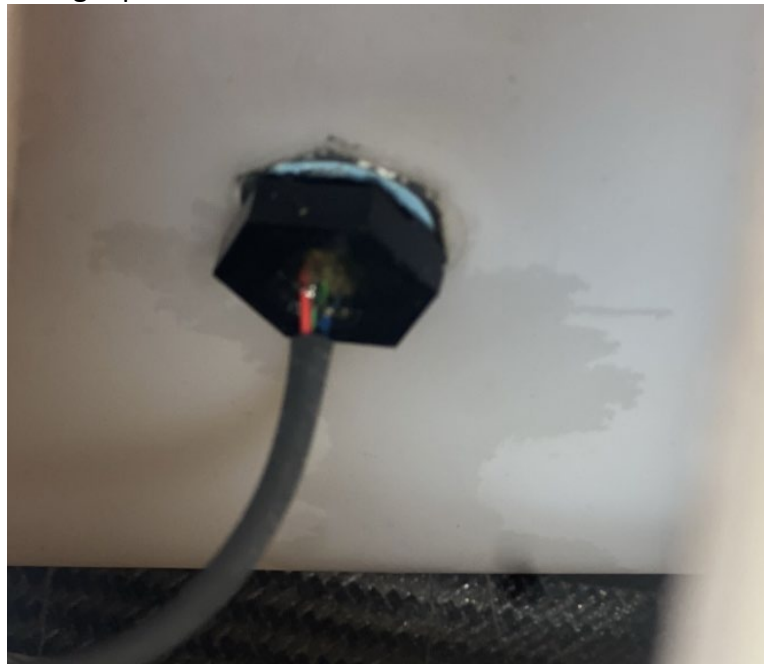
3. Ensure that at least 2 gallons of fuel are in the tank. Inspect for weeping/staining around the low-level sensor insert. (Figure 2)
 - a. If weeping/staining is present – FAIL.

Figure 2. Weeping/Staining around Sensor

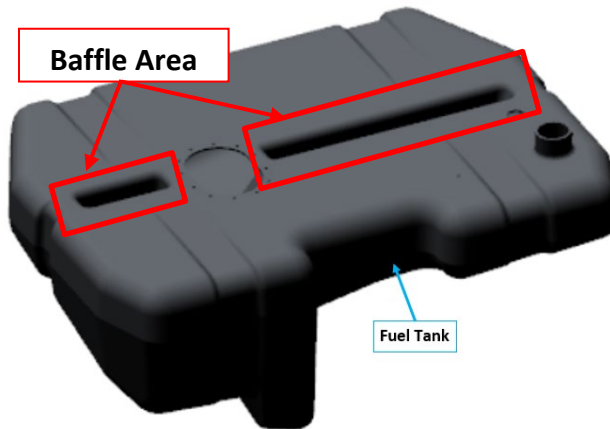
4. Fill the fuel tank (at least 18 gallons) and inspect for leakage around the baffle area. (Figure 3)
 - a. If evidence of leakage is present – FAIL.

Figure 3. Baffle Area
