# SERVICE BULLETIN

## SB-012724-A

**ID NUMBER & REVISION:** SB-012724-A  
**SUBJECT:** NLG Limit Switch Retrofit  
**RELEASE DATE:** 16 May 2024  
**EFFECTIVE DATE:** 16 May 2024  
**SUPERSEDES NOTICE:** SB-080323-B  
**AIRCRAFT AFFECTED:** **MAKE & MODEL:** ICON A5  
**SERIAL NUMBERS:** If SB-080323 was NOT completed: 00001-00015, 00018-00027, 00029-00033, 00035, 00036, 00038-00049, 00051-00072, 00074, 00076-00083, 00085, 00086, 00088-00182, 00184-00188

**REQUIRED ACTION:** Retrofit reed switch style NLG actuators with mechanical limit switches with long arms.

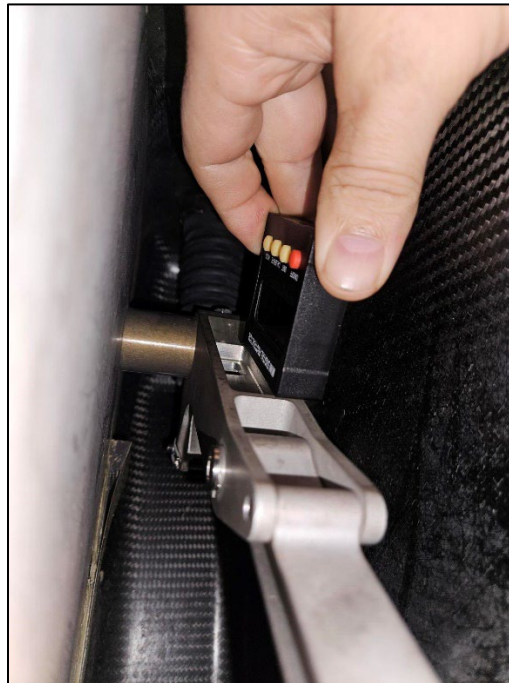
*Figure 4. Bellcrank Measurement*

- c. If the measured difference is greater than  $1.5^\circ$ , the actuator, and all mounting hardware (bushings, bolts, etc), must be replaced.

- a. With the weight off the nose landing gear, gently rotate the NLG bellcrank forward with moderate hand pressure. Measure the angle with a digital protractor (**Figure 4**). Record measurement.

- b. With the weight off the nose landing gear, gently rotate the NLG bellcrank backward with moderate hand pressure. Measure the angle with a digital protractor, taking care to take the measurement in the same location as before. Record measurement.
