SERVICE BULLETIN

SB-121924-A

ID NUMBER & REVISION: SB-121924-A
SUBJECT: (MANDATORY) Redressal of ROTAX SB-912i-015iS Mandatory Inspection and Replacement of Expansion Tank Assy
RELEASE DATE: 22 January 2025
EFFECTIVE DATE: 22 January 2025
SUPERSEDES NOTICE: N/A
AIRCRAFT AFFECTED: **MAKE & MODEL:** ICON A5
SERIAL NUMBERS: 00001-00224
REQUIRED ACTION: Inspect and/or replace the ROTAX Expansion Tank Assy in accordance with ROTAX SB-912i-015iS. **This is mandatory.**
TIME OF COMPLIANCE: Refer to ROTAX SB-912i-015, Section 1.5:

Inspection and/or replacement of expansion tank assy. for ROTAX® 912, 914, 912 i, 915 i and 916 i (Series) Aircraft Engines

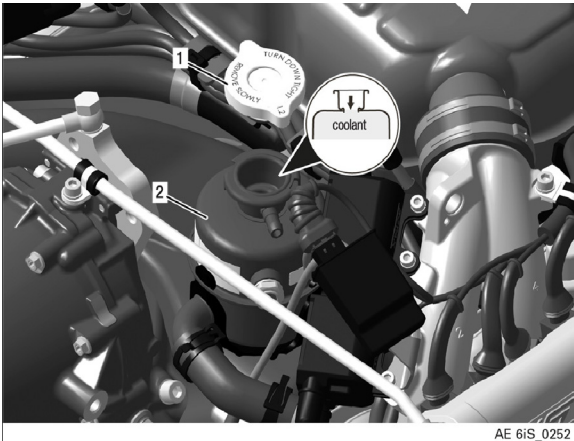
Fig. 3

Step	Procedure
1	If necessary, clamp closed the hose to the coolant overflow bottle.
2	Remove the radiator cap from the expansion tank.
3	Drain coolant until bottom of the expansion tank assy. is clearly visible.
4	Perform an internal visual inspection of the expansion tank assy. using a bore-scope or similar optical device.
5	If the visual inspection shows consistent welding, the expansion tank assy. is serviceable (See Fig. 5), continue with step 7.
6	If any connection has inconsistent or missing welds, the expansion tank assy. is unserviceable and must be replaced (See Fig. 6), continue with section 3.5.2).
7	Refill coolant into the expansion tank. See Maintenance Manual Line Chapter 12-10-00 section Coolant check/replenish. See also SI-912 i-001,SI-912-016,SI-914-019, SI-915 i-001,SI-916 i-001, current issue. NOTE: If the engine is equipped with a thermostat valve, follow the manufacturer's instructions.

8	Apply small amount of coolant to rubber surfaces inside radiator cap (provides lubrication to prevent binding). Tighten the radiator cap by hand.
9	Perform an engine test run and check for leaks. Replenish with clean coolant as required. See Maintenance Manual Line Chapter 12-10-00 section Coolant check/replenish.
10	Make an entry in the engine logbook stating the execution of this Service Bulletin and the inspection findings. Continue with section 3.6)

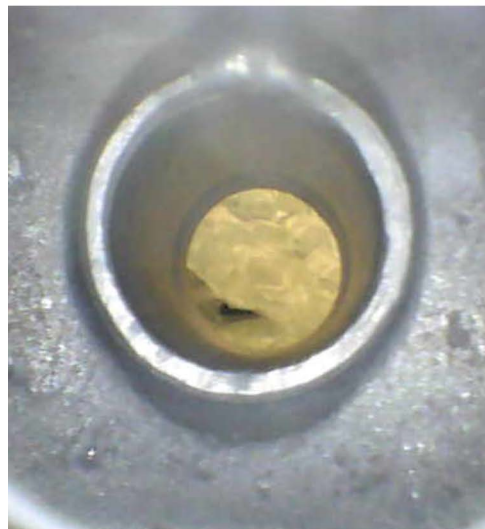
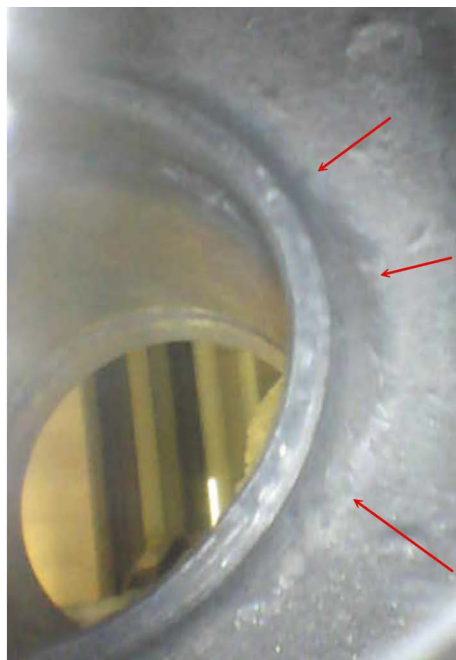
Fig. 5: GOOD Welding – total view / GOOD Welding – side view

Step	Procedure
1	Remove the radiator cap from the expansion tank.
2	Perform an internal visual inspection using a bore-scope or similar device.
3	If the visual inspection shows consistent welding, the expansion tank assy. is serviceable (See Fig. 5), continue with section 3.6 . NOTE: Welding must be present and contiguous around every connection.
4	If the visual inspection shows any connection with inconsistent or missing welds, the expansion tank assy. is unserviceable and must be replaced (See Fig. 6).
5	Apply small amount of coolant to rubber surfaces inside radiator cap (provides lubrication to prevent binding). Tighten the radiator cap by hand.

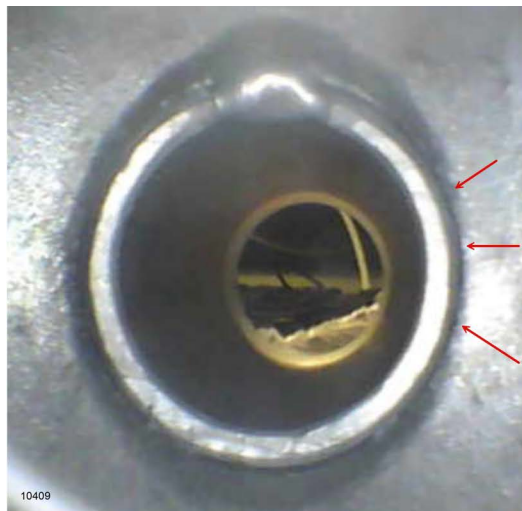
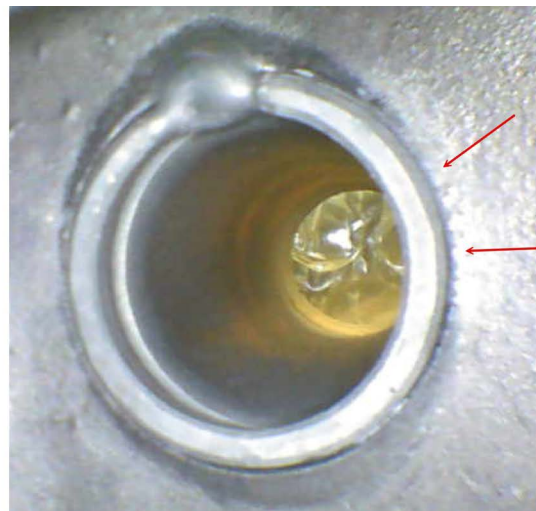
Fig. 6: BAD Welding – total view / BAD Welding – side view

Due to a deviation in the manufacturing process, the individual components of the expansion tank assy. may not be sufficiently welded. Sealing of the assy. may be compromised and coolant leakage and subsequently an overheating of the engine may occur.
