SERVICE BULLETIN

SB-030525-A

ID NUMBER & REVISION: SB-030525-A
SUBJECT: Repair ELT GPS Connector Wiring
RELEASE DATE: 07 March 2025
EFFECTIVE DATE: 07 March 2025
SUPERSEDES NOTICE: SD-111324-A (upon completion of this Notice)

AIRCRAFT AFFECTED: **MAKE & MODEL:** ICON A5
SERIAL NUMBERS: 00201, 00209-00218, 00220-00224

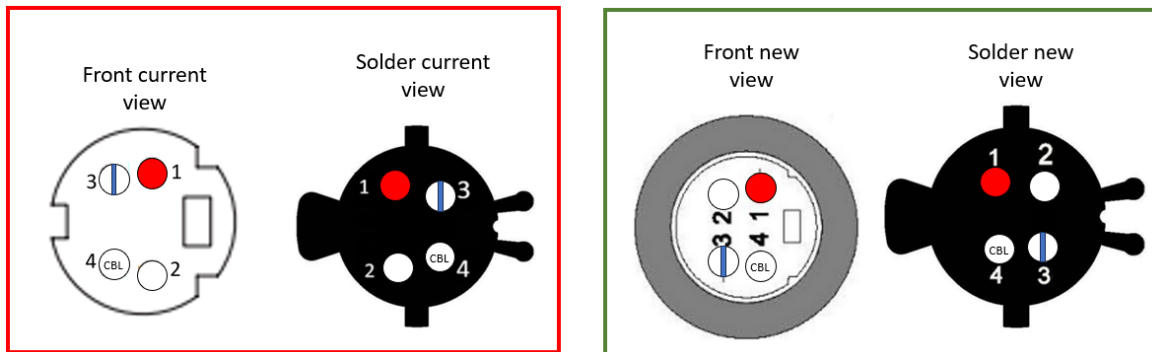
ICON has identified that the ELT GPS Connector, D9157P, may have been pinned incorrectly. This can drain the ELT battery, which may prevent the ELT from functioning. This may be recognized by a failed self-test, a red light flashing on the remote panel, and/or audible squelching from the overhead speaker.

Figure 1. Incorrect Wiring (left), Correct Wiring (right)

REQUIRED ACTION: Re-pin the GPS Connector (D9157P) and re-install. This repair addresses the issue identified in *SD-111324-A ELT GPS Connector Wiring (Interim)*.
