SERVICE BULLETIN

SB-021425-A

ID NUMBER & REVISION: SB-021425-A
SUBJECT: (Mandatory) ELT Antenna Cracking
RELEASE DATE: 04 April 2025
EFFECTIVE DATE: 04 April 2025
SUPERSEDES NOTICE: N/A
AIRCRAFT AFFECTED: **MAKE & MODEL:** ICON A5
SERIAL NUMBERS: 00001, 00003-00224
REQUIRED ACTION: Inspect for signs of damage to the base and/or whip of the ELT antenna. **The inspection portion of this Service Bulletin is mandatory.** If damage is identified, replace the antenna with the RAMI AV-300 Rod Antenna.
TIME OF COMPLIANCE: **Initial Inspection:** Within 40 flight hours, or at next condition (100-hr/annual) inspection, whichever comes first.
Recurring Inspection: At each condition inspection, until repair is completed.
REVISION HISTORY: **A** Initial Release

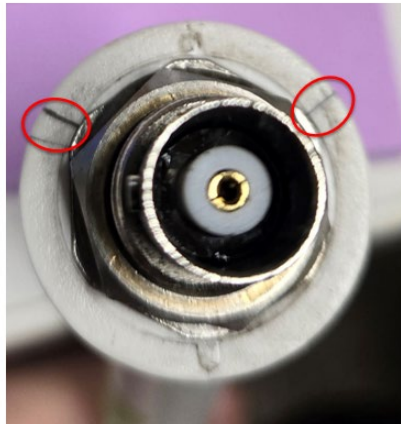
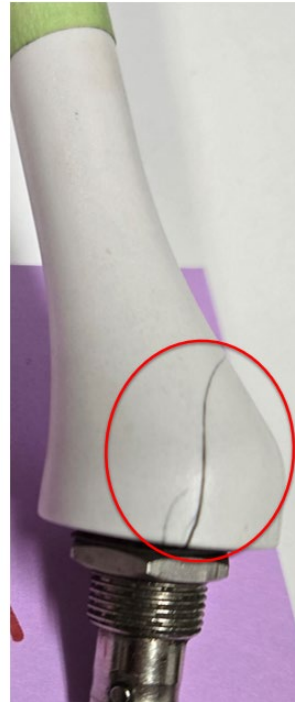
1. Remove the Top Engine Cowl in accordance with the Aircraft Maintenance Manual, task 100497.
2. Remove the ELT Antenna in accordance with the Aircraft Maintenance Manual, task 100141.
 - a. Discard the star washer.
3. Inspect the Cowl around the ELT Antenna connector hole. If any cracks or damage are found on the Cowl, stop and contact ICON.
4. Inspect the entire ELT Antenna, including the plastic base and the wire whip, for any cracks or signs of damage, including corrosion. Cracks at the base of the Antenna may or may not be visible from the side.
 - a. If any damage is found, proceed to Repair Instructions.

Figure 1. Examples of Cracks in Antenna Base

ICON has identified a suitable replacement antenna, the RAMI AV-300 Rod Antenna. It is recommended to install this antenna at the next suitable service opportunity, but no later than the identification of any sign of damage. Until the antenna is replaced, regular inspections are required to support informed decision-making.
