# SERVICE BULLETIN

## SB-021425-B

**SUBJECT:** (Mandatory) ELT Antenna Cracking

**AIRCRAFT AFFECTED:** **MAKE & MODEL:** ICON A5  
**SERIAL NUMBERS:** 00001, 00003-00224

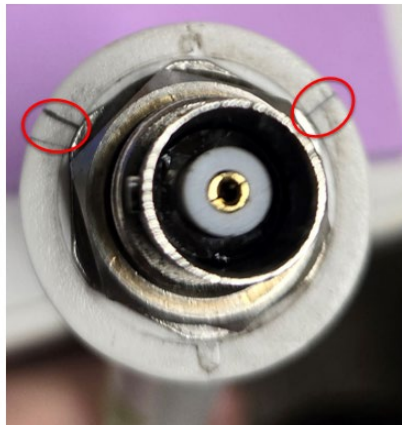
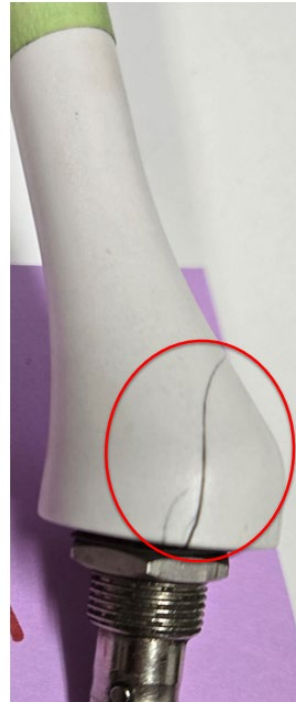
1. Remove the Top Engine Cowl in accordance with the Aircraft Maintenance Manual, task 100497.
2. Remove the ELT Antenna in accordance with the Aircraft Maintenance Manual, task 100141.
  - a. Discard the star washer.
3. Inspect the Cowl around the ELT Antenna connector hole. If any cracks or damage are found on the Cowl, stop and contact ICON.
4. Inspect the entire ELT Antenna, including the plastic base and the wire whip, for any cracks or signs of damage, including corrosion. Cracks at the base of the Antenna may or may not be visible from the side.
  - a. If any damage is found, proceed to Repair Instructions.

*Figure 1. Examples of Cracks in Antenna Base*

5. If no damage is found, reinstall Antenna (with a new star washer MS35333-78) in accordance with the Aircraft Maintenance Manual, task 100141.
  - a. To prevent damage, use only water or a mild soap solution to clean the plastic portion of the Antenna. Refer to [ACK Maintenance Advisory MA E-04.2](#) for more information.
