SERVICE BULLETIN

SB-010917 REV A

SUBJECT: Fuel Tank Leak in Cockpit

AIRCRAFT AFFECTED: MODEL: ICON A5

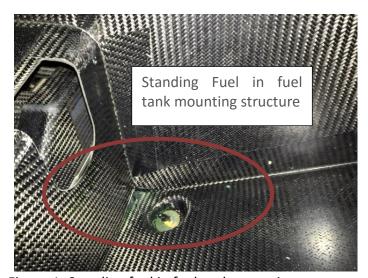
- 8. ___Inspect the fuel tank mounting structure for standing fuel and or fuel residue. Clean fuel tank mounting structure thoroughly with isopropyl alcohol. If standing fuel is present (as shown in figure 1) inspect the bottom of the hull under the fuel tank mounting structure back to the bilge pump area for fuel and thoroughly clean the hull of fuel and fuel residue.

Figure 1: Standing fuel in fuel tank mounting structure.

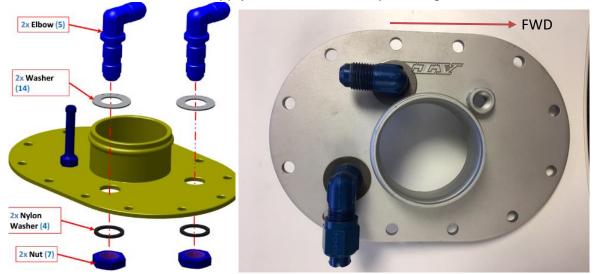
Figure 2: Assembly diagram of the bulkhead fittings and hardware in the filler neck access port.

- 9. ___Inspect the fuel tank mounting structure velcro adhesion to the structure. Replace the velcro after a thorough cleaning and prepping of the surface with isopropyl alcohol.
- 10. ___Remove the 12x 1/4 bolts from the fuel tank filler neck access port, disconnecting the fuel pickup line from the AN833-6D bulkhead elbow fitting, completely remove the fuel tank filler neck access port plate.
- 11. ___Inspect the AN833-6D bulkhead fitting nylon washers, replace if damaged.
- 12. ___Re-install pickup side AN833-6D bulkhead fitting NAS1149C0932R steel washer, 95606A520 nylon washer and AN924-6D nut. Apply Loctite 243 and torque fitting and nut to 120-150 in-lb.
