SERVICE BULLETIN

SB-011118 REV A

DATE ISSUED: 1/11/2018
DATE EFFECTIVE: 1/11/2018
SUPERSEDES NOTICE: SD-062117
SUBJECT: Throttle Cable Assembly Retrofit
AIRCRAFT AFFECTED: **MODEL:** A5
S/N: 00001, 00003 to 00020
REQUIRED ACTION: Retrofit the throttle cable system
TIME OF COMPLIANCE: 1) Within 90 days of issuance or;
2) Prior to next flight - If the throttle cable has been disconnected from the engine throttle body for any reason

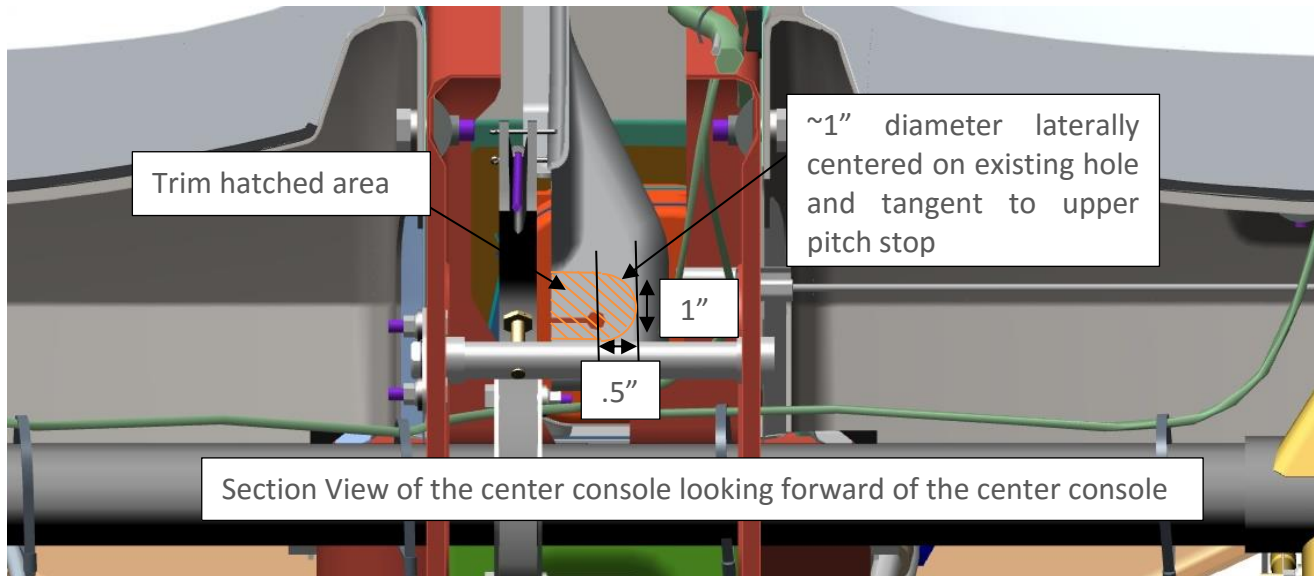
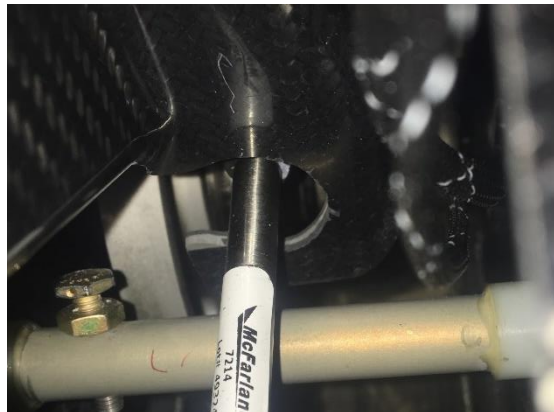
Figure 1: Details of center console modifications

View looking forward showing a completed trimming of the center console

1. Using a pencil grinder or other suitable tool trim the hatched area of the throttle bracket shown in the graphic and photo below in Figure 1. Clean up the edges of the trimmed area with 100 grit sandpaper.

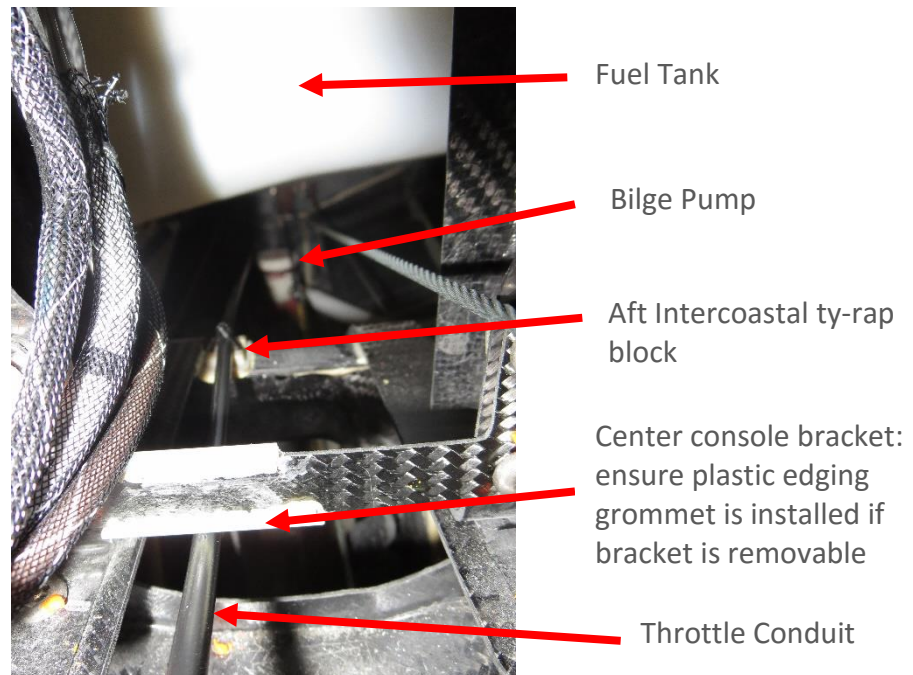
Figure 6: View Looking aft inside the center console

Note: Early serial numbered aircraft don't have a removeable center console bracket as shown below. If the aircraft has a removeable bracket, ensure there is a plastic edging grommet installed between the conduit and bracket to avoid a chafing condition.

- Starting in the center console, route the conduit aft under the center console bracket through the to the aft intercostal ty-rap block and secure the conduit with a TY24MX ty-rap as shown in the Figure 6.

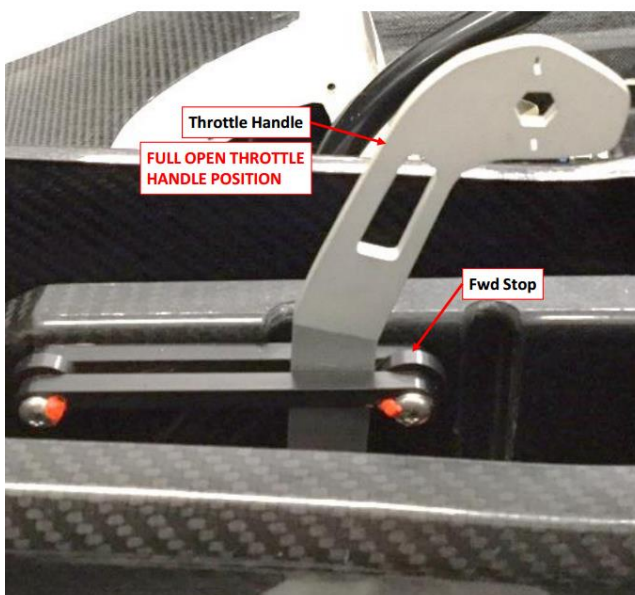
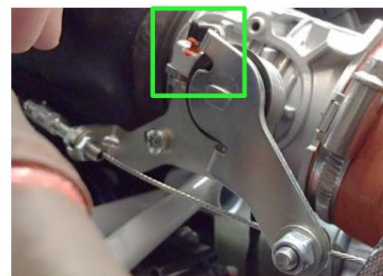
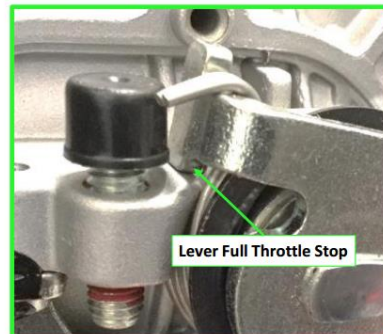
CAUTION: DO NOT DAMAGE THE BUSHING BY OVER TORQUEING CABLE FIXATION SCEW

- i. (This step requires 2 technicians – one at handle, one at engine). In cockpit, move throttle handle to full throttle position (FWD stop). At engine, ensure the lever full throttle stop contacts the throttle body before the throttle handle contacts the FWD stop. Adjust position of cable in cable fixation fastener as required.
- j. When cable adjustment is complete, torque cable fixation fastener to 35±5 in-lb. Apply torque stripe. Do not over tighten and ensure the cable fixation fastener can still rotate on the throttle lever of the throttle body once torqued.
