SERVICE BULLETIN

SB-041417 REV A

DATE ISSUED: 4/14/2017
DATE EFFECTIVE: 4/14/2017
SUPERSEDES NOTICE: None
SUBJECT: Loose flap interconnect rod end check nut
AIRCRAFT AFFECTED: **MODEL:** ICON A5
S/N: 00001,00003-00019
REQUIRED ACTION: Visually inspect the affected aircraft
TIME OF COMPLIANCE: 1) Within the next 10 hours of flight

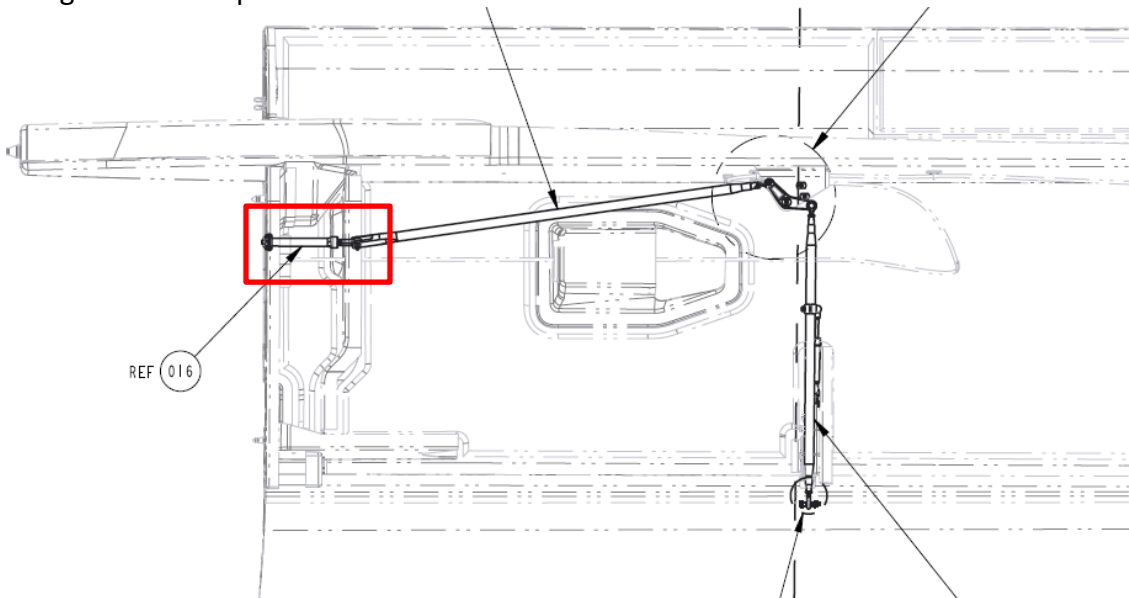
Figure 1: Flap control system (wing side only) with flap interconnect tube highlighted.

1. Fold each wing and remove the inboard wing inspection panel in accordance with the latest maintenance manual.
2. Using a lighted borescope through either the wing inspection panel or through the BL38 rib wing fold tube access to visually inspect for a torque stripe on the wing interconnect rod end check

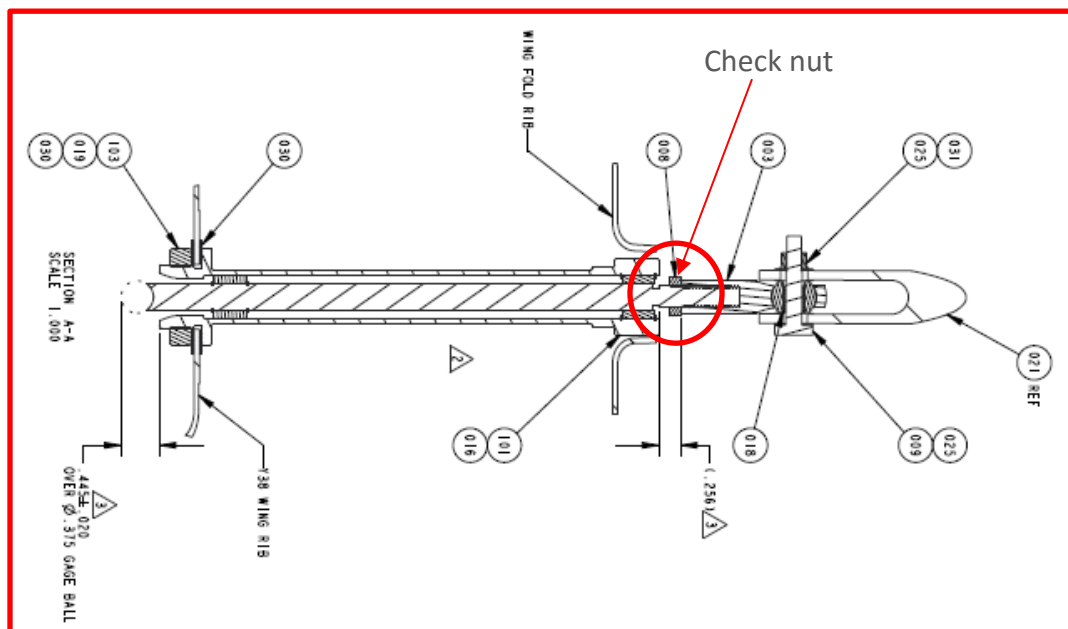
It was discovered upon preflight inspection that an aircraft flap trailing edge was not faired with centerwing trailing edge and was resting approximately ½" lower. Upon further inspection, the flap interconnect tube rod end check nut was backed off from the rod end and the flap interconnect rod could freely rotate adjusting retracted position of the flap. With the wings extended the rod could not rotate far enough for the rod end to fall off, however during trailering operations or with the wing folded the rod could be rotated enough for the rod end to fall off disconnecting the flap control system on one side.

Figure 2: Flap interconnect tube with check nut called out.

nut inside both wings. It may facilitate the inspection process to manually move the flap while using the borescope.

3. If a torque strip is found intact and bridges from the checknut to the rod end proceed to step 4. If no torque stripe is found the the existing torque stripe is broken, contact ICON owner support for further instructions.
