SERVICE BULLETIN

SB-060217-02 REV A

DATE ISSUED: 6/2/2017
DATE EFFECTIVE: 6/2/2017
SUPERSEDES NOTICE: None
SUBJECT: Engine Wire Harness Protection
AIRCRAFT AFFECTED: **MODEL:** ICON A5
S/N: 00001, 00003 - 00020
REQUIRED ACTION: Inspect any engine wire harness for chaffing. Use F4 tape to protect any areas that are prone to chaffing or is chaffing.
TIME OF COMPLIANCE: At the next regularly scheduled inspection or within six (6) months after the effective date of this Service Bulletin, whichever occurs first.

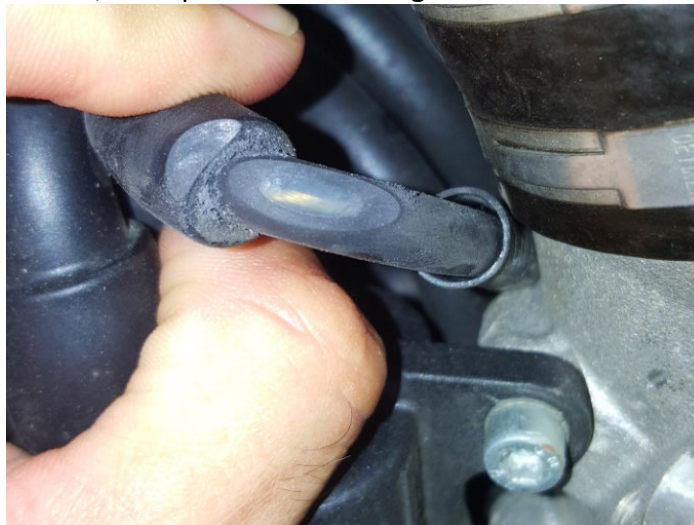
During routine inspection of the aircraft, it was discovered that engine wire harness revealed areas prone to chaffing. The above aircraft may experience a chafing condition of the electrical harness during normal operation. A chafing condition of the electrical harness may result in electrical arcing, tripped circuit fuse, and loss of component function, example as shown in Figure 1.

Figure 1: Wire Chafe

1. Inspect concerned areas for wire harness damaged as seen in Figure 1, proceed to step 2.
2. If chaffing damage to insulation of wires is found and has not damaged the copper wires, individually wrap any damaged wire insulation using F4 tape. Then re-wrap entire bundle using F4 tape.
3. Ensure ignition leads do not touch inner cowling with a minimum clearance of .25" (inch). Cut engine zip ties and adjust/pull ignition wiring to the center of the engine and re-attach zip ties as needed.
4. Re-install engine cowling per ICON maintenance manual chapter 3.4.2.
