SERVICE BULLETIN

SB-070716 REV D

DATE ISSUED: 8/1/2017
DATE EFFECTIVE: 8/1/2017
SUPERSEDES NOTICE: SB-070716 rev C
SUBJECT: ENGINE REGULATOR B OVERHEATING
AIRCRAFT AFFECTED: **MODEL:** A5
S/N: 00001, 00003 - 00020
REQUIRED ACTION: INSTALLING HEAT SINK (P/N 8822T13) TO ENGINE REGULATOR B IS NOT REQUIRED IF THE CURRENT CONFIGURATION HAS THE FAN (ICA011495) INSTALLED.
NOTE: UNTIL THIS SERVICE BULLETIN IS COMPLIED WITH, OPERATE UNDER THE FOLLOWING TEMPORARY OPERATING LIMITATIONS:
TURN ON ALL INTERIOR AND EXTERIOR LIGHTING TO FULL BRIGHTNESS PRIOR TO AND DURING ENGINE OPERATION. INSPECT WIRES OF REGULATOR B FOR DISCOLORATION AFTER EACH ENGINE OPERATION. NOTIFY MANUFACTURER IF SIGNS OF DISCOLORATION ARE VISIBLE.
TIME OF COMPLIANCE: INSPECT WIRES OF REGULATOR B FOR DISCOLORATION AFTER COMPLIANCE WITH THIS SERVICE BULLETIN AND INSPECT EVERY 50 AFH OR INSPECT PRIOR NEXT FLIGHT IF THE FLIGHT WAS OVER 3 HOURS CONTINUOUS. NOTIFY MANUFACTURER IF SIGNS OF DISCOLORATION BECOMES VISIBLE.

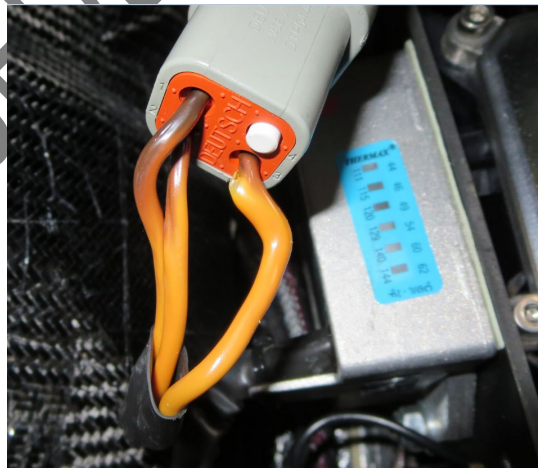
It was discovered during ICON flight operations that the engine regulator wiring harness had features of discoloration (browning).

It was determined through testing that this discoloration was a result of the wire overheating beyond its rated temperature. Although there have been no customer safety or performance notifications from an overheated wire, to date, ICON Aircraft is implementing a solution to prevent overheating of this wire. This Service Bulletin is to provide instructions on how to install high efficiency heat sinks that lower the wire temperature below the temperature rating and a new regulator as necessary.
