SERVICE BULLETIN

SB-081616 REV A

DATE ISSUED: 8/16/2016
DATE EFFECTIVE: 8/16/2016
SUPERSEDES NOTICE: None
SUBJECT: Engine Wire Harness Protection
AIRCRAFT AFFECTED: **MODEL:** ICON A5
S/N: 00001, 00003 - 00011
REQUIRED ACTION: Inspect engine wire harness for chaffing. Use spiral wrap to protect any areas that are prone to chaffing.
TIME OF COMPLIANCE: Before next flight

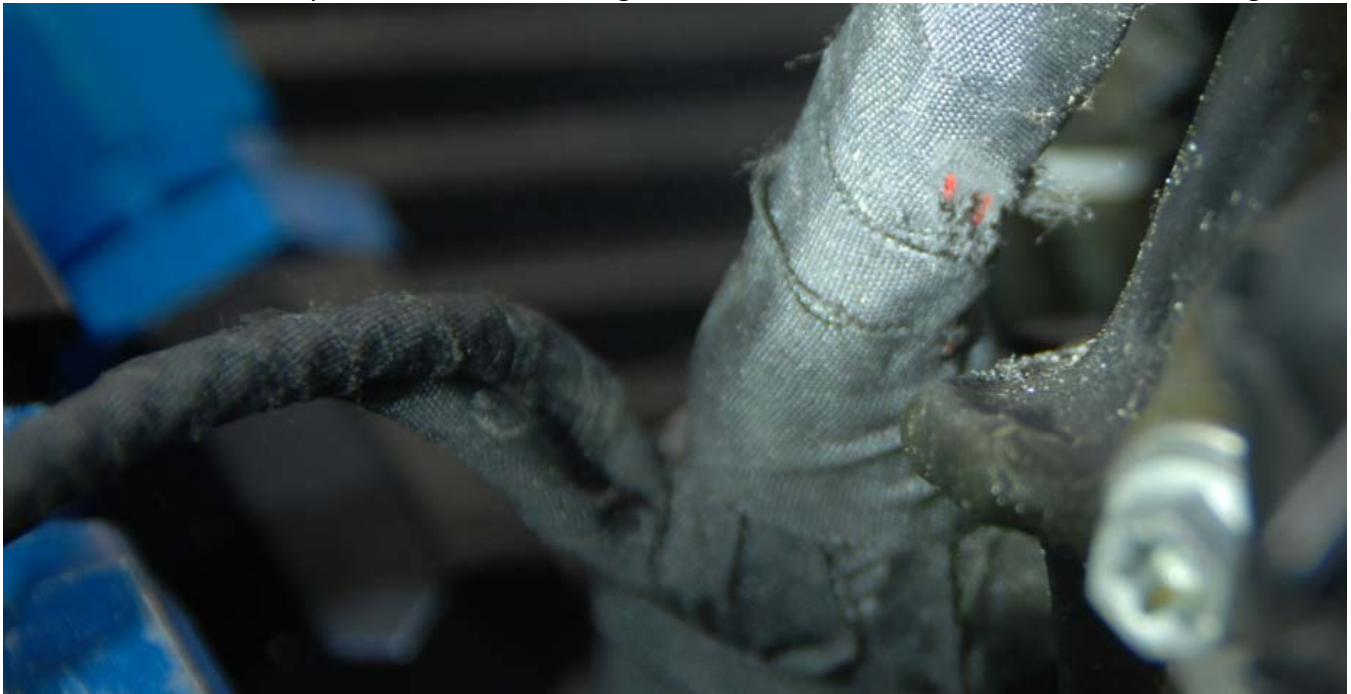
It was discovered during post flight check that an aircraft had a short caused by chaffed wires from the engine wire harness chaffing against the plenum box on the top left hand (LH) side of the engine. Upon inspection, the engine wire harness branch going to the LH side fuel injectors was pressed against the forward left side of the plenum box and chaffing occurred due to the natural vibration of the engine.

Figure 1. Engine wire harness damage due to chaffing

1. Inspect concerned areas for wire harness damaged as seen in Figure 1. If no damage is found, proceed to step 3.
2. If chaffing damage to insulation of wires is found, unwrap damaged area and individually wrap any damaged wire insulation using F4 tape. Then re-wrap entire bundle using F4 tape.
3. Using spiral wrap HT 1/2 N-100, wrap any portions of the engine wire harness that are not within the clearance minimum or are in contact with corners or sharp edges of plenum box.
4. Re-install engine cowling per ICON maintenance manual chapter 3.4.2.
