SERVICE BULLETIN

SB-082317 REV A

DATE ISSUED: 8/23/2017
DATE EFFECTIVE: 8/23/2017
SUPERSEDES NOTICE: None
SUBJECT: Starboard (STBD) Forward Bulkhead pass through for Main Wire Harness has missing Grommet
AIRCRAFT AFFECTED: **MODEL:** ICON A5
S/N: 00001,00003-00020
REQUIRED ACTION:

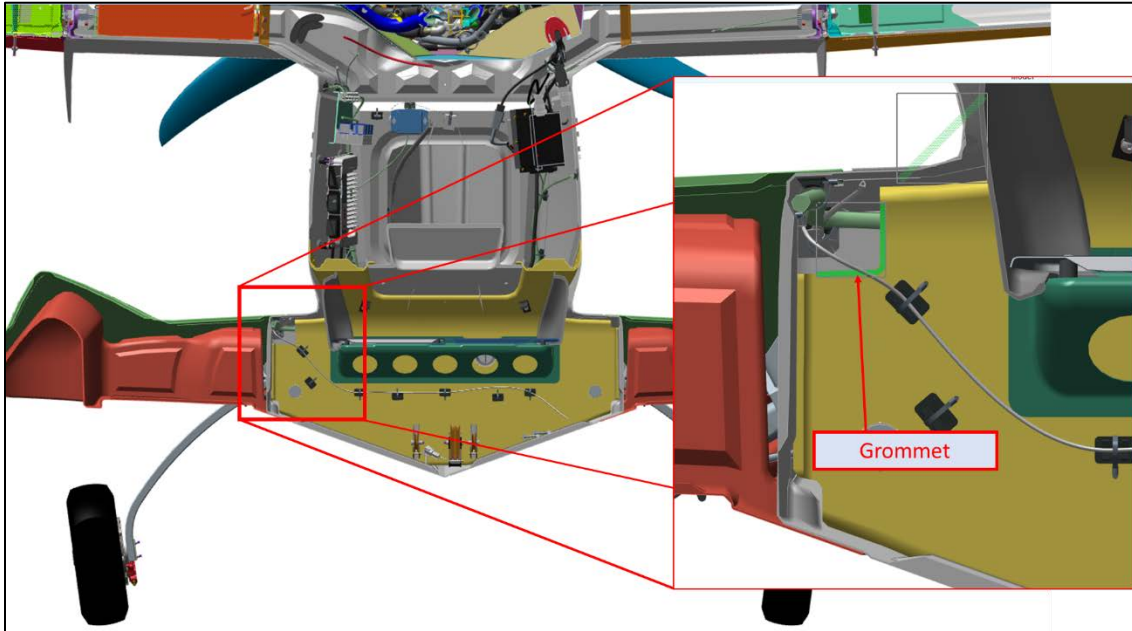
ICON is committed to designing, manufacturing, delivering, and supporting a high quality Light Sport Aircraft, providing a level of safety well beyond expectations. During routine maintenance of the aircraft, it was discovered that the grommet was missing on the STBD forward bulkhead pass through, Figure 1. The bulkhead pass through surface caused chafing of the main wire harness causing intermittent failure

Figure 1: Grommet Placement (Green line)

1) Visually inspect for STBD forward bulkhead grommet – Immediately
A) If the grommet **IS** in place – Operation of the aircraft can continue. Compliance with this Service Bulletin can be recorded as complete via inspection.

B) If the grommet is **NOT** in place - Determine if the main wiring harness is touching the STBD forward bulkhead at the pass through
I) If the main wiring harness is **NOT** touching the STBD forward bulk head at the pass through - Install grommet within 10 hours of flight time.
II) If the main wiring harness **IS** touching the STBD forward bulk head at the pass through - Visually inspect wiring harness expandable sleeving protection and underlying wiring for damage where the harness contacts the bulkhead

a. If no damage is evident – It is permissible to relocate the aircraft to the nearest maintenance facility and within the next 2 hours of operation install the grommet

b. If there **IS** damage to the protective sleeving and/or wiring – Immediately discontinue operation of the aircraft, install grommet, assess the damage and report findings to ICON CS&S for repair instructions.
TIME OF COMPLIANCE: Prior to next flight

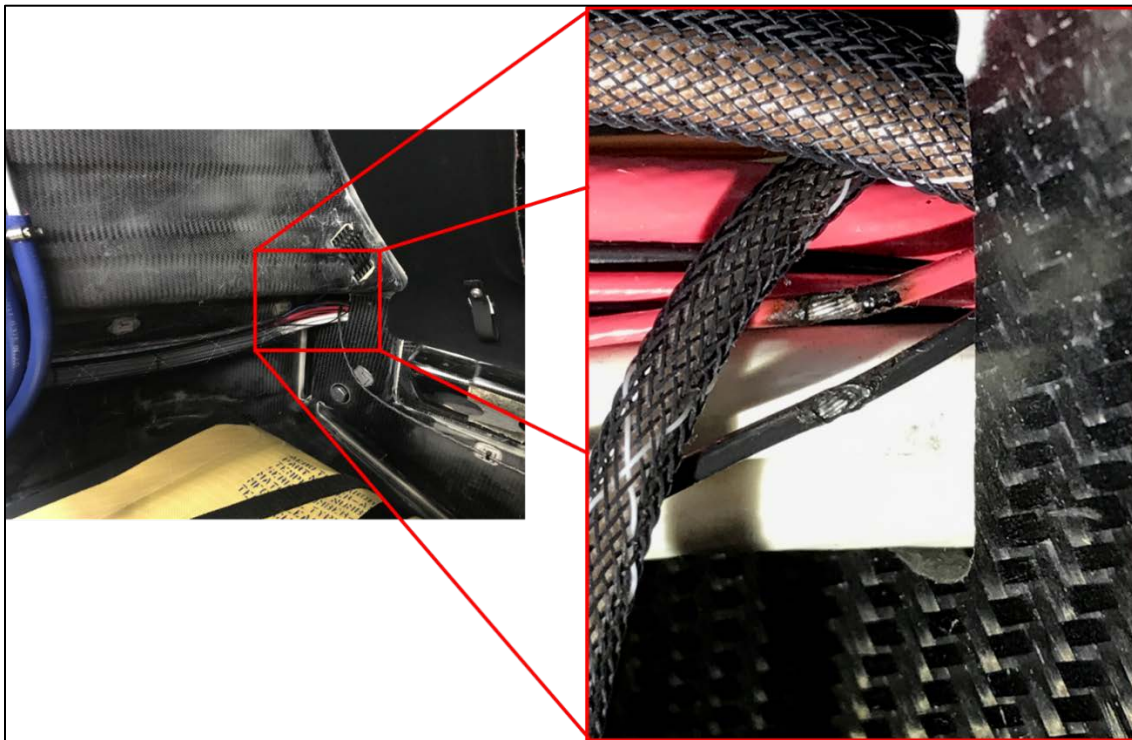
of the fuel pump. This also caused several failures of the fuses and eventually the wires were burned, Figure 2.

Figure 2: Burned Wires

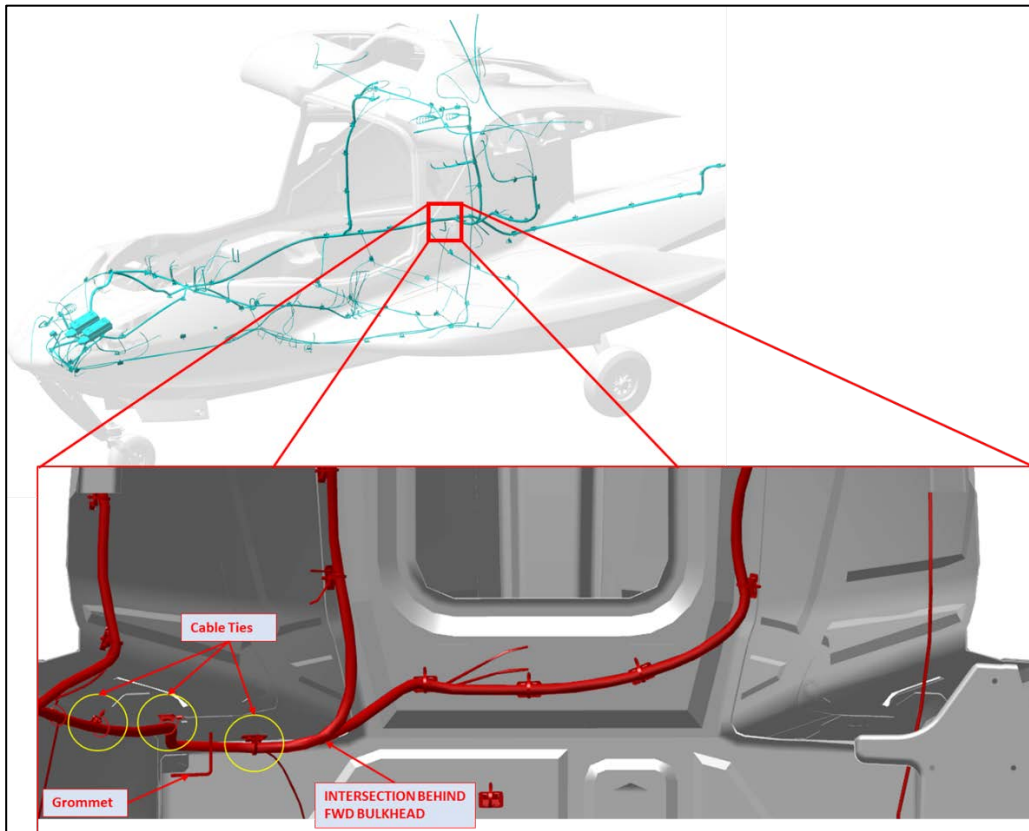
Figure 3: Grommet Install & Ty-Rap Locations

Instructions to install grommet, Figure 3 & 4:

1. Bond Plastic edging grommet to FWD Bulkhead Pass Through
 - a. Wipe bonding surface with isopropyl alcohol discarding cloth after each pass
 - b. Lightly abrade bonding surface using 80-100 grit sandpaper abrade an area approx. ¼" beyond the bonding surface.

- c. Vacuum the area abraded to remove any remaining particulate residues
 - d. Wipe bonding surface again with isopropyl alcohol discarding cloth after each pass
2. Bond plastic edging grommet (MS21266) with CB200 or MA830 adhesive on STBD FWD bulkhead pass through as shown. Follow manufacturer's instructions for cure time.

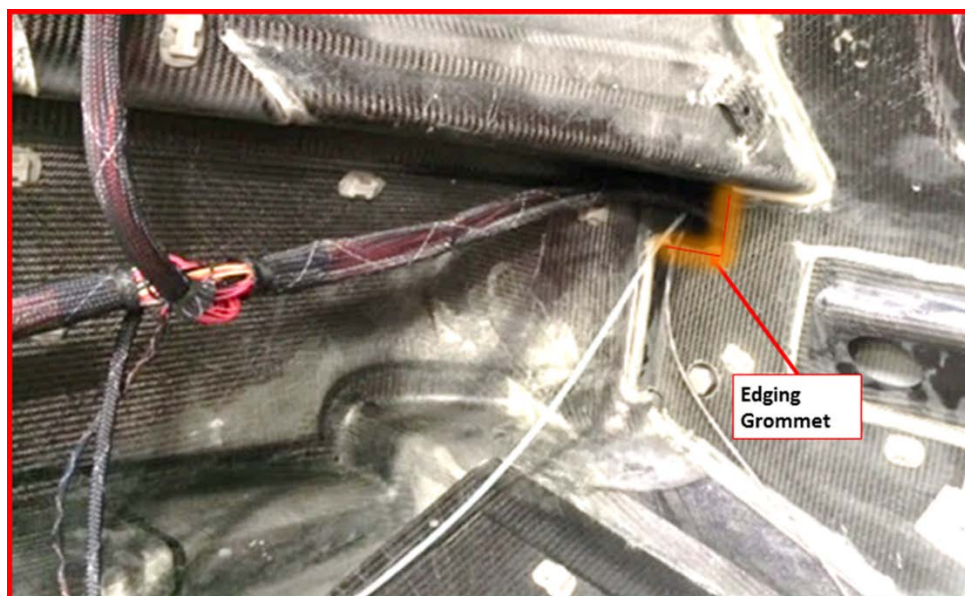
Figure 4: Grommet Install Location
