SERVICE BULLETIN

SB-100616 REV A

DATE ISSUED: 10/6/2016
DATE EFFECTIVE: 10/6/2016
SUPERSEDES NOTICE: None
SUBJECT: Water Rudder
AIRCRAFT AFFECTED: **MODEL:** ICON A5
S/N: 00001, 00003-00013
REQUIRED ACTION: Inspect Water Rudder Attach Fitting
TIME OF COMPLIANCE: Within 5 flight hours

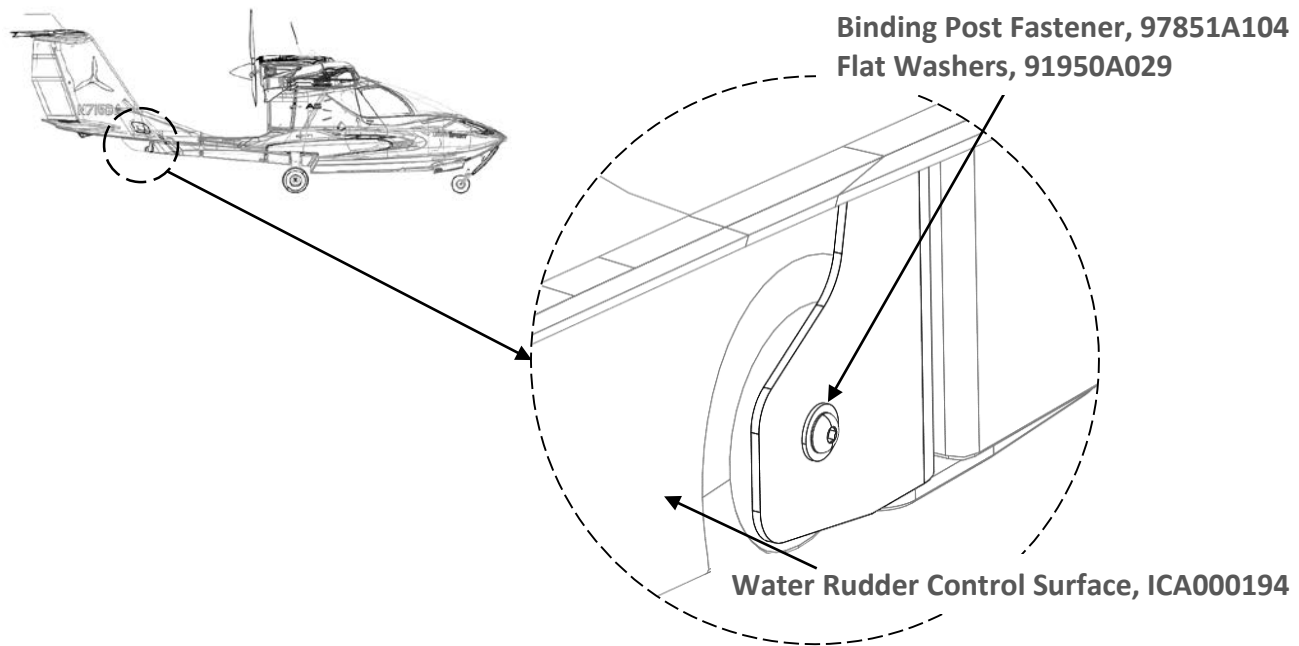
Figure 1 - Removal of Binding Post Fastener and Water Rudder Control Surface

There has been an occurrence where the Water Rudder Attachment Fastener has departed the airplane, allowing the Water Rudder Control Surface to become loose. The event resulted in reduced performance in the rudder system. This service bulletin provides instructions for inspecting the Water Rudder Attachment Fastener and surrounding hardware for evidence of loosening, corrosion, damage, fatigue, or wear.

1. Remove the paired Binding Post Fastener, 97851A104, and Flat Washers, 91950A029, from the Water Rudder Control Surface Installation, as indicated in Figure 1.
2. Carefully separate the Water Rudder Control Surface (ICA000194) from the Water Rudder Pivot Flange (ICA009104) to permit inspection.
3. Check hardware, bushings, and bore for evidence of corrosion, damage, fatigue, or wear. Replace any damaged hardware. Retain all others for re-use.
4. Check for evidence of Loctite 243 (blue) on the threads of the removed fastener.
5. Report findings to ICON Owner Support.

1. Locate the Rudder Control Surface (ICA000194) appropriately within the Water Rudder Pivot Flange (ICA009104).
2. Apply Loctite 243 to the threads of the Binding Post Fastener 97851A104 and re-install with Flat Washers, 91950A029. Torque to 12-15 in-lb. Follow adhesive manufacturer's recommendations for material handling, preparation, application, cleanup, and curing.
3. Rig the rudder system in accordance with the Aircraft Maintenance Manual, ICA000833. Ensure proper function before returning to service.
