SAFETY DIRECTIVE/ALERT

SD-030216 REV B

DATE ISSUED: 03/07/2016
DATE EFFECTIVE: 03/07/2016
SUPERSEDES NOTICE: N/A
SUBJECT: Fuel System
AIRCRAFT AFFECTED: **MODEL:** A5
S/N: 00001, 00002, 00003
REQUIRED ACTION: Install fuel system upgrade
TIME OF COMPLIANCE: Prior to Next Flight

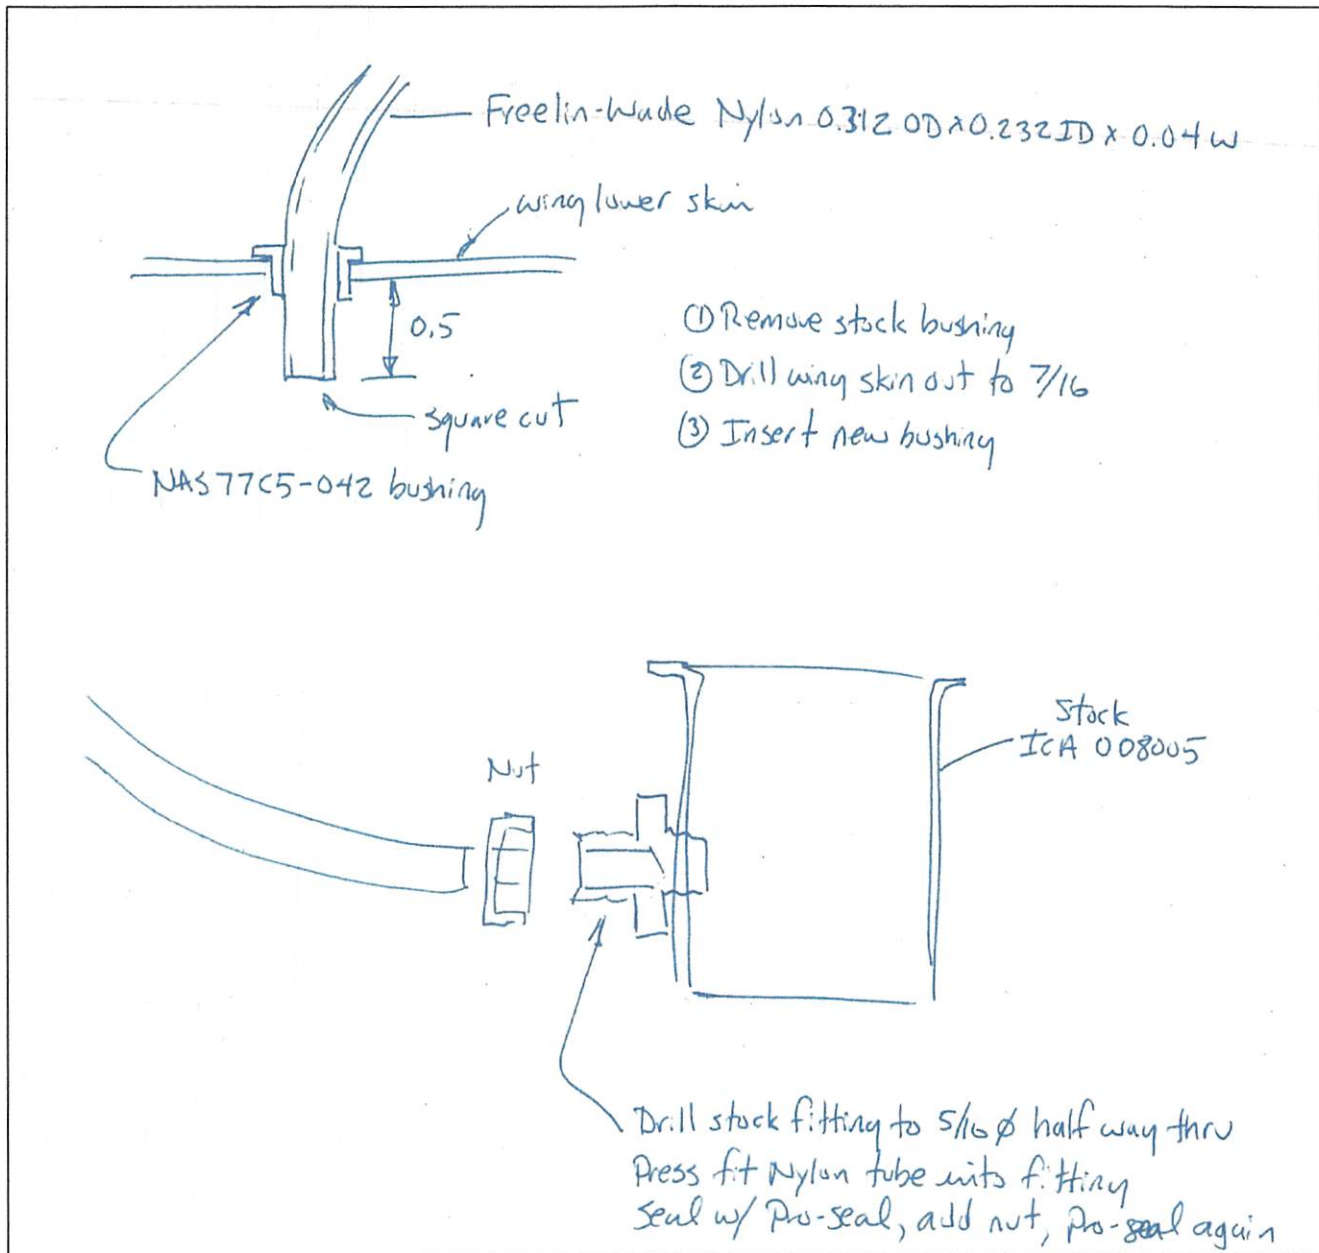
ICON has experienced several anomalies related to the functionality of the A5 fuel system. Although none of these events individually have resulted in a safety of flight issue, ICON believes when assessed collectively could potentially have an impact to the safety of flight.

1. Bond in new NAS77C5-042 bushing into 7/16" hole in wing.
2. Use Nylon tubing to re-route vent line and install per notes from removal and attached sketches.
3. Inside the fuselage just short of the wing fold tube attachment, splice the line with connector 5111K472.
4. Reference Figure 1 and Figure 2, use a 5/16" drill to open up the stock compression fitting and nut to accept new tubing. Use CB200 to bond assembly together and to seal tube to nut.
