SAFETY DIRECTIVE/ALERT

SD-051117 REV A

DATE ISSUED: 05/11/2017
DATE EFFECTIVE: 05/11/2017
SUPERSEDES NOTICE: N/A
SUBJECT: Throttle cable assembly damage
AIRCRAFT AFFECTED: **MODEL:** A5
S/N: 00001 to 00020
REQUIRED ACTION: Inspect throttle cable assembly and replace if damaged
TIME OF COMPLIANCE: 1) If the aircraft throttle has any tendency to retract toward idle when at full throttle stop – inspect Immediately.
2) If no tendency of the throttle to retract when at full throttle – in the next 10 hours of service.

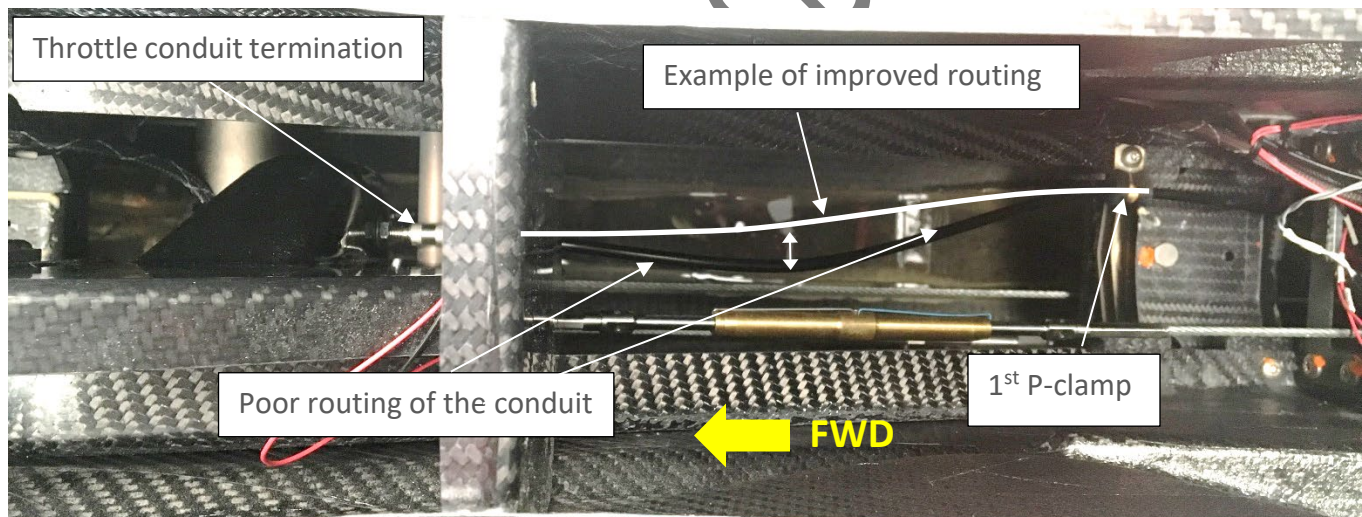
4. If the throttle cable has any tendency to buckle or kink while going from idle to full the throttle the cable must be replaced.
5. Inspect the conduit routing between the conduit termination and the first p-clamp. It should be a nearly straight with smooth bends. There should be not be any excess build-up of conduit as shown in the photo below. If so loosen the 1st P-clamp and remove any excess. This may also be accomplished during step 6 below.

6. Loosen the check nuts on the throttle conduit terminal, run the check nut to the base of the conduit termination and re-tighten the check nuts to lock the conduit in place. This will move the conduit forward, decreasing the effective buckling length of the cable. Actuate the throttle lever to full and ensure that the throttle cable fork swage does not contact the conduit terminal, if so, adjust the terminal position such that it doesn't.
7. Remove baggage inspection panel and locate and inspect the throttle conduit routing. There should be no permanent bends or deformations in the conduit. Inspect the center console

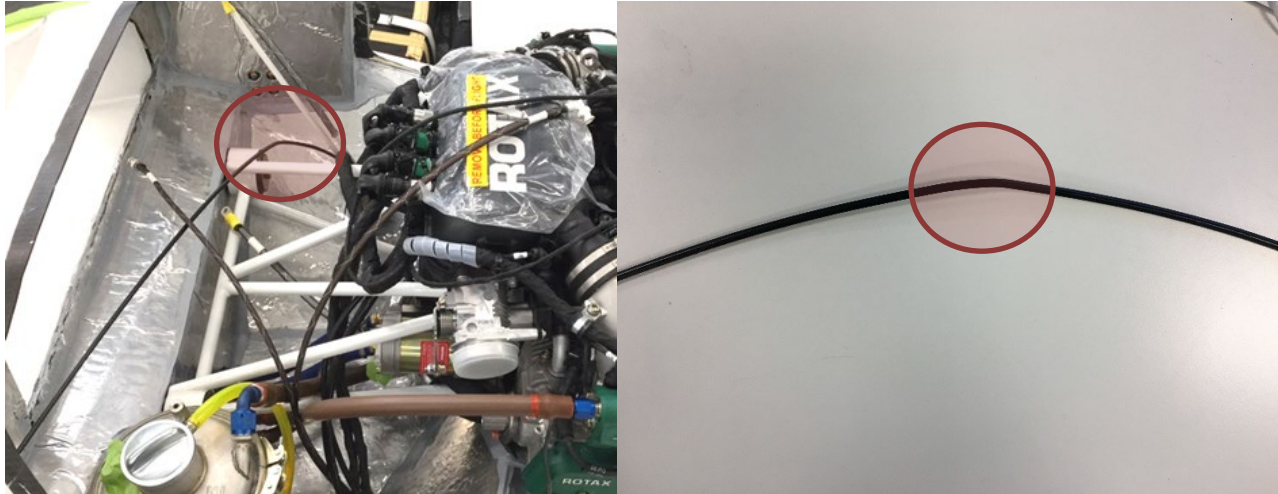
intercostal for the rubber grommet presence of the rubber grommet. If so replace the conduit. An example of a permanent bends are shown in photo below.
