SERVICE BULLETIN

SB-032420-B

ID NUMBER & REVISION: SB-032420-B
SUBJECT: Recurring Inspection of Nose Landing Gear (NLG) Actuator Rigging and NLG Actuator Stop Switches
RELEASE DATE: 09 October 2023
EFFECTIVE DATE: 09 October 2023
SUPERSEDES NOTICE: SB-032420-A
AIRCRAFT AFFECTED: **MAKE & MODEL:** ICON A5
SERIAL NUMBERS: 00001-00015, 00017-00033, 00035-00036, 00038-00086, 00088-00182, 00184-00188

REQUIRED ACTION: Recurring inspection of the NLG actuator rigging, and NLG actuator stop switches.

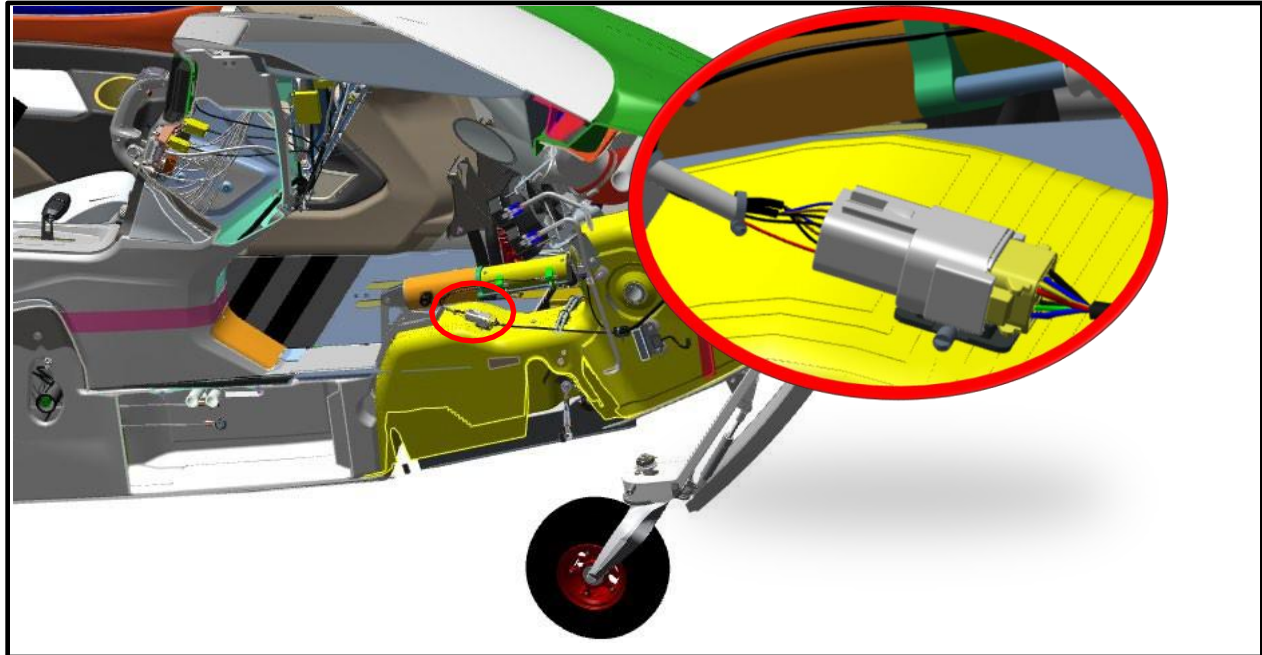
Figure 1 NLG Electrical Connector

1. Ensure the landing gear switch is down.
2. Turn on master power and ensure that the landing gear position indicator indicates that the landing gear is down.
3. Turn the master power off.
4. Disconnect the NLG actuator 8 pin connector shown in Figure 1.

8. After completing the stop switch resistance checks, reconnect the NLG actuator connector and re-secure the connector to the ty-block using a TY24MX cable tie. The landing gear should be swung to confirm satisfactory actuation after reconnecting this connector.

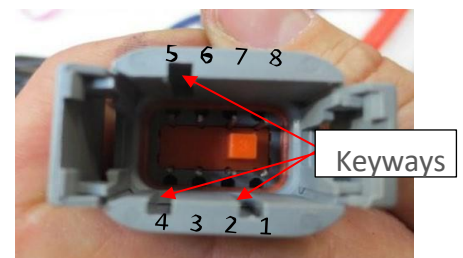
5. On the NLG actuator side of the connector the pins are labeled 1-8 as shown below.
6. Using a multimeter, set it to measure resistance (ohms). Measure the resistance between the following pins and record the value:

Table 1 Resistance Measurement of the NLG Stop Switches

Between Pins	Value if NLG is down	Measured Value
2 & 3	Open	
3 & 4	< 1 Ohm	
2 & 4	Open	
5 & 6	Open	
6 & 7	< 1 Ohm	
5 & 7	Open

7. The resistance value of the above list of pins should be either **Open** or **less than 1 ohm**. If you get a value greater than 1 Ohm during any of the resistance checks, then STOP this procedure. - This reading indicates the stop switch is bad, and the actuator needs to be removed from service and sent to ICON for repairs.

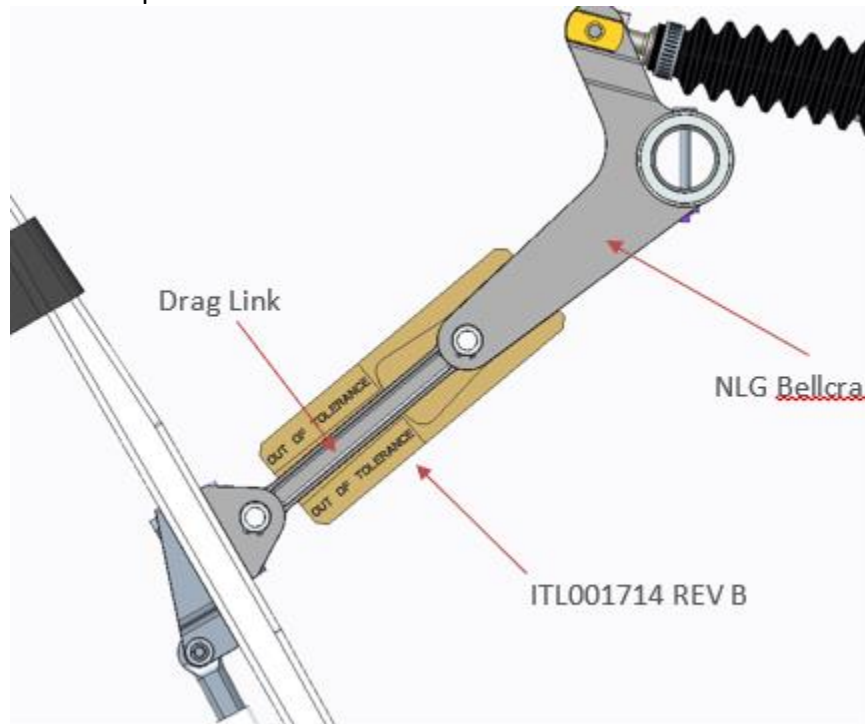
Figure 2 ITL001714 Rev B Indexed on NLG Bellcrank showing the drag link within the “in tolerance” range.

1. With wings folded and normal resting aircraft weight on the NLG check:
 - a. Hold ITL001714 in position. Reference the tool off-of-drag link wrist pin head and bell crank body. Verify drag link is fully in the “in tolerance” window. If within tolerance, move to step 2.

- b. If **not in tolerance (Fig. 2)**, the nose landing gear needs to be re-rigged within the “nominal range” using ITL001714 Rev B and rigging procedure section below.

8. Check the NLG rigging using ICON Tool No. ITL001714 REV B.
 - a. If drag link falls within the “in tolerance” range, repeat Steps 2-8 an additional 24 times for a total of 25 times. Reinstall the 15A MLG fuse.
 - b. If **the drag link indication is not “in tolerance” (Fig. 2)**, and the nose landing gear has not been re-rigged in step 1, rig the NLG actuator to the “nominal range” using ICON Tool No. ITL001714 Rev B by following the procedure in the ICON A5 Maintenance Manual (ICA000833, section [100391](#) or [100392](#)) and repeat steps 2-8 of this section 24 additional times. Reinstall the 15A MLG fuse.

- c. If at any time the NLG has been re-rigged once during this process and the drag link falls outside the “in tolerance” range during the 25 NLG cycles, the actuator stop switch is not functioning correctly and needs to be replaced. Remove the NLG actuator and send it back to ICON for repairs.
