SERVICE BULLETIN

SB-032420-B

SUBJECT: Recurring Inspection of Nose Landing Gear (NLG) Actuator Rigging and NLG Actuator Stop Switches

AIRCRAFT AFFECTED: **MAKE & MODEL:** ICON A5

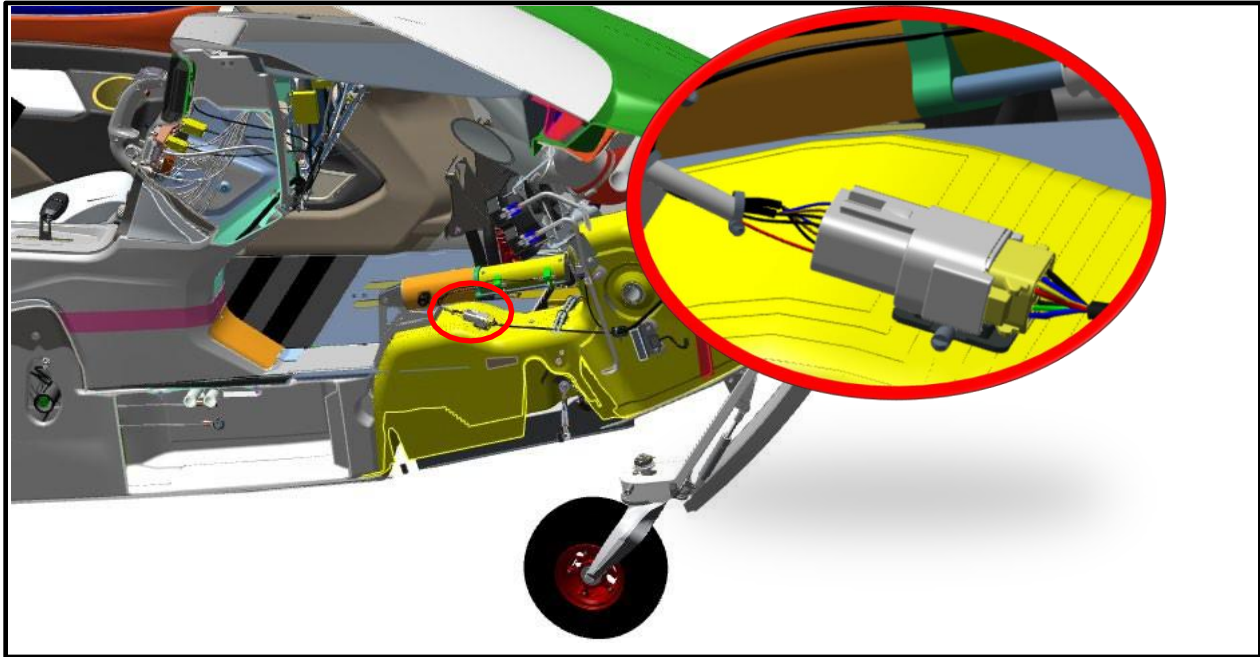
Figure 1 NLG Electrical Connector

1. Ensure the landing gear switch is down.
2. Turn on master power and ensure that the landing gear position indicator indicates that the landing gear is down.
3. Turn the master power off.
4. Disconnect the NLG actuator 8 pin connector shown in Figure 1.

8. After completing the stop switch resistance checks, reconnect the NLG actuator connector and re-secure the connector to the ty-block using a TY24MX cable tie. The landing gear should be swung to confirm satisfactory actuation after reconnecting this connector.

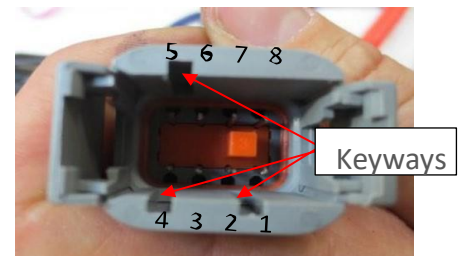
5. On the NLG actuator side of the connector the pins are labeled 1-8 as shown below.
6. Using a multimeter, set it to measure resistance (ohms). Measure the resistance between the following pins and record the value:

Table 1 Resistance Measurement of the NLG Stop Switches

Between Pins	Value if NLG is down	Measured Value
2 & 3	Open	
3 & 4	< 1 Ohm	
2 & 4	Open	
5 & 6	Open	
6 & 7	< 1 Ohm	
5 & 7	Open

7. The resistance value of the above list of pins should be either **Open** or **less than 1 ohm**. If you get a value greater than 1 Ohm during any of the resistance checks, then STOP this procedure. - This reading indicates the stop switch is bad, and the actuator needs to be removed from service and sent to ICON for repairs.

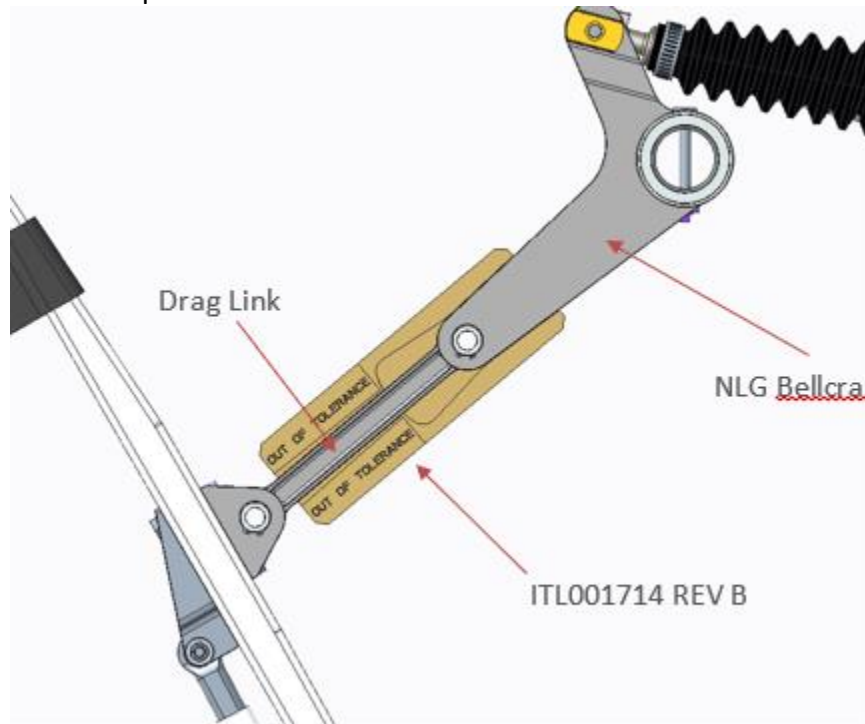
Figure 2 ITL001714 Rev B Indexed on NLG Bellcrank showing the drag link within the "in tolerance" range.

1. With wings folded and normal resting aircraft weight on the NLG check:
 - a. Hold ITL001714 in position. Reference the tool off-of-drag link wrist pin head and bell crank body. Verify drag link is fully in the “in tolerance” window. If within tolerance, move to step 2.

- b. If **not in tolerance (Fig. 2)**, the nose landing gear needs to be re-rigged within the “nominal range” using ITL001714 Rev B and rigging procedure section below.

8. Check the NLG rigging using ICON Tool No. ITL001714 REV B.
 - a. If drag link falls within the “in tolerance” range, repeat Steps 2-8 an additional 24 times for a total of 25 times. Reinstall the 15A MLG fuse.
 - b. If the drag link indication is not “in tolerance” (Fig. 2), and the nose landing gear has not been re-rigged in step 1, rig the NLG actuator to the “nominal range” using ICON Tool No. ITL001714 Rev B by following the procedure in the ICON A5 Maintenance Manual (ICA000833, section [100391](#) or [100392](#)) and repeat steps 2-8 of this section 24 additional times. Reinstall the 15A MLG fuse.

- c. If at any time the NLG has been re-rigged once during this process and the drag link falls outside the “in tolerance” range during the 25 NLG cycles, the actuator stop switch is not functioning correctly and needs to be replaced. Remove the NLG actuator and send it back to ICON for repairs.

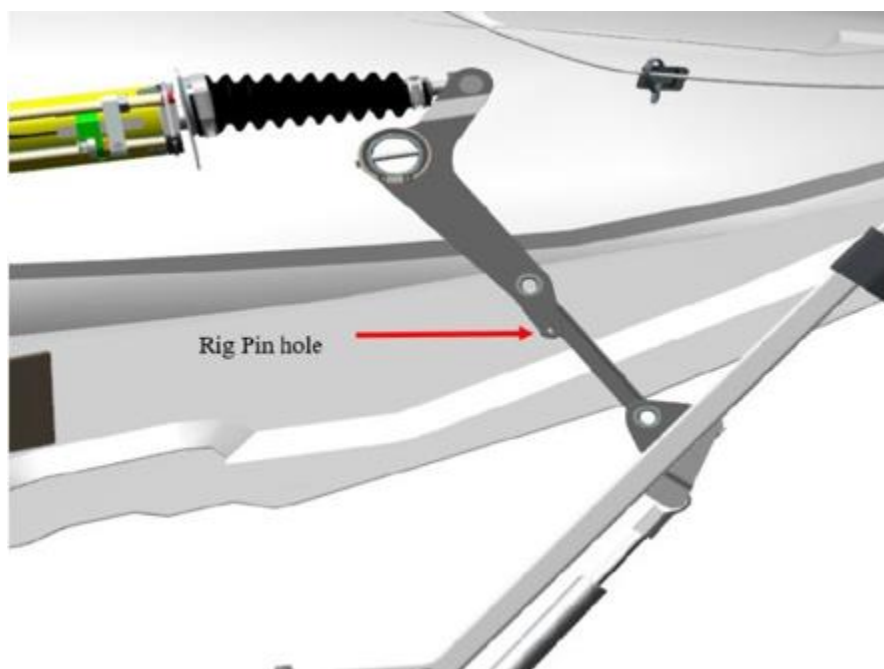
Figure 4 Location of the NLG rig pin hole.

1. With wings folded and normal resting aircraft weight on the NLG check:
 - a. If a 0.163-inch rigging pin **can be inserted** into the NLG rigging hole (figure 2), then proceed to step 2 of this section.

- b. If a 0.163-inch rigging pin **cannot be inserted** into the NLG rigging hole, then the nose landing gear needs to be re-rigged using a 0.1885"-0.1875" rigging pin in accordance with the ICON A5 Maintenance Manual (ICA000833, section 100391 or 100392).

8. Check the NLG rigging using a 0.163-inch rigging pin.
 - a. If a 0.163 in rig pin **can be installed** into the NLG rigging hole, repeat Steps 2-8 of this section an additional 24 times for a total of 25 times. Reinstall the 15A MLG fuse.
 - b. If a 0.163-inch rig pin **cannot be installed**, and nose landing gear as not been re-rigged in step 1, rig the NLG actuator using a 0.1885-0.1875 rigging pin in accordance with the ICON A5 Maintenance Manual (ICA000833, section 100704) and repeat steps 2-8 of this section, 24 additional times. Reinstall the 15A MLG fuse.
 - c. If at any time the NLG has been re-rigged once during this process and 0.163 in. rig pin is unable to be inserted during the 25 NLG cycles, the actuator stop switch is not functioning correctly and needs to be replaced. Remove the NLG actuator and send it back to ICON for repairs.
