SERVICE BULLETIN

SB-060217-01 REV A

DATE ISSUED: 6/2/2017
DATE EFFECTIVE: 6/2/2017
SUPERSEDES NOTICE: None
SUBJECT: Wire Harness/Wires Protection
AIRCRAFT AFFECTED: **MODEL:** ICON A5
S/N: 00001, 00003 – 00020
REQUIRED ACTION: Inspect any wire harness/wires for chaffing. Use spiral wrap or F4 tape to protect any areas that are prone to chaffing and nicks.
TIME OF COMPLIANCE: At a scheduled maintenance period or during routine inspection.

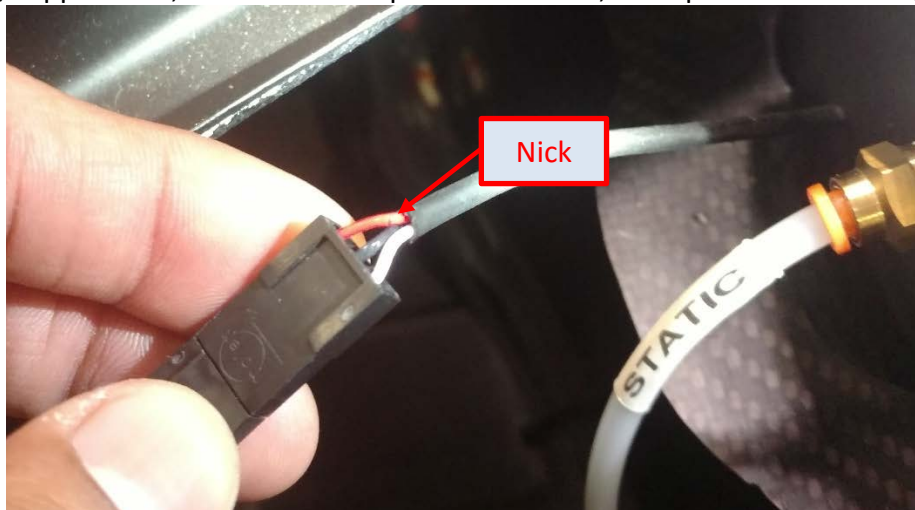
Figure 1: Wire Chafe

During routine inspection of the aircraft, it was discovered that wire harness/wires revealed areas prone to chaffing or nicks. The above aircraft may experience a chafing or nicks condition of the electrical harness/wires during normal operation. A chafing/nicks condition of the electrical harness may result in electrical arcing, tripped fuse, and loss of component function, example as shown in Figure 1.

1. Inspect concerned areas for wire/wire harness damaged like Figure 1, proceed to step 2.
2. If chaffing or nick damage to insulation of wires is found and has not damaged the copper wires, individually wrap any damaged wire insulation using F4 tape. Then re-wrap entire bundle using F4 tape, leave a minimum no touch clearance.
3. Using spiral wrap HT 1/2 N-100, wrap any portions of the wire harness that may contact corners or sharp edges of the components as required.
4. Re-assemble aircraft as per ICON maintenance manual.
