SERVICE BULLETIN**SB-093025-A****INSTRUCTIONS:**

SERVICE BULLETIN

SB-093025-A

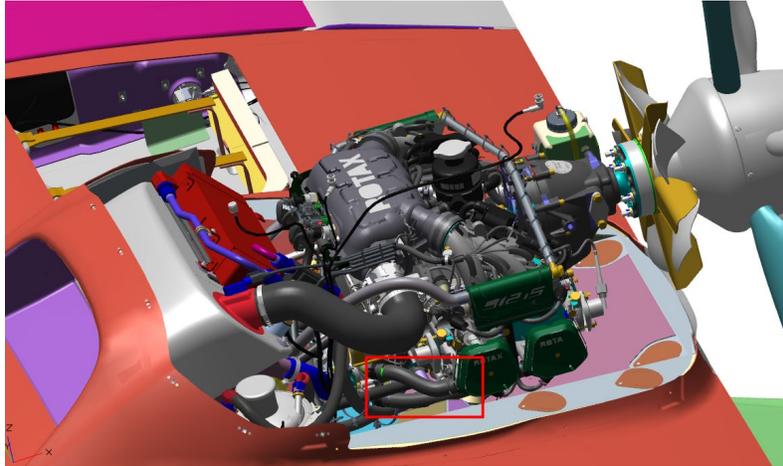
*Figure 1. Location of Chafing*

1. Remove the Engine Cowl and LH Muffler Fairing in accordance with the Aircraft Maintenance Manual, task 100497 (Remove Engine Cowlings).
2. Remove the LH Exhaust in accordance with the Aircraft Maintenance Manual, task 100501/100162 (Remove Exhaust System).
3. Inspect for contact between the Firewall and Coolant Hose (Figure 2) and/or between the Engine Mount Lug and Coolant Hose (Figure 3). If there is clearance, proceed to Reassembly; if contact/chafing is identified, proceed to Repair.
 - a. **NOTE:** *Coolant hoses may be orange silicone or black rubber hoses.*

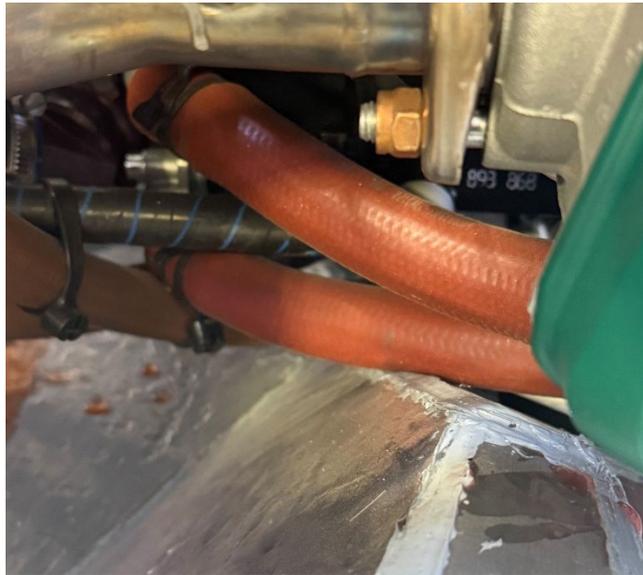
*Figure 2. Interference Between Firewall and Coolant Hose*

7. Verify that there is clearance between the hoses and firewall, and between the hoses and engine mount (Figure 2).
8. As needed, reapply Fire Barrier sealant to the firewall so there are no exposed edges/seams. (Figure 5)

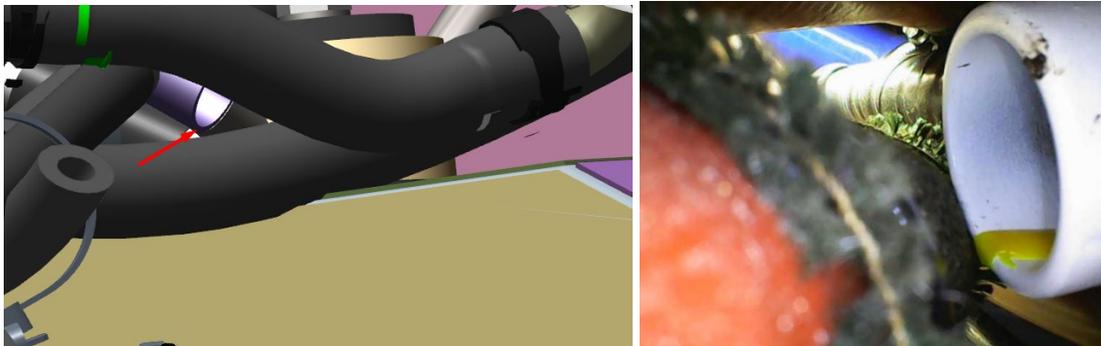
*Figure 3. Interference Between Engine Mount Lug and Coolant Hose*

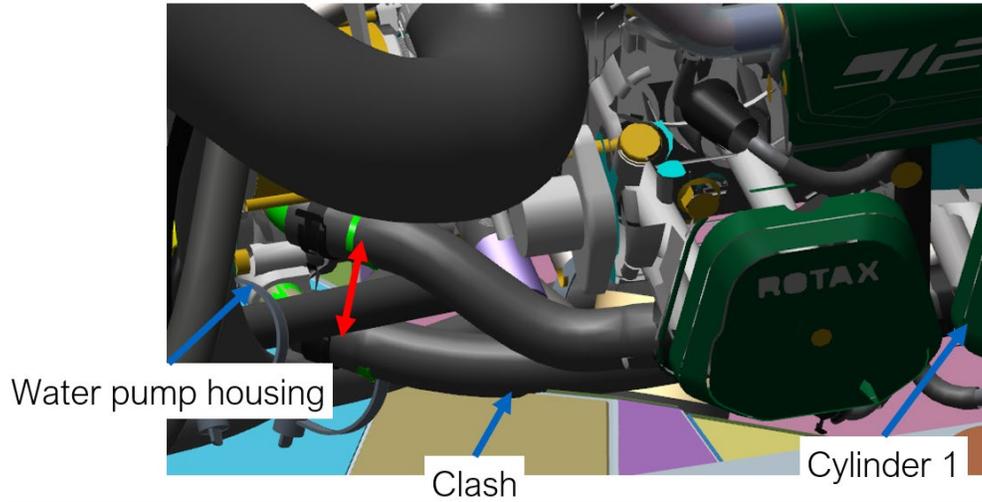
*Figure 4. Swap Hoses at Water Pump*

6. Disconnect the coolant hoses from the water pump housing (not the cylinder ends), then reconnect them in opposite locations, so that the upper water pump outlet connects to Cyl 1 and the lower water pump outlet connects to Cyl 3. (Figure 4, Figure 6)

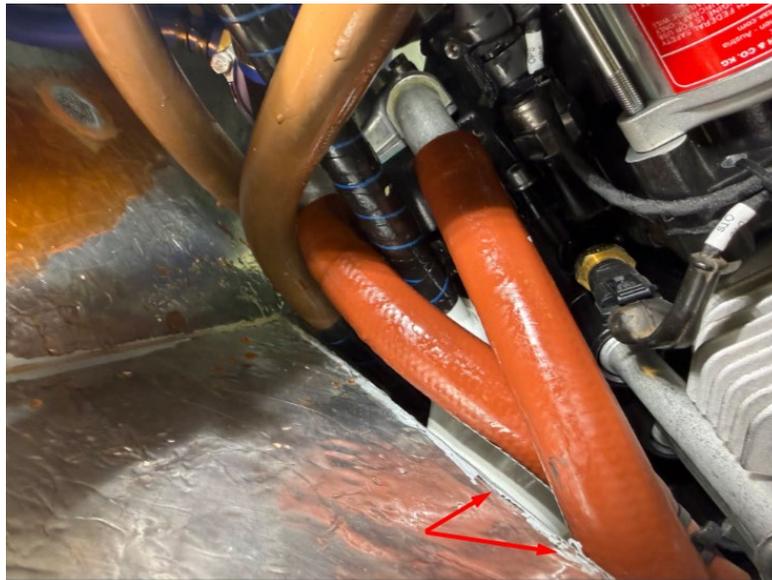
*Figure 5. Damaged Fire Barrier Sealant*

- a. Wipe clean with mineral spirits and wipe dry with a clean cloth.
 - b. **WARNING:** *When using mineral spirits, ensure work area is well ventilated and located near an emergency eye wash station. Wear the following PPE: Safety glasses with side shields or chemical goggles; Chemical resistant gloves (nitrile or equivalent).*

- c. **CAUTION:** *Do not clean with isopropyl alcohol.*
 - d. Ensure the surface is dry before applying FIRE BARRIER 2000PLUS sealant.
 - e. Apply FIRE BARRIER 2000PLUS sealant in accordance with manufacturer's instructions, with a minimum 1/2 in. overlap with existing sealant.

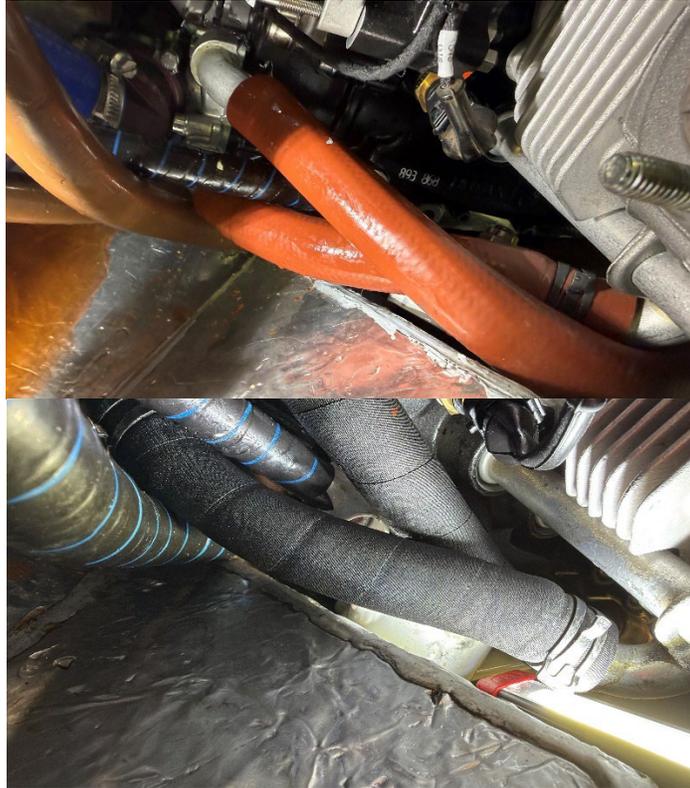
Figure 6. Completed Repair
