SERVICE BULLETIN

SB-041018 REV B

DATE ISSUED: 6/14/2018
DATE EFFECTIVE: 6/14/2018
SUPERSEDES NOTICE: SB-041018-A
SUBJECT: Rudder pedal brake master cylinder lower attachment bolt replacement and rod end inspection

AIRCRAFT AFFECTED: **MODEL:** ICON A5
S/N: 00001-00020, 00022-00036

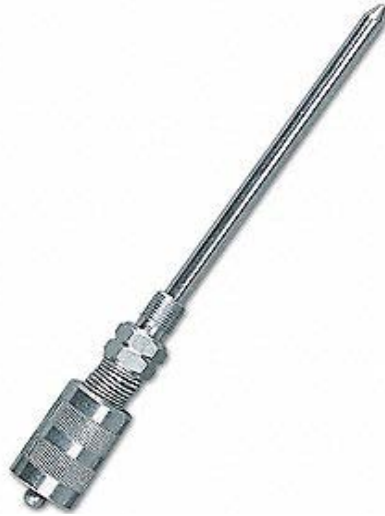
Figure 1: Needle nose grease fitting adapter.

1. Westward Needle nose grease fitting adapter Model number 13X058 or equivalent (shown in Figure 1)
