SERVICE BULLETIN

SB-121924-A

ID NUMBER & REVISION: SB-121924-A
SUBJECT: (MANDATORY) Redressal of ROTAX SB-912i-015iS Mandatory Inspection and Replacement of Expansion Tank Assy
RELEASE DATE: 22 January 2025
EFFECTIVE DATE: 22 January 2025
SUPERSEDES NOTICE: N/A
AIRCRAFT AFFECTED: **MAKE & MODEL:** ICON A5
SERIAL NUMBERS: 00001-00224
REQUIRED ACTION: Inspect and/or replace the ROTAX Expansion Tank Assy in accordance with ROTAX SB-912i-015iS. **This is mandatory.**
TIME OF COMPLIANCE: Refer to ROTAX SB-912i-015, Section 1.5:

Inspection and/or replacement of expansion tank assy. for ROTAX® 912, 914, 912 i, 915 i and 916 i (Series) Aircraft Engines

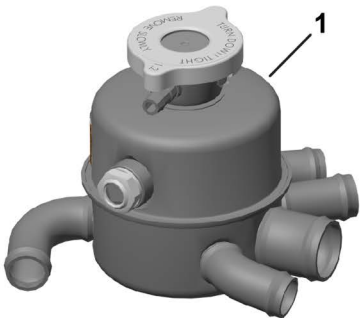
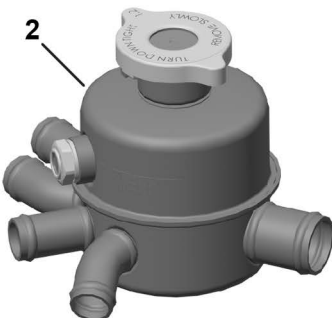
Fig. 1

Fig.1/ pos.	part no.	Qty/ engine	Description
1	922668	(1)	EXPANSION TANK ASSY.
2	922666	(1)	EXPANSION TANK ASSY.
-	-	AR	COOLANT (as specified in the latest Service Instruction SI-912-016, SI-914-019, SI-912 i-001, SI-915 i-001,SI-916 i-001)
