### SERVICE BULLETIN SB-101722-C

ID NUMBER & REVISION:	SB-1	L0172	2-C				
SUBJECT:	Can	opy La	atch Installa	ation			
RELEASE DATE:	15 C	Decen	nber 2022				
EFFECTIVE DATE:	15 C	Decen	nber 2022				
SUPERSEDES NOTICE:	SB-1	L0172	2-В				
AIRCRAFT AFFECTED:	MA	KE & I	MODEL:	ICON A5			
	SER	IAL N	UMBERS:	ASN: 0013	0 – 00153; (	00155	5; 00156; 00158 – 00166
<b>REQUIRED ACTION:</b>	Insp	ect th	ne canopy	atch mech	anism for p	prope	r torque and installation.
	Adju	ust the	e canopy la	tch mechar	nism if torqu	ue spe	ecifications are not met.
TIME OF COMPLIANCE:	At t	he ne	xt Service li	nterval or if	the canopy	/ latcł	n opens during flight.
<b>REVISION HISTORY:</b>	Α	Initia	l Release				
LEVEL OF CERTIFICATION			Pilot/Own	er		$\boxtimes$	A & P
<b>REQUIRED</b> (any level check	ked		LSA Repair	man – Insp	ection	$\boxtimes$	Certified Repair Station

ICON has identified a situation where the canopy latch mechanism would not remain closed during flight. In addition, the canopy latch mechanism could be opened with less than the required amount of force per ICON specifications. The intent of this service bulletin (SB-101722-C) is to provide guidance for the inspection of the canopy latch and adju

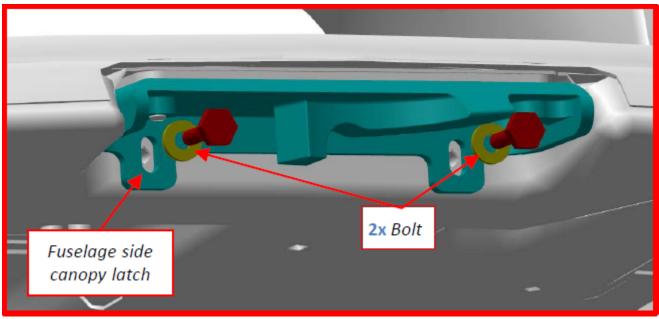
Figure 1 Bolts and Back of Strike Plate

- 1. Lift the canopy up and out of the way
- 2. Loosen the two bolts on the back of the strike plate
  - a. See Figure 1

4. Torque the two bolts on back of the strike plate to 26 in-lb.

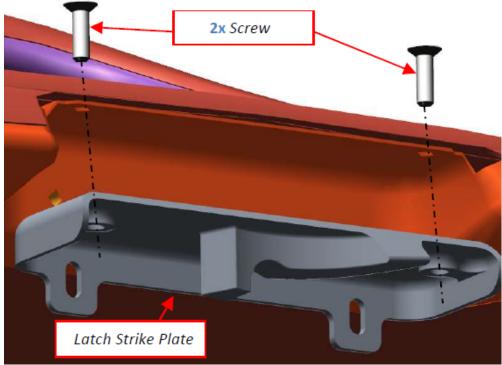
Figure 2 Screws on Top of Strike Plate

- 3. Inspect the two screws on top of the strike plate
  - a. Verify the two screws are torqued to 26 in-lb
  - b. See Figure 2

**NOTE**: If SIL-POXY is present it will be reapplied as the final step of canopy latch torque adjustments have been made.

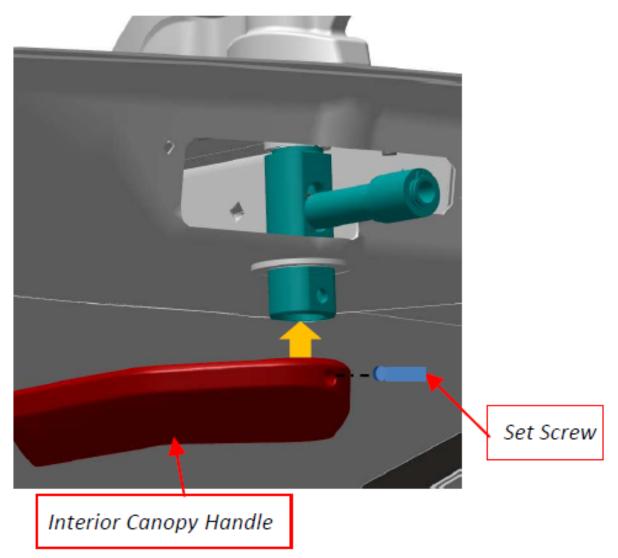
- 1. Sitting in the cockpit with canopy closed, remove the interior canopy latch handle by removing the set screw
  - a. See Figure 3

- 5. Validate the Canopy Latch torque after the latch striker arm is torqued to ensure nothing has changed
- 6. Install the canopy latch handle by inserting the handle over the canopy latch shaft and installing the set screw.
  - a. Apply Loctite 243 to the set screw
  - b. Torque set screw to 2-4 in-lb.
  - c. See Figure 3

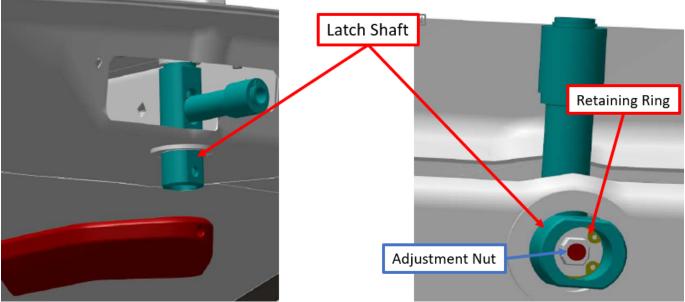
Figure 4 Latch Shaft and Retaining Ring

- 1. While seated in the cockpit, inspect the inside of the canopy latch shaft for proper installation of the retaining ring.
  - a. See Figure 4
- 2. Ensure the retaining ring is seated in the inner groove of the latch shaft
  - a. See Figure 5

- 3. If the retaining ring is not properly seated into position:
  - a. With needle nose pliers, carefully push the retaining ring back into position by firmly pushing up on the retaining ring until it clicks/ snaps into place.
  - b. If Unable to confidently seat snap ring into place, loosen the striker latch arm to allow smooth up and down adjustments (see Figure 6)

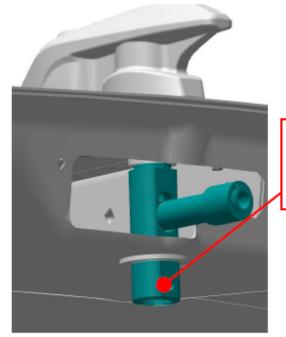
Figure 7 Torque Check on Canopy Latch

- 1. On the canopy latch shaft, use a force gauge or tool ITL002660 adapter and torque wrench (see Figure 8) to check the torque of the canopy latch mechanism.
  - a. 20 to 35 in lb to open canopy
  - b. 25 MAX in lb to close canopy
  - c. See Figure 7

Use a force gauge or a torque wrench with the ITL002660 adapter tool to check for proper torque setting.

2. If the torque measurements are not within limits proceed with Canopy Latch Adjustment.

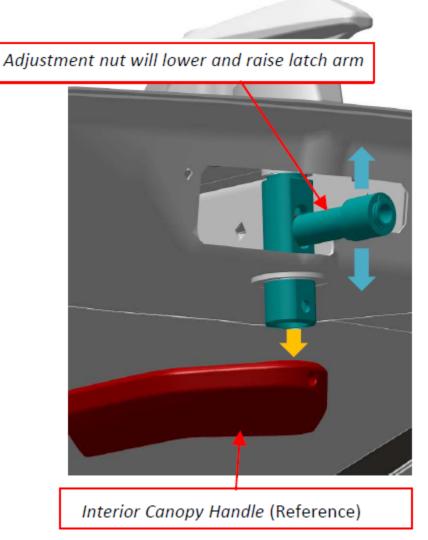
Figure 9 Canopy Latch Adjustment

- 1. Slightly loosen striker arm to allow for smooth up and down adjustments
- 2. With the canopy closed and canopy latch closed, turn the adjustment nut inside the canopy latch to adjust the torque required to open and closed the canopy latch.
  - a. See Figures 9 and 10

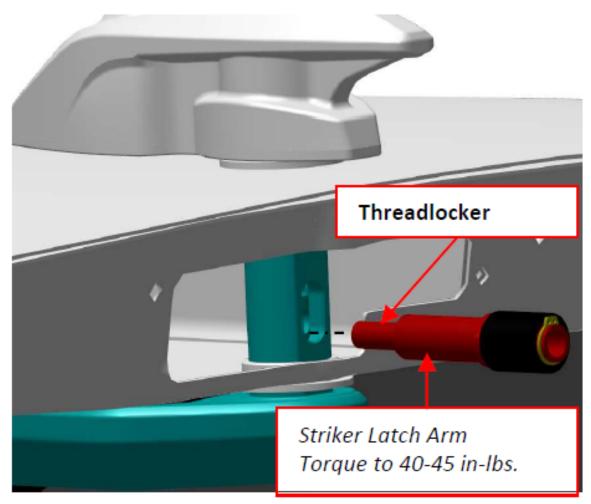
Figure 11 Canopy Torque Adjustment

- 3. On the canopy latch shaft, use a force gauge or tool ITL002660 adapter and torque wrench (see Figure 8) to check the torque of the canopy latch mechanism.
  - a. 20 to 35 in-lb to open canopy
  - b. Verify that the close force is no more than 25 in-lb to close canopy
  - c. See Figure 11

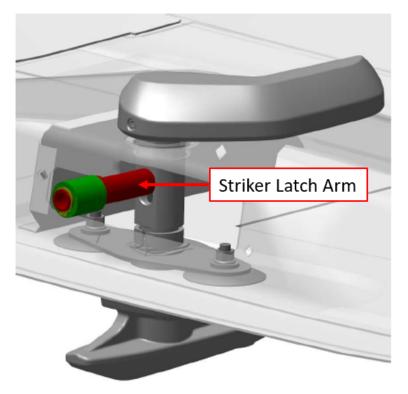
Figure 12 Striker Latch Arm

- 4. Torque Striker Latch Arm to 40-45 in-lb
  - a. See Figure 12
